BAL HARBOUR VILLAGE

UTILITY MASTER PLAN

FEBRUARY 2015

CRAIG A. SMITH & ASSOCIATES
7777 GLADES RD, SUITE 410
BOCA RATON, FL 33434
561.314.4445

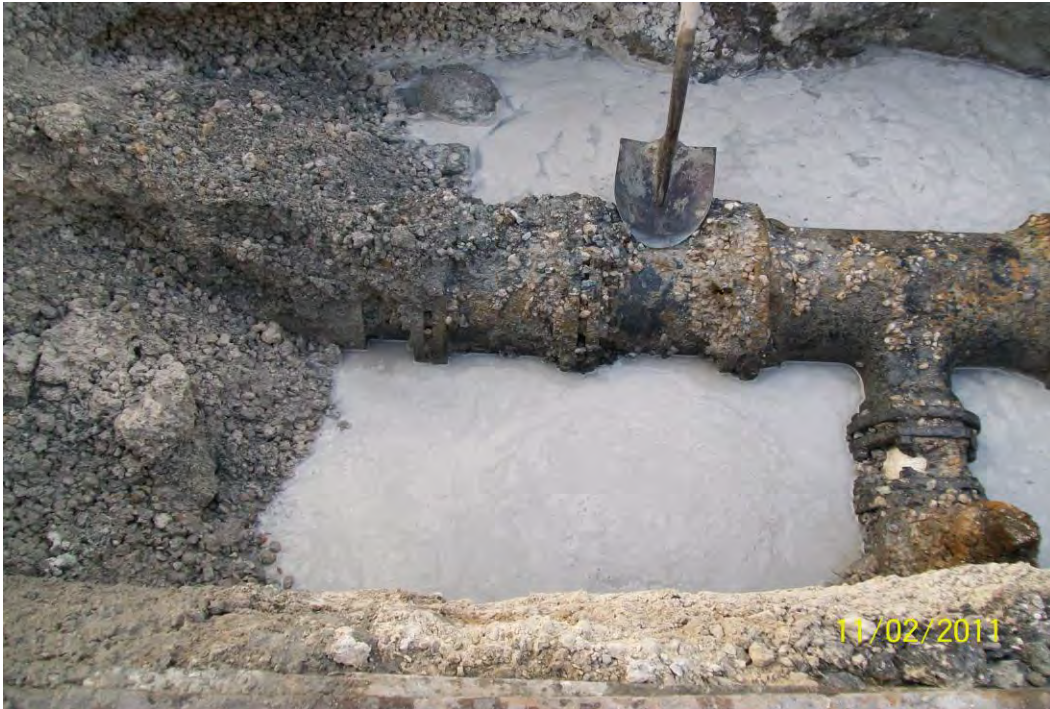
Photo 15 : Leaking water main pipe uncovered.

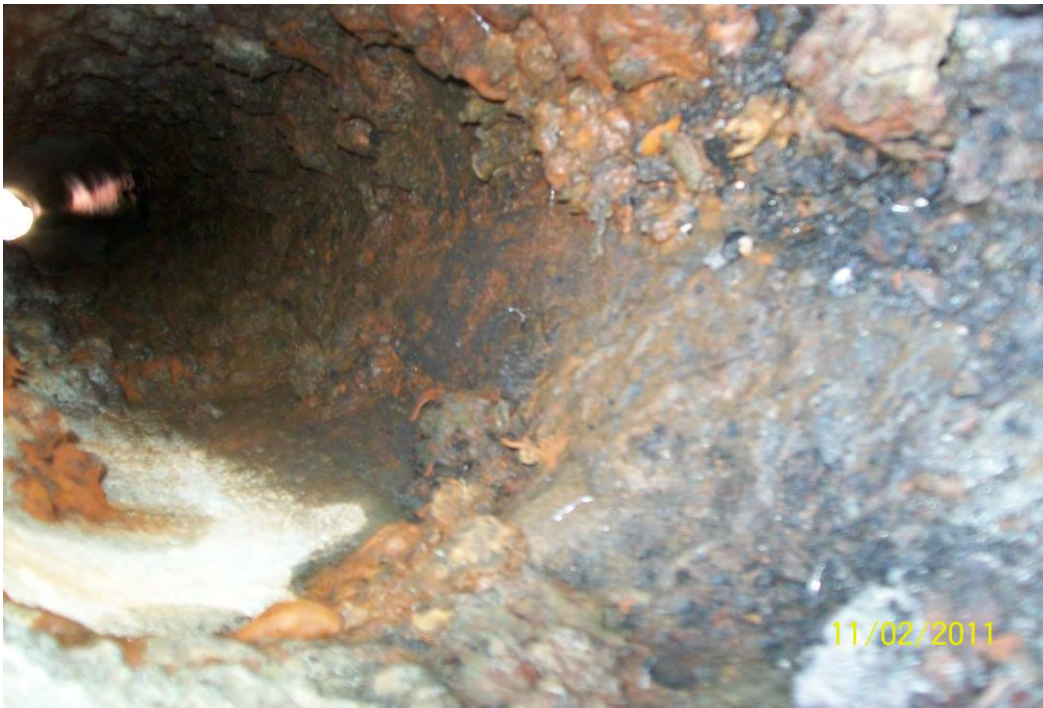
Photo 16 : Inside of water main pipe removed for repair.

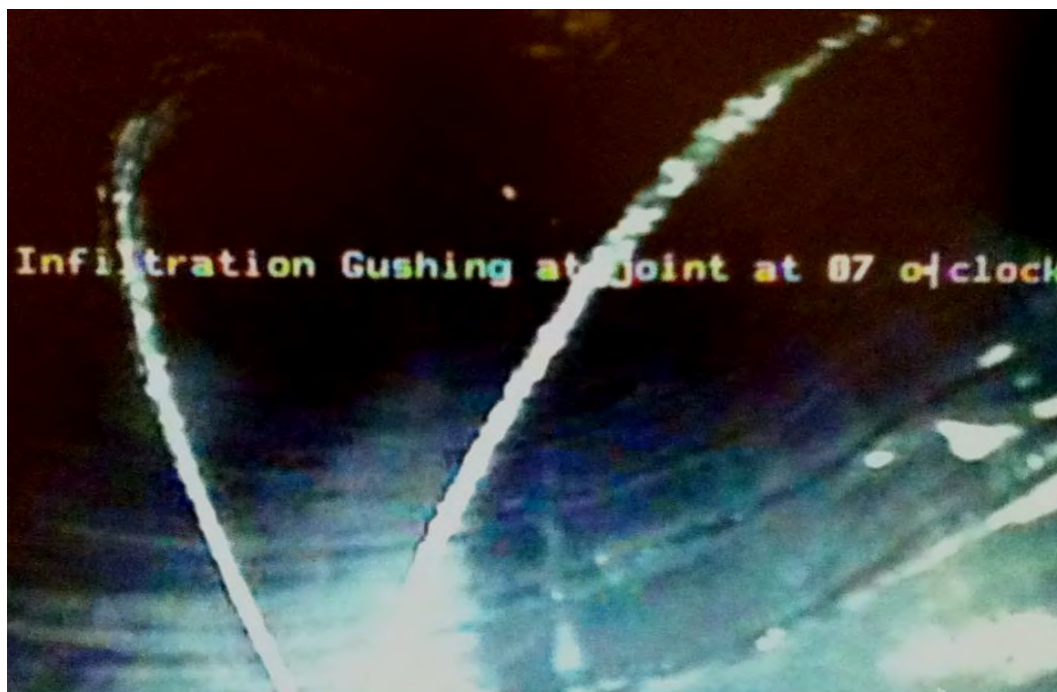
Photo 13: Groundwater infiltration into stormwater pipe.

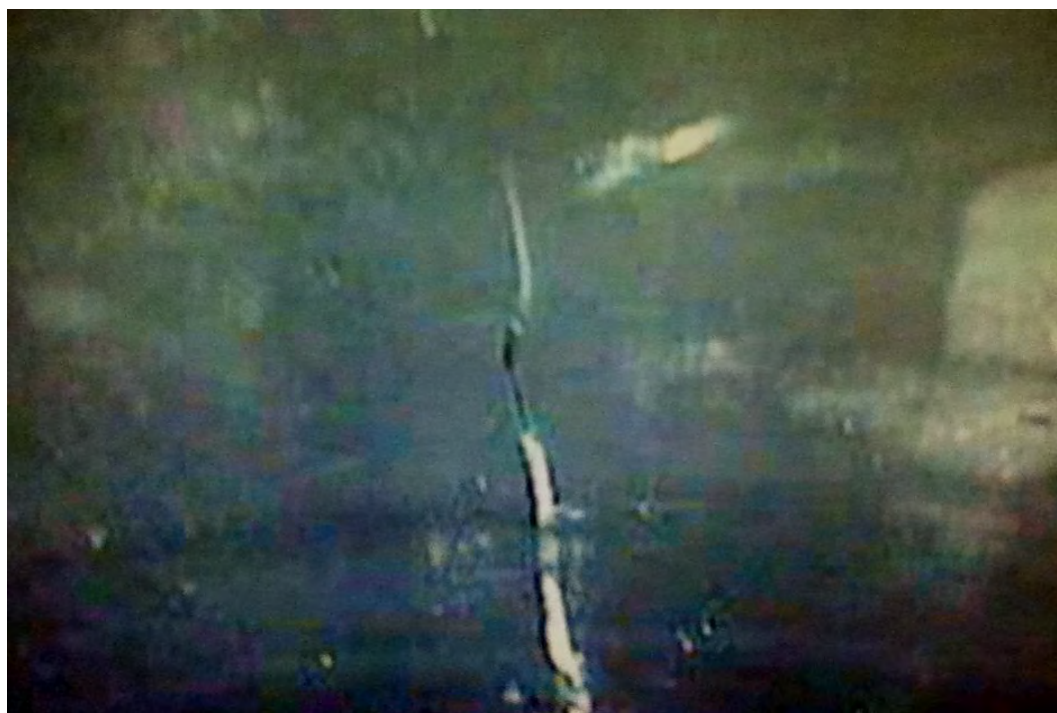
Photo 14: Longitudinal crack at top of stormwater pipe.

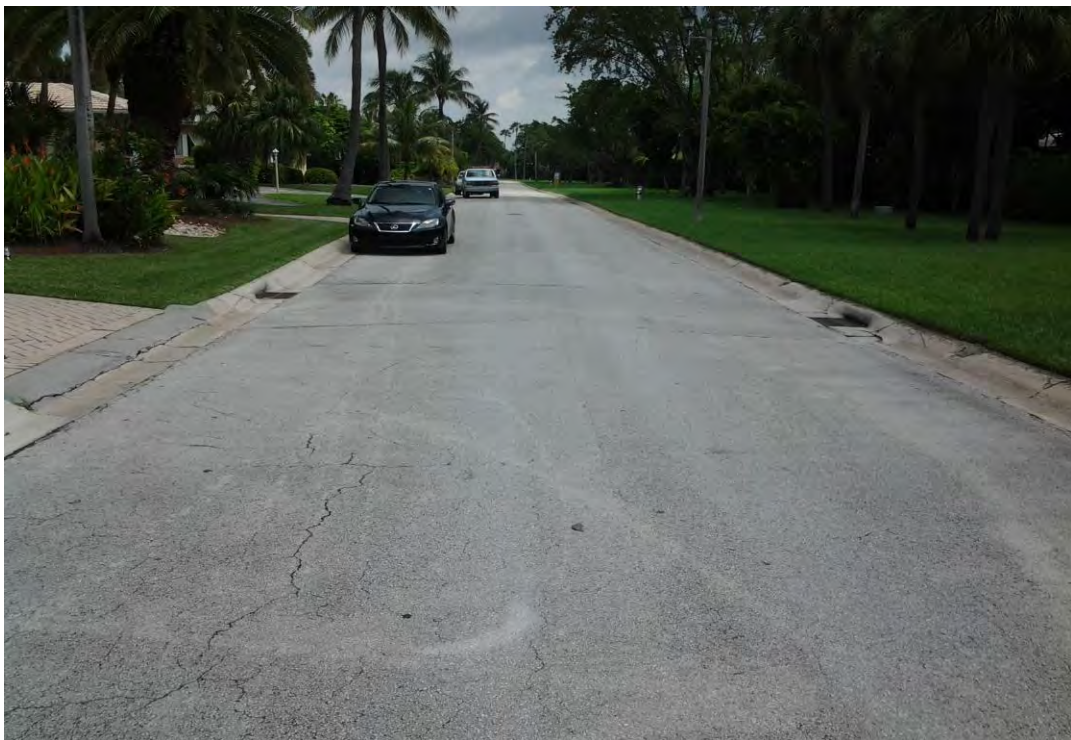
Photo 2 : Park Drive, road and curb surface cracking, looking north.

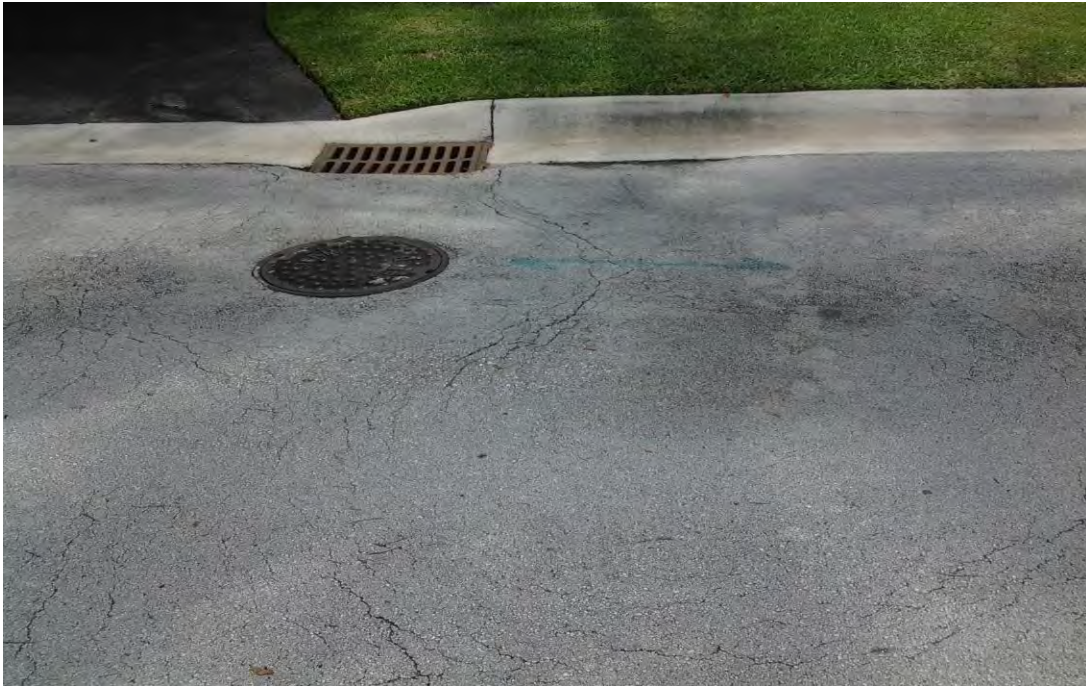
Photo 3 : Bal Cross Drive, road surface cracks, looking east.

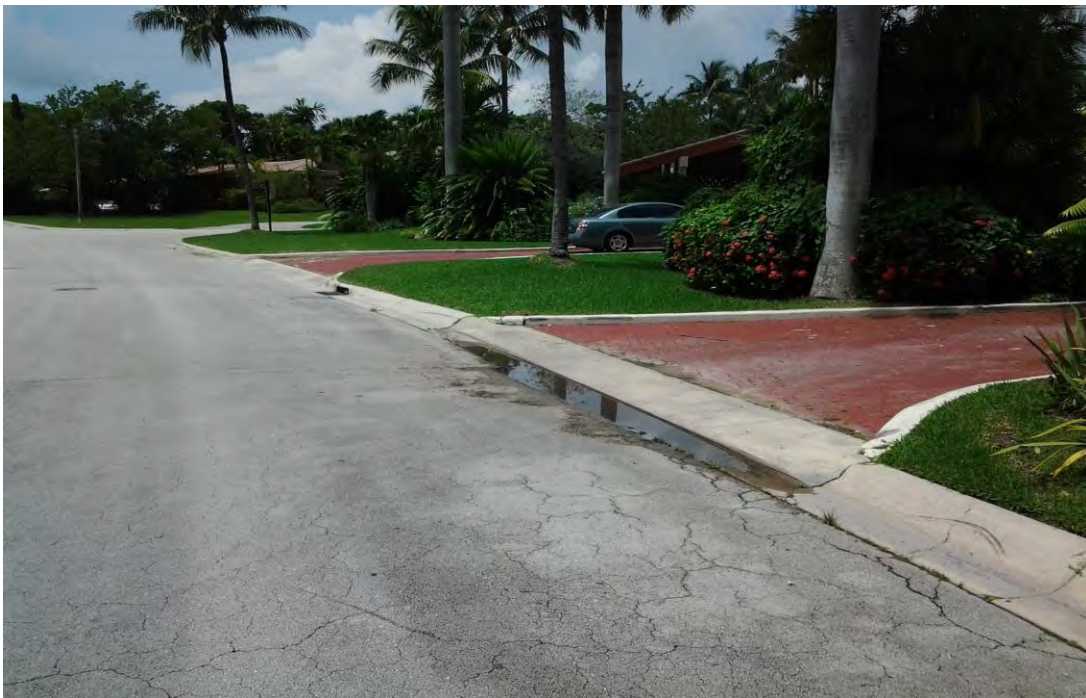
Photo 4 : Bal Cross Drive, curb settling and surface cracks, looking south.

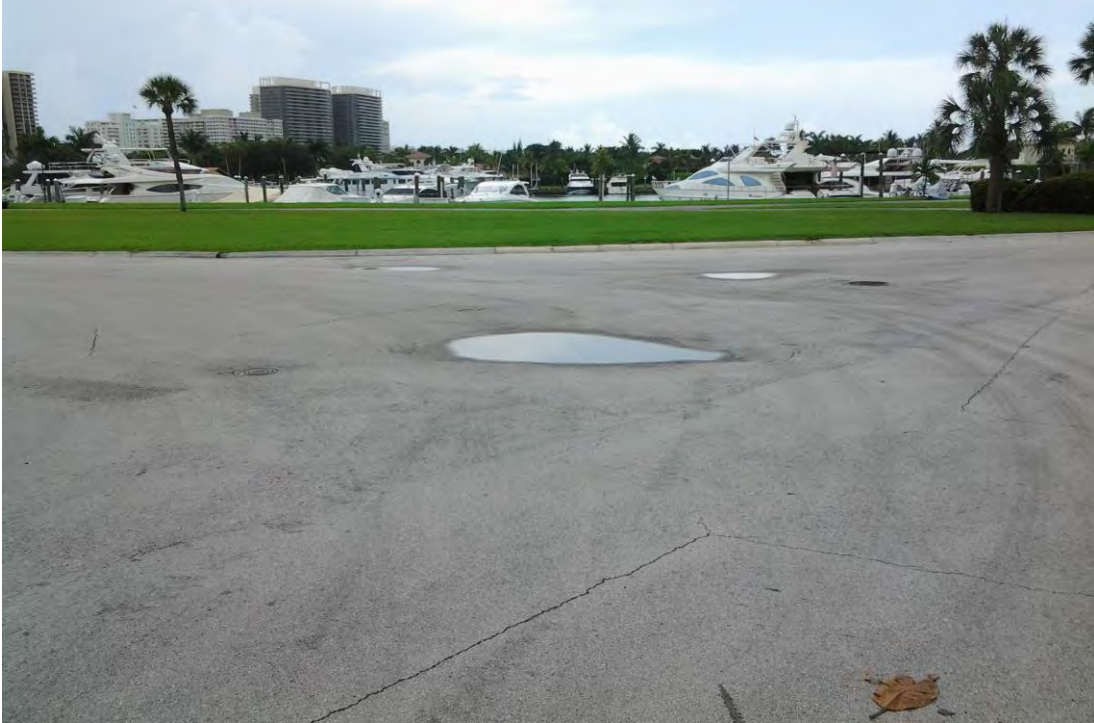
Photo 7 : Harbour Way, surface ponding and cracking, looking south.

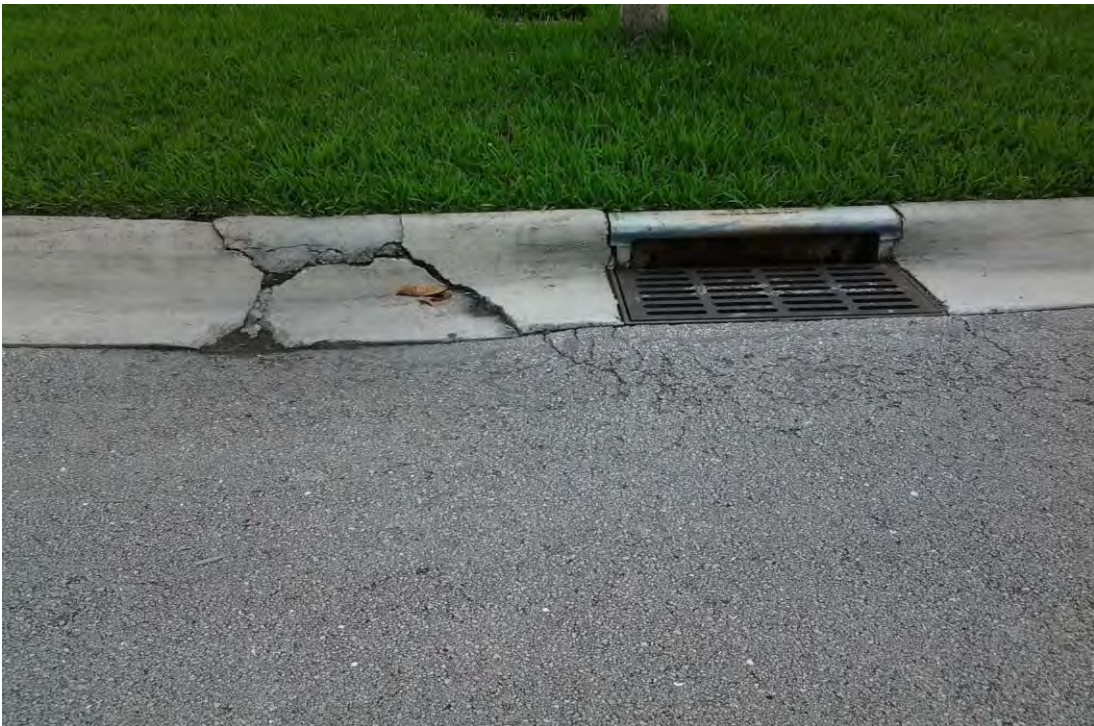
Photo 8 : Bal Bay Drive, curb failure, looking southeast.

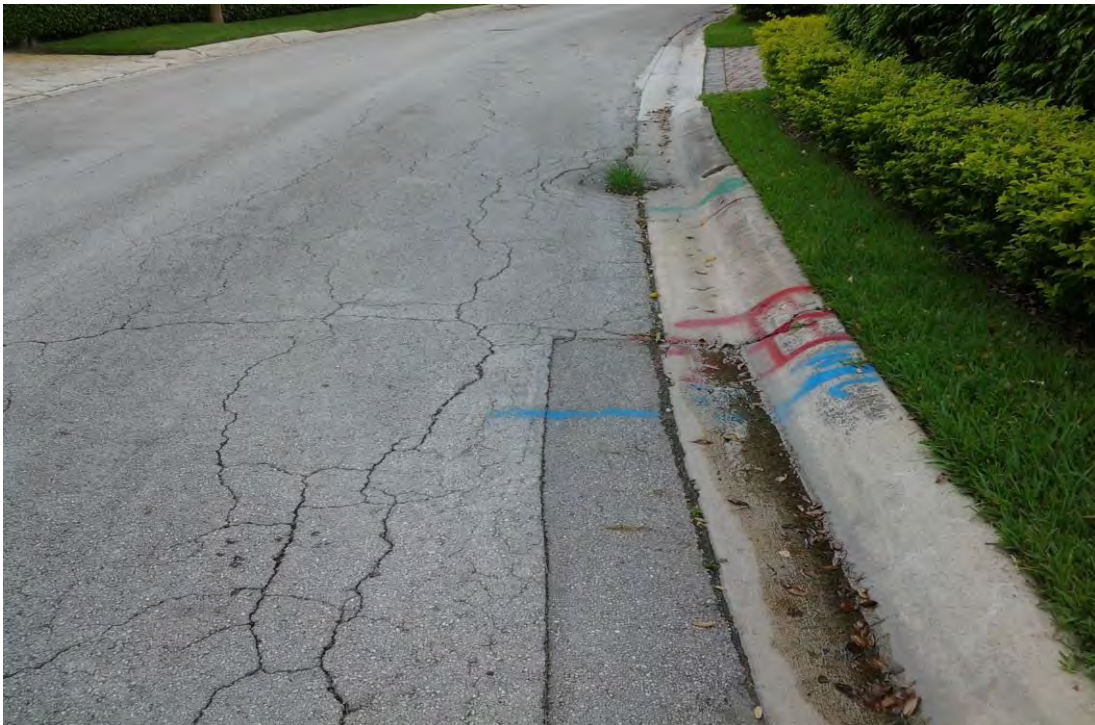
Photo 10 : Bal Bay Drive, roadway repair and cracking, looking north.

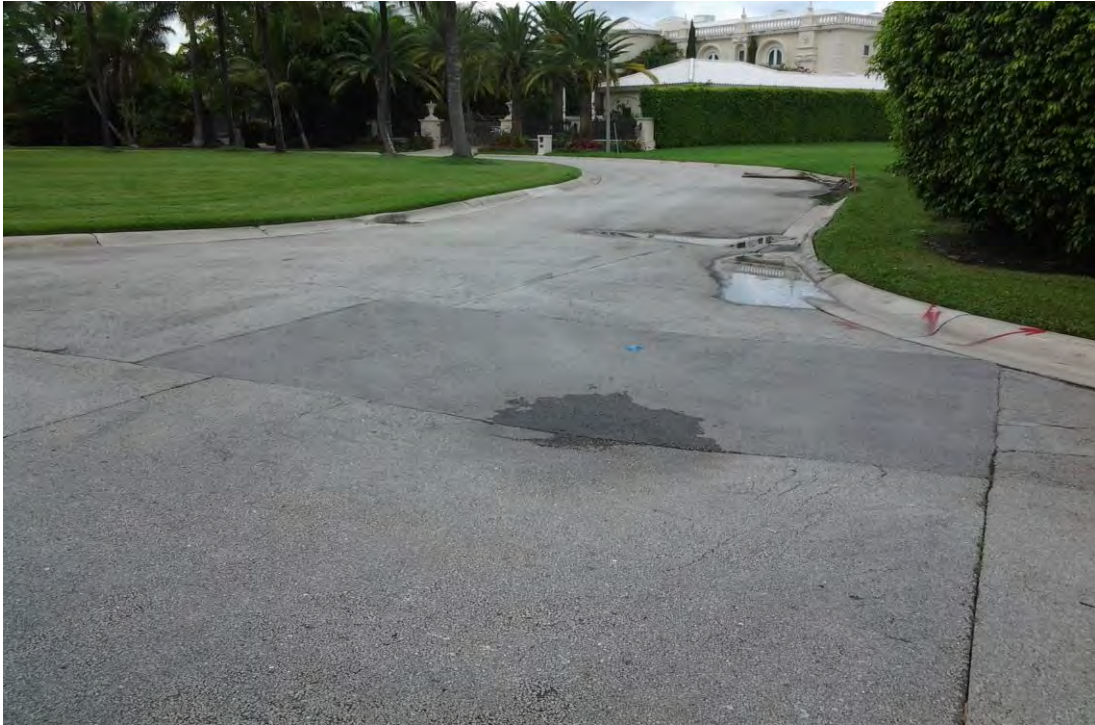
Photo 11: Bal Bay Drive, road repairs and settling, looking southwest.

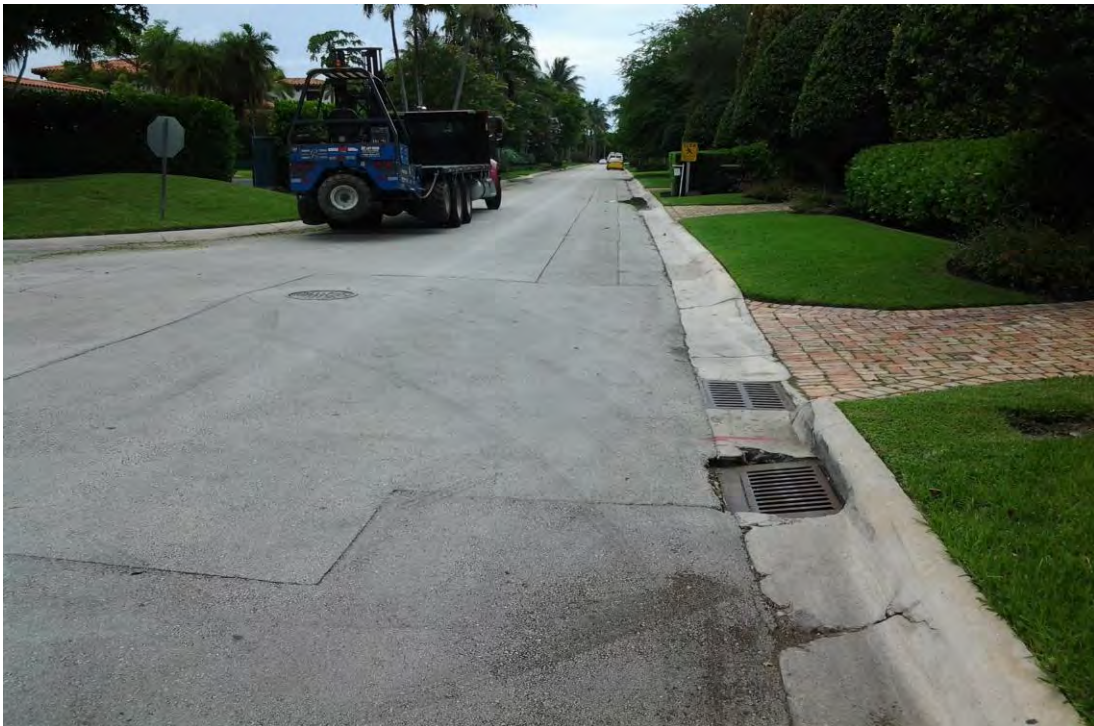
Photo 12 : Bal Bay Drive and Balfour Drive, structure settling and road repairs, looking northwest.

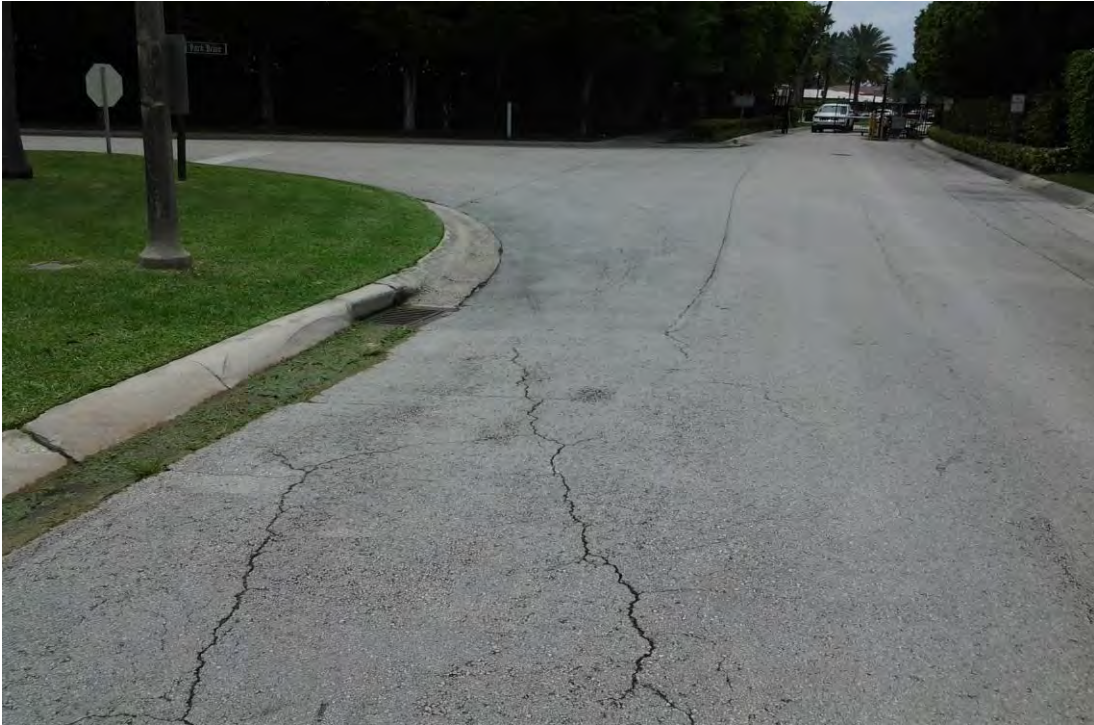
Photo 13 : Bal Bay Drive, road and curb failures, looking south.

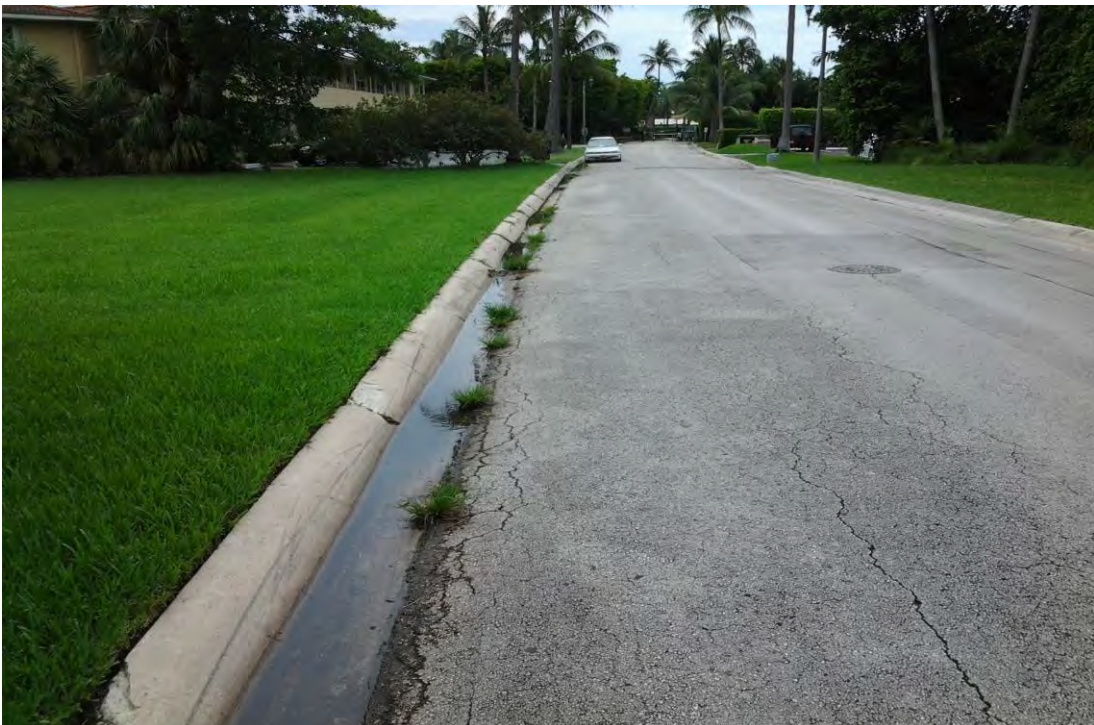
Photo 14 : Bal Bay Drive, curb settling and ponding, looking south.

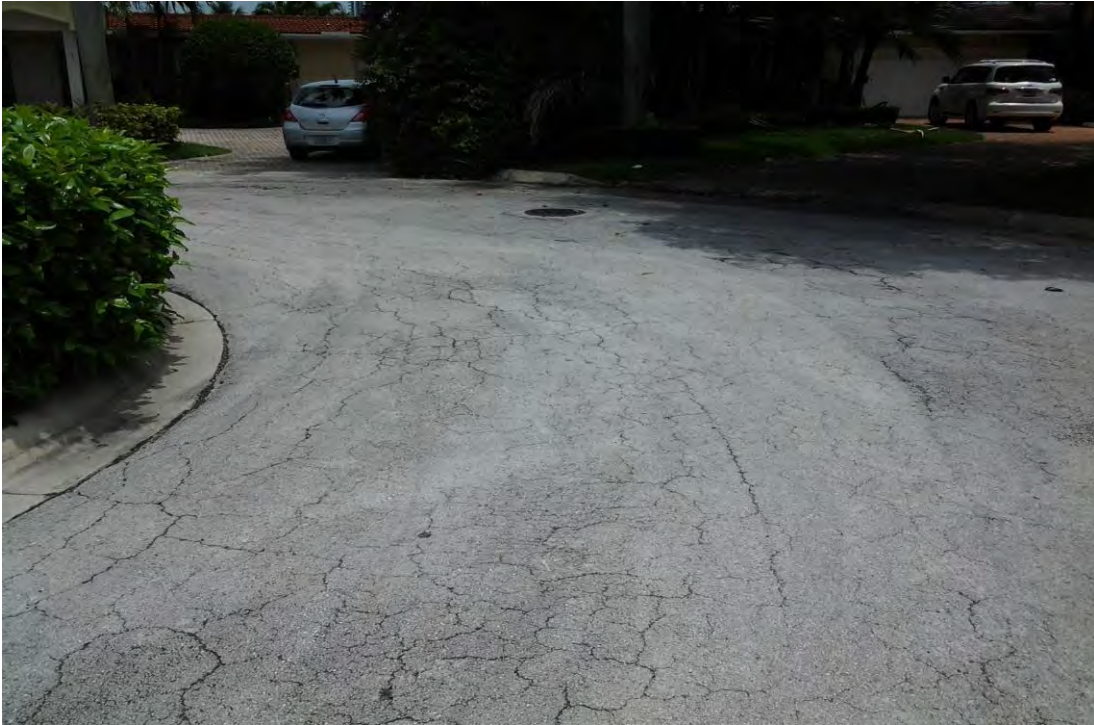
Photo 15 : Camden Court, road surface cracking, looking east.

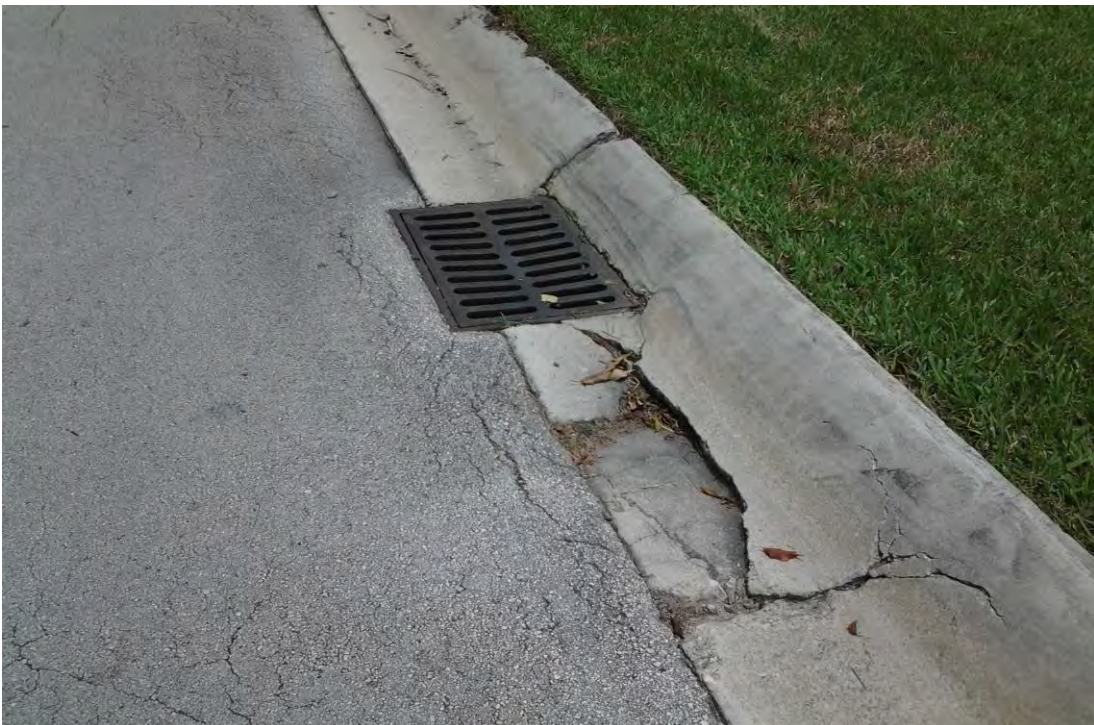
Photo 16 : Park Drive, curb failure, looking north.

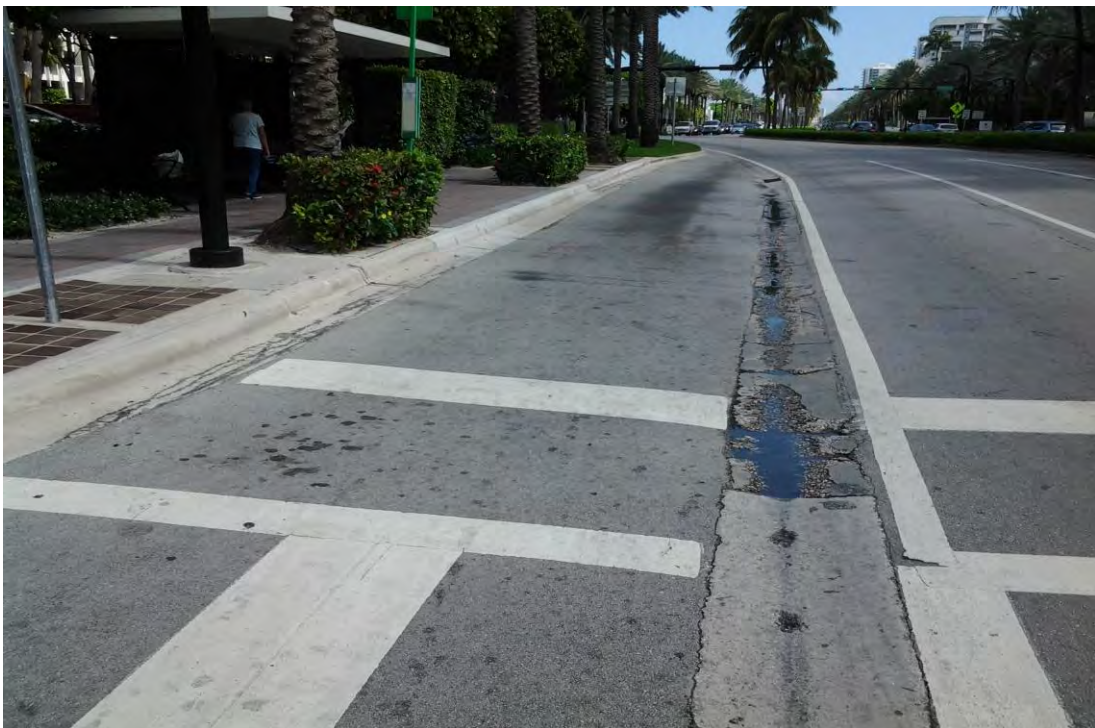
Photo 2 : Damaged concrete gutter at Shops Bus Stop, looking north.

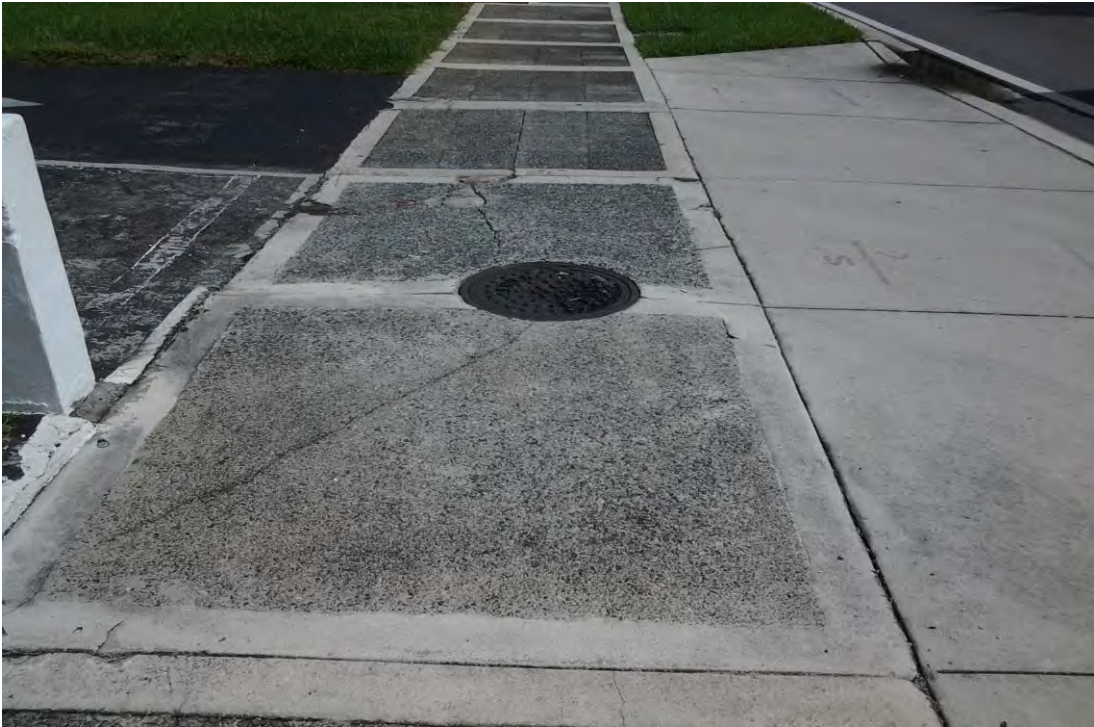
Photo 3 : Damaged sidewalk west side of Collins Avenue, looking north.

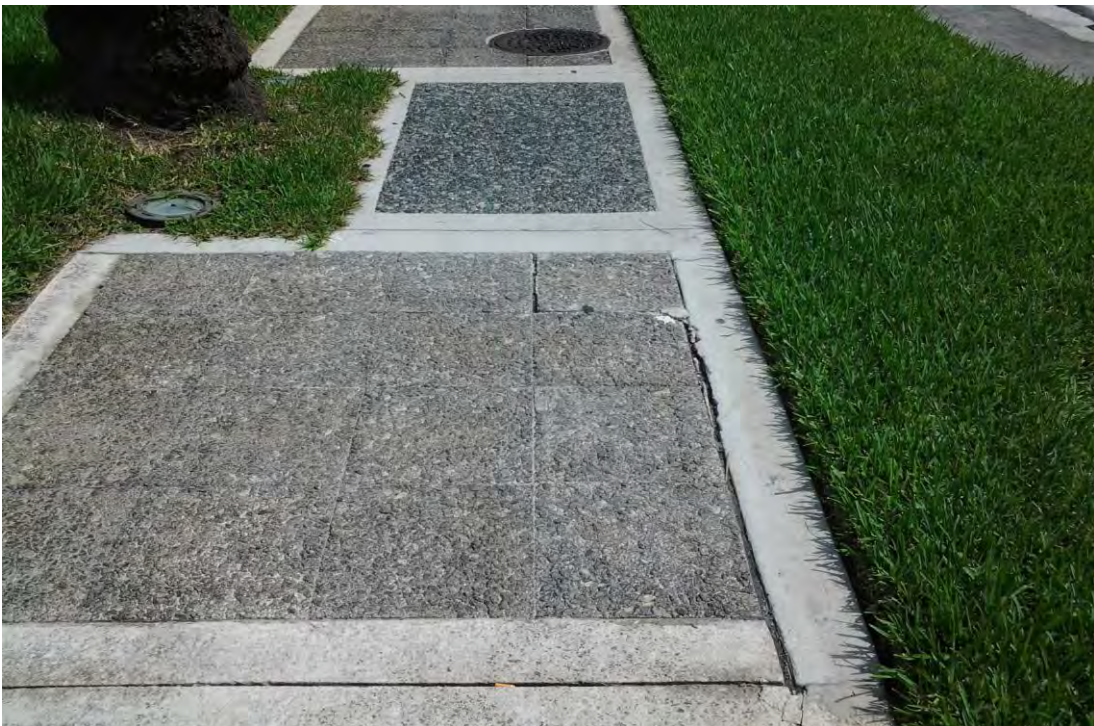
Photo 4 : Cracked sidewalk south of Harbour Way, looking north.

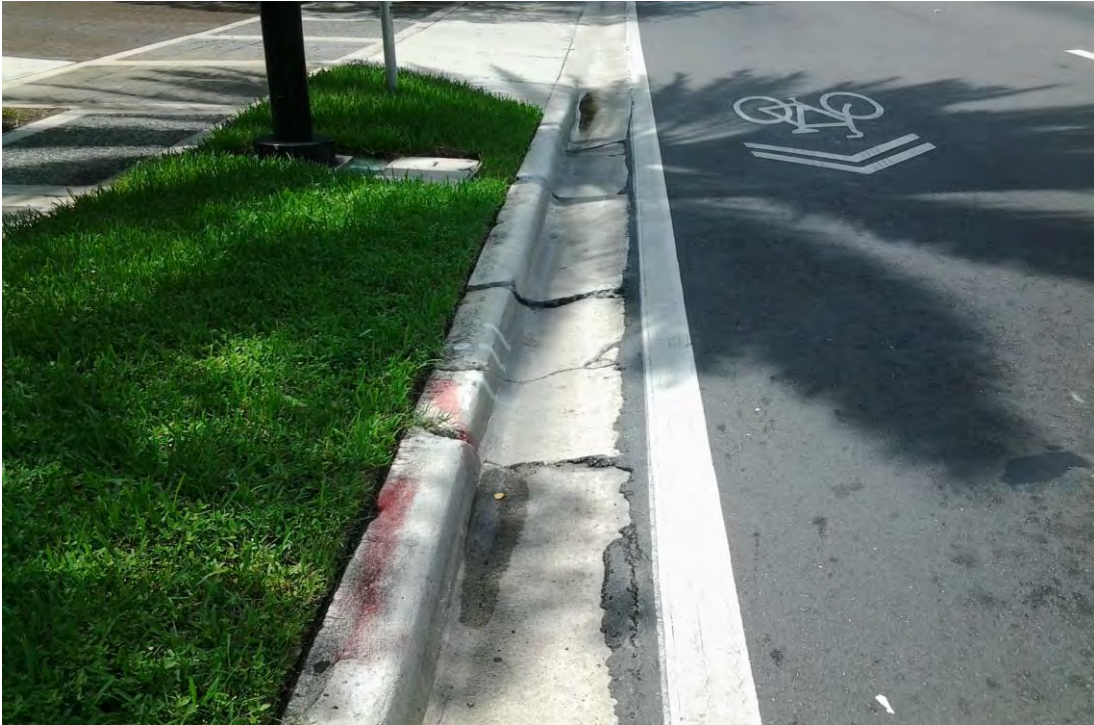
Photo 7 : Curb failures at *Plaza of Bal Harbour*, looking south.

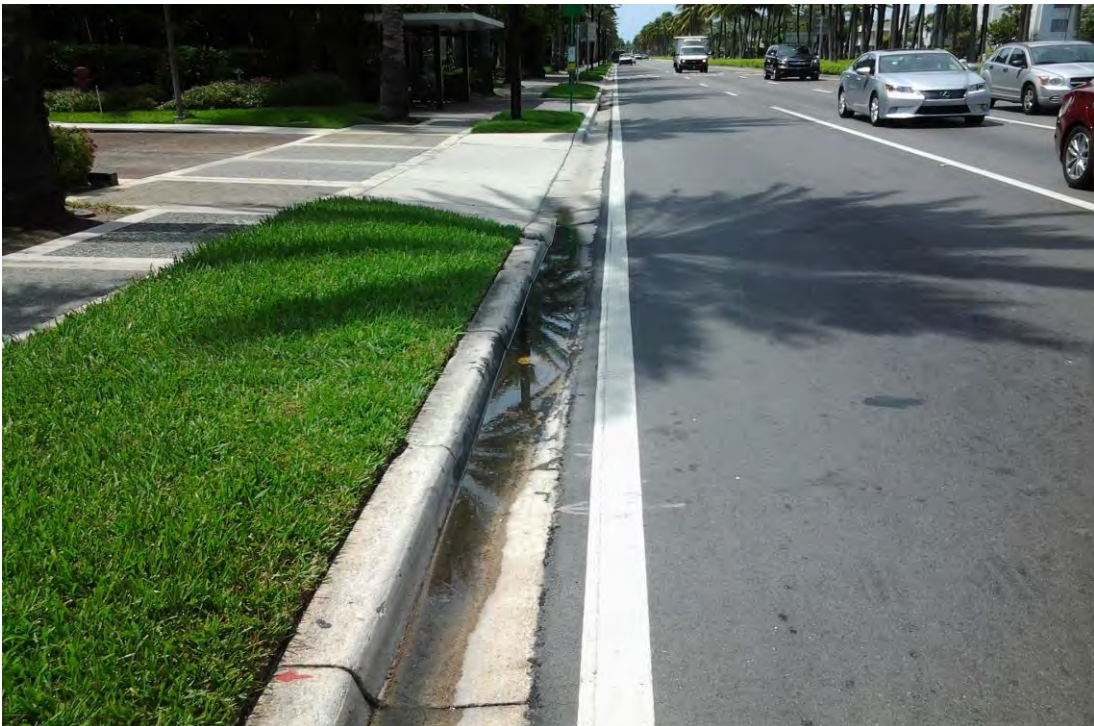
Photo 8 : Ponding in gutter on east side of Collins Ave., looking south.

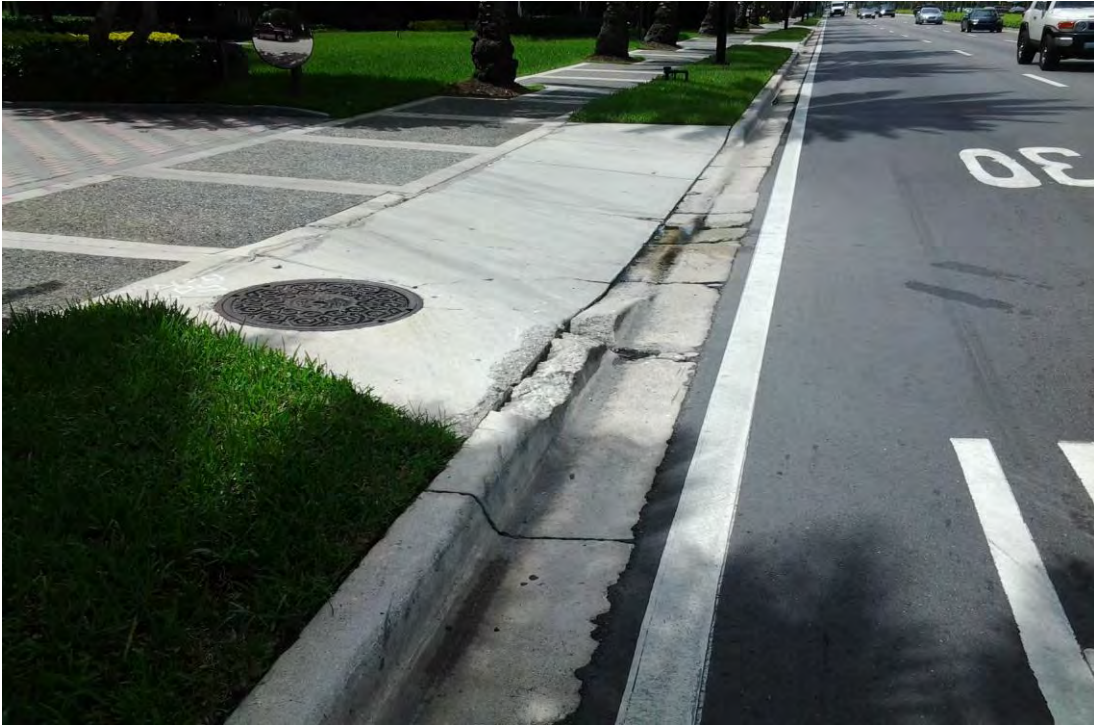
Photo 9 : Curb failures at *101 Bal Harbour*, looking south.

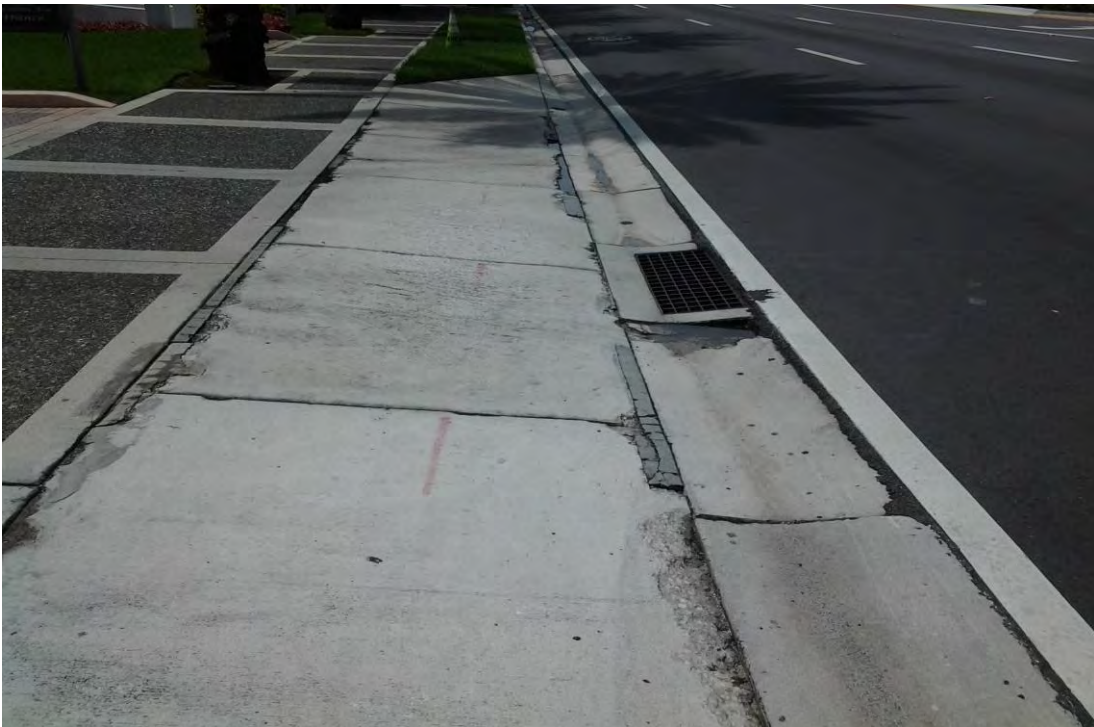
Photo 10 : Driveway approach damage at *Seaview Hotel*, looking south.

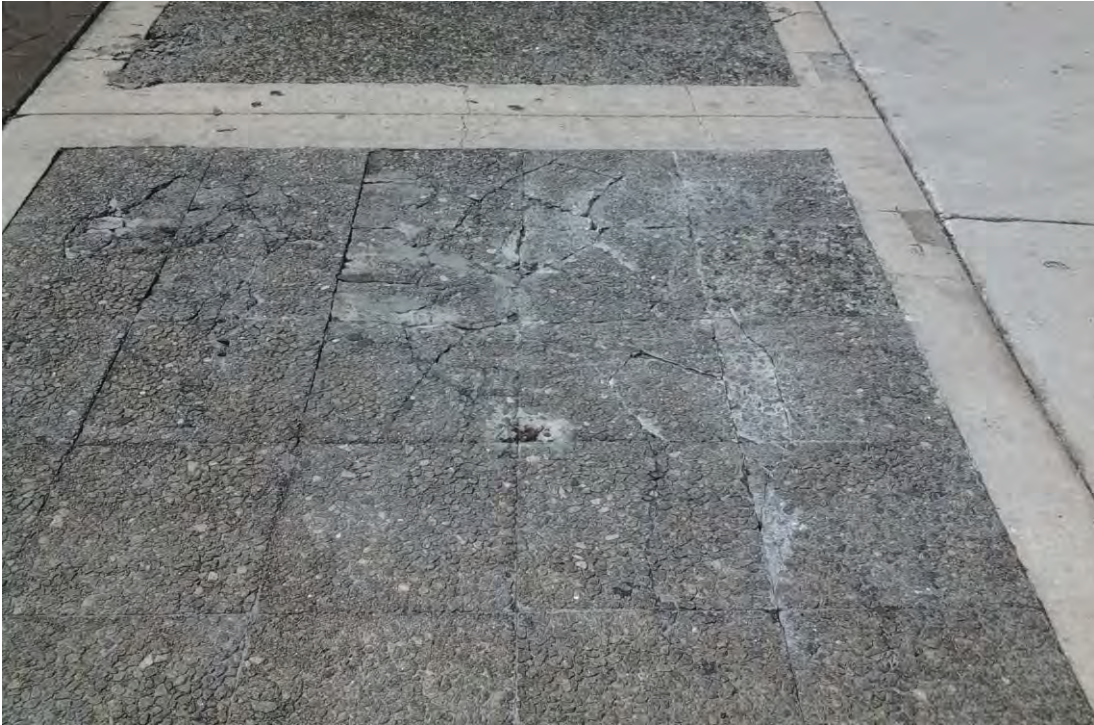
Photo 11: Cracked sidewalk at *Tiffany*, looking south.

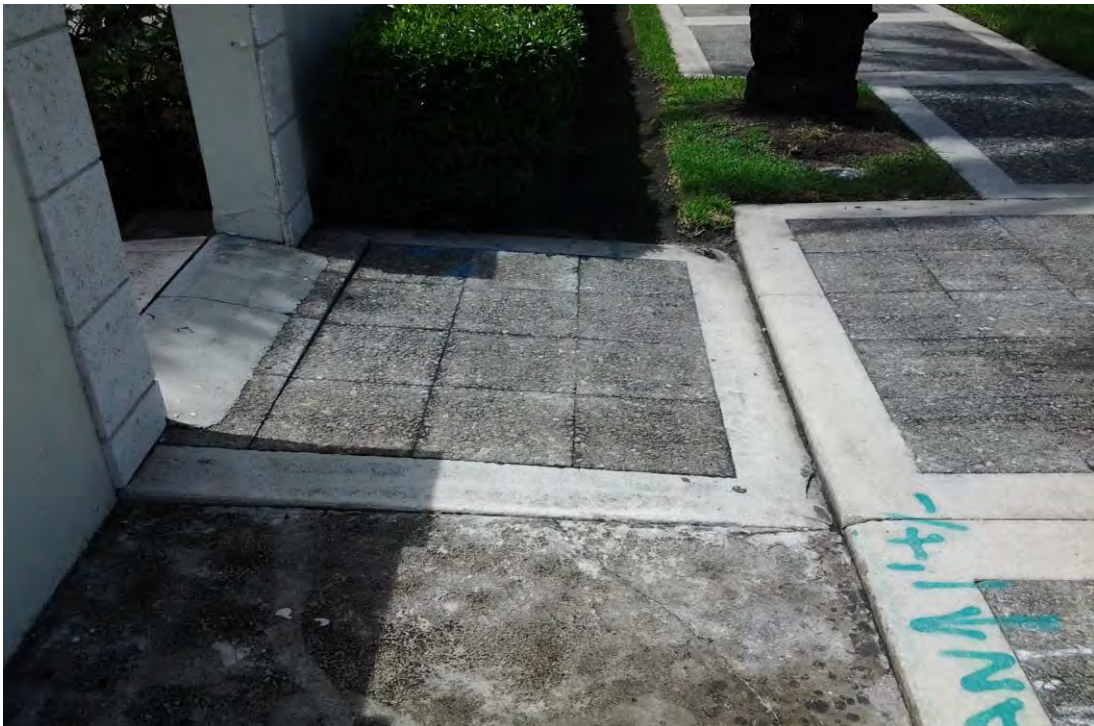
Photo 12 : Settling sidewalk at *Bal Moral*, looking south.

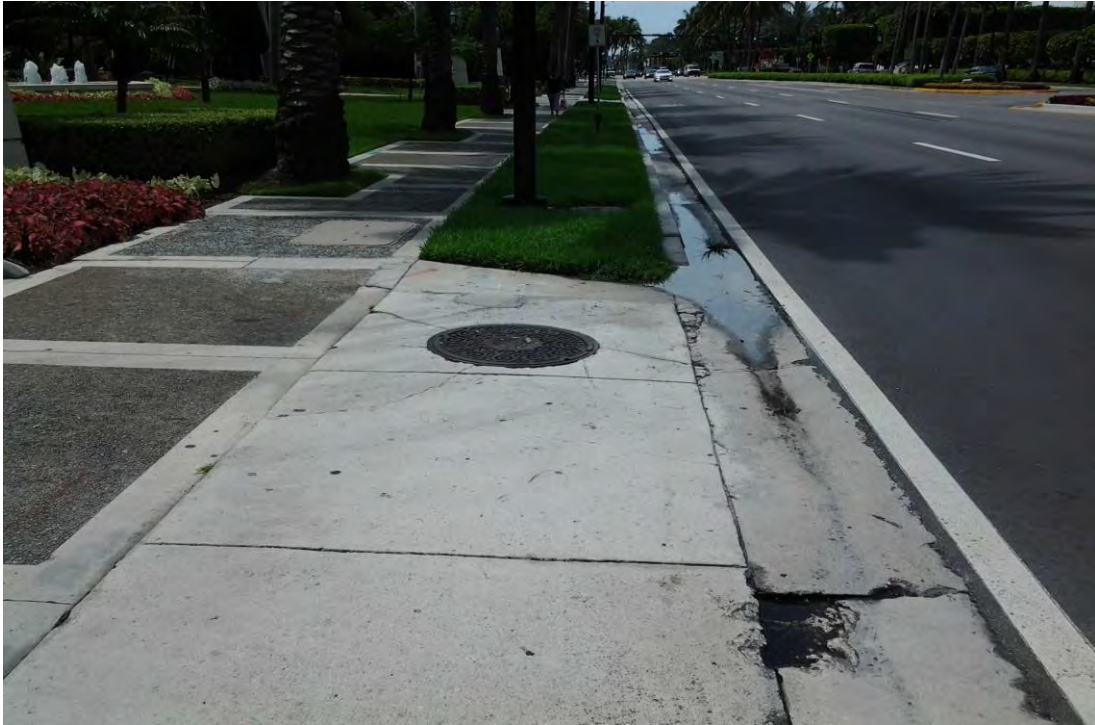
Photo 13 : Gutter failures and ponding at *Bal Moral*, looking south.

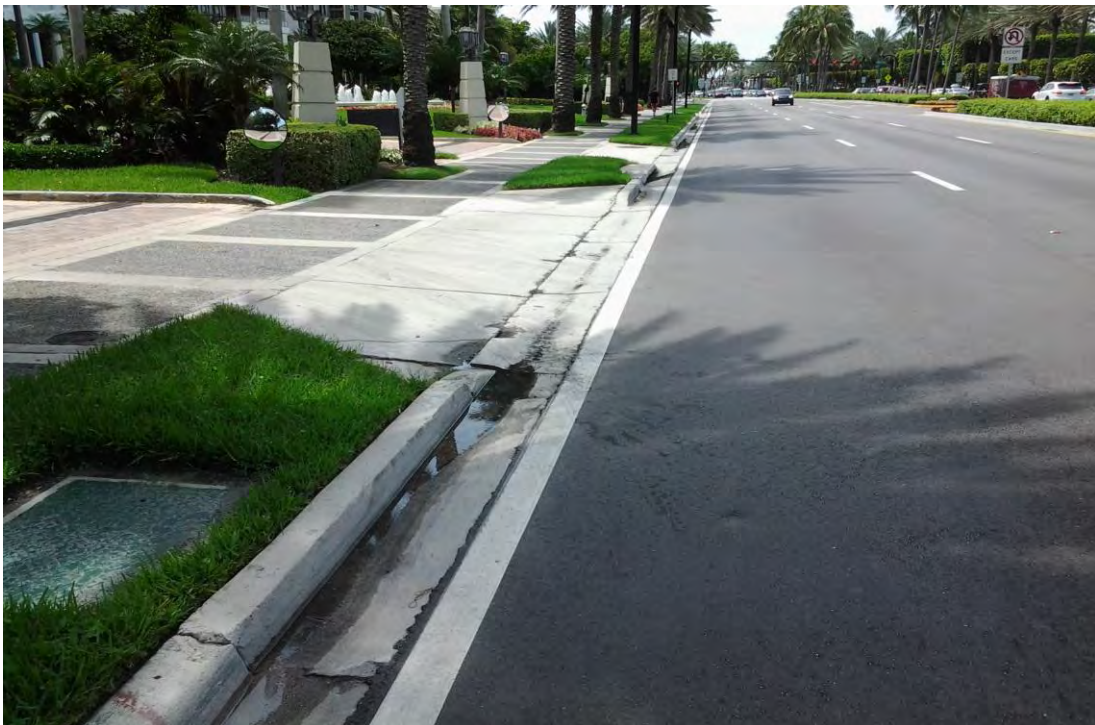
Photo 14 : Damaged curb and gutter at *Bal Moral*, looking south.

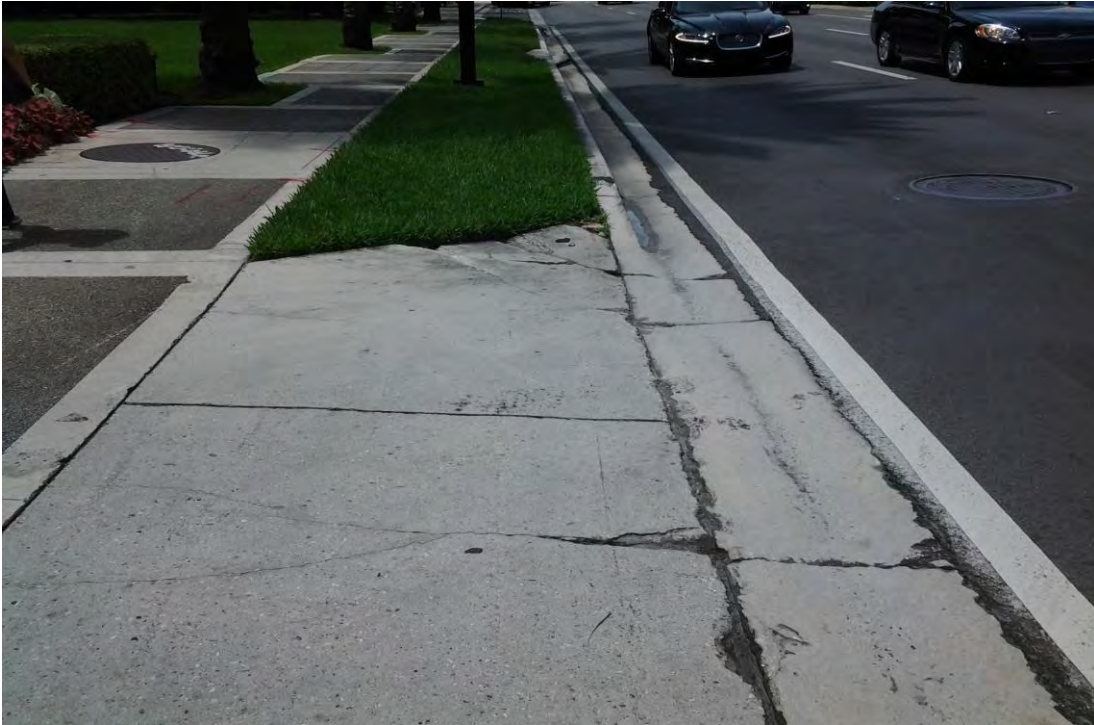
Photo 15 : Damaged south entrance at *Bal Moral*, looking south.

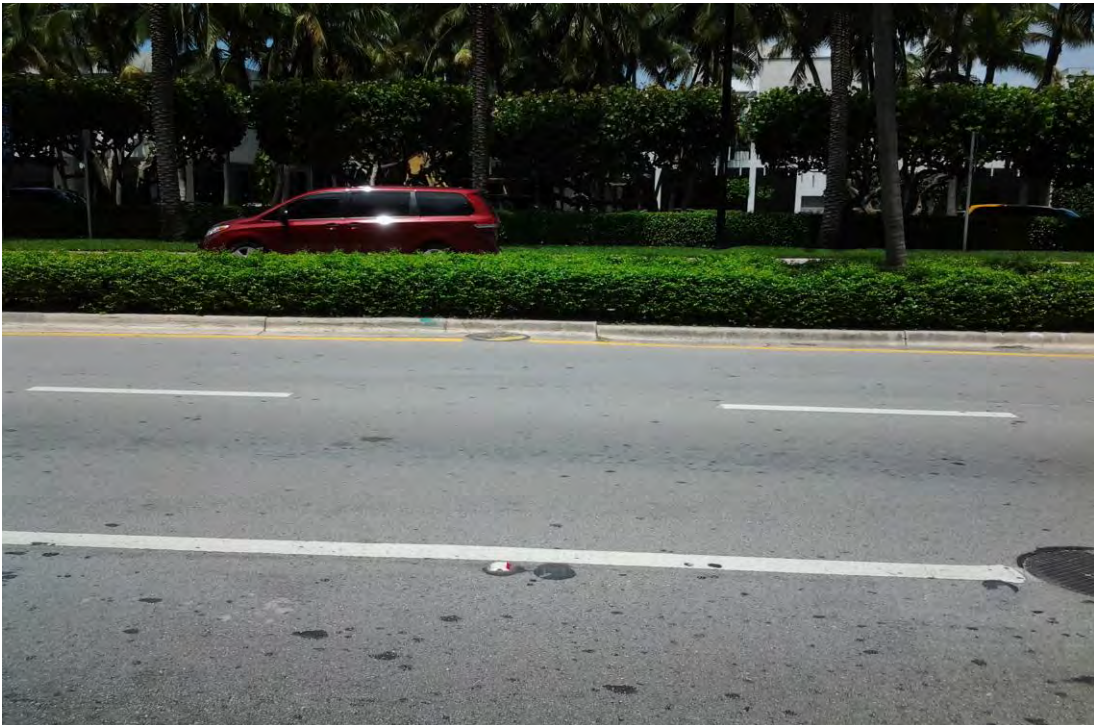
Photo 16 : Curb and Gutter settling in center median, looking west.
