BAL HARBOUR VILLAGE

UTILITY MASTER PLAN

FEBRUARY 2015

CRAIG A. SMITH & ASSOCIATES
7777 GLADES RD, SUITE 410
BOCA RATON, FL 33434
561.314.4445

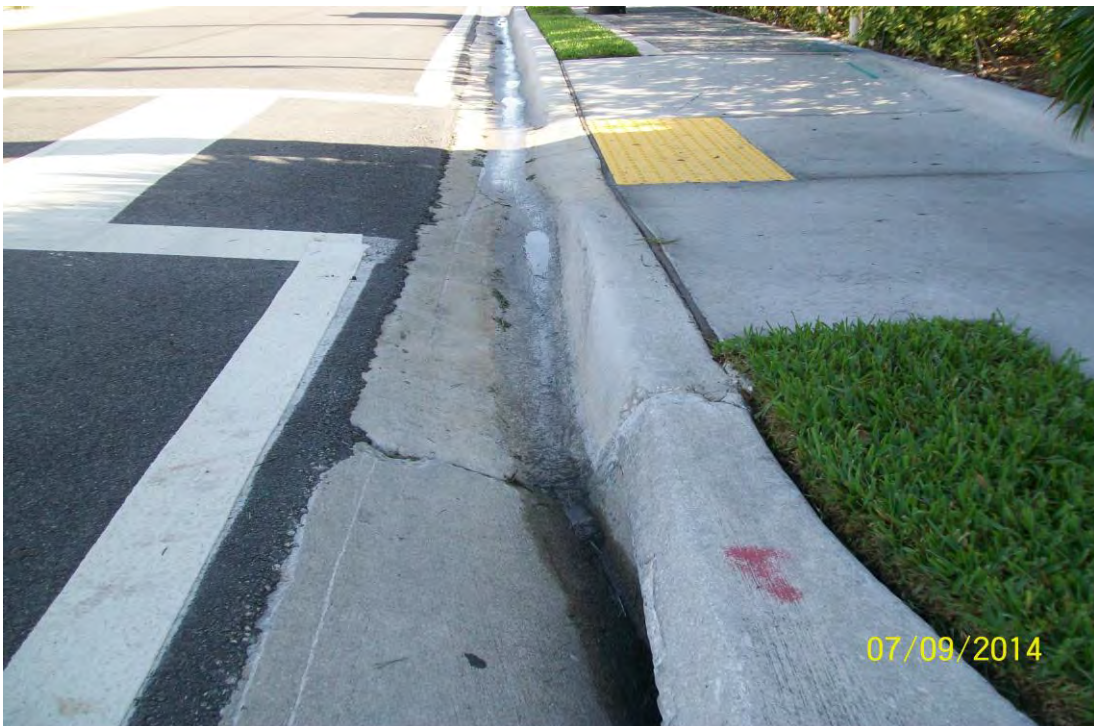
Photo 18 : Damaged gutter in front of *Carlton Terrace*, looking north.

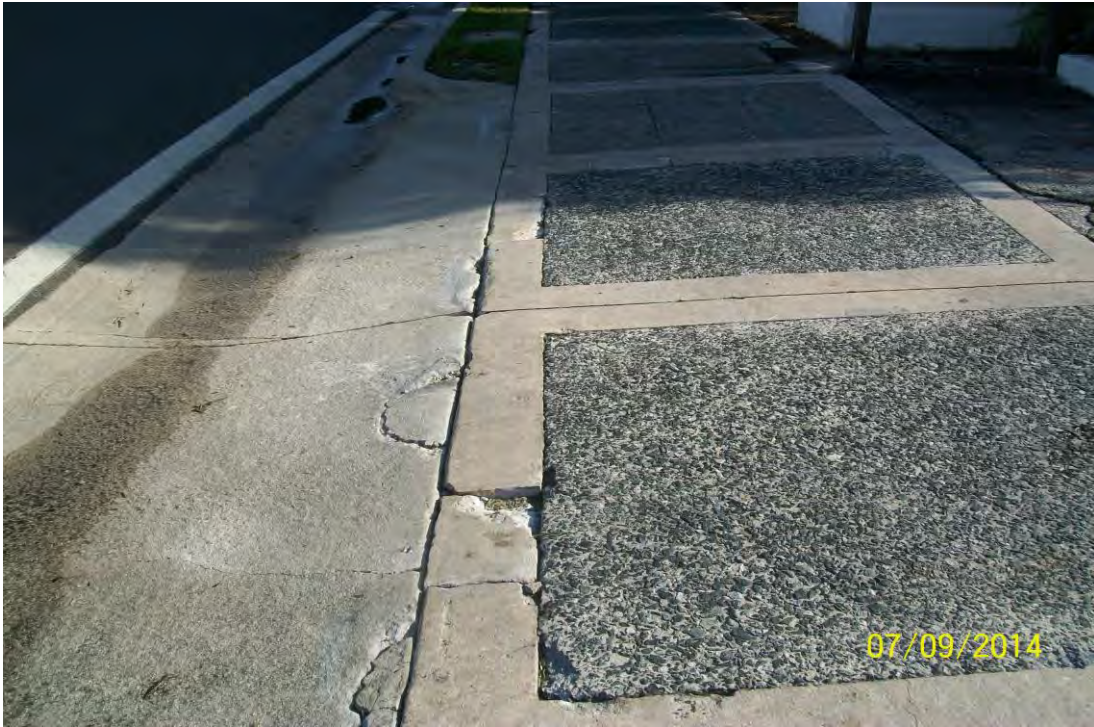
Photo 19 : Damaged walk and gutter at *Carlton Terrace*, looking north.

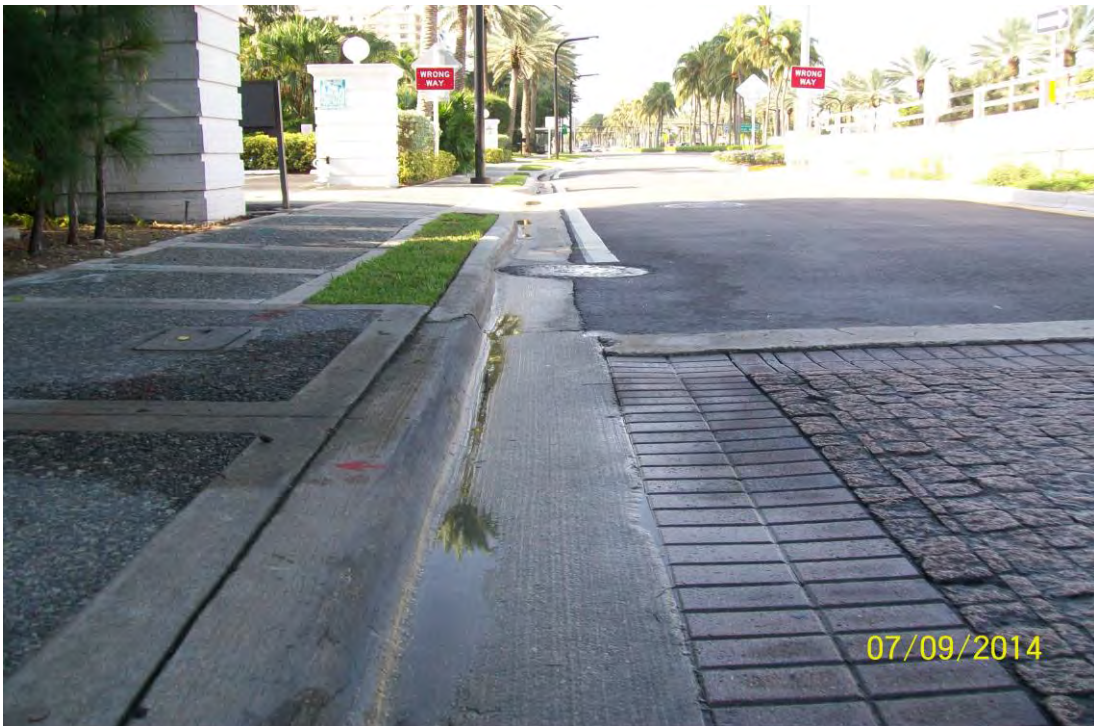
Photo 20 : Standing water at *Harbour House*, looking south.

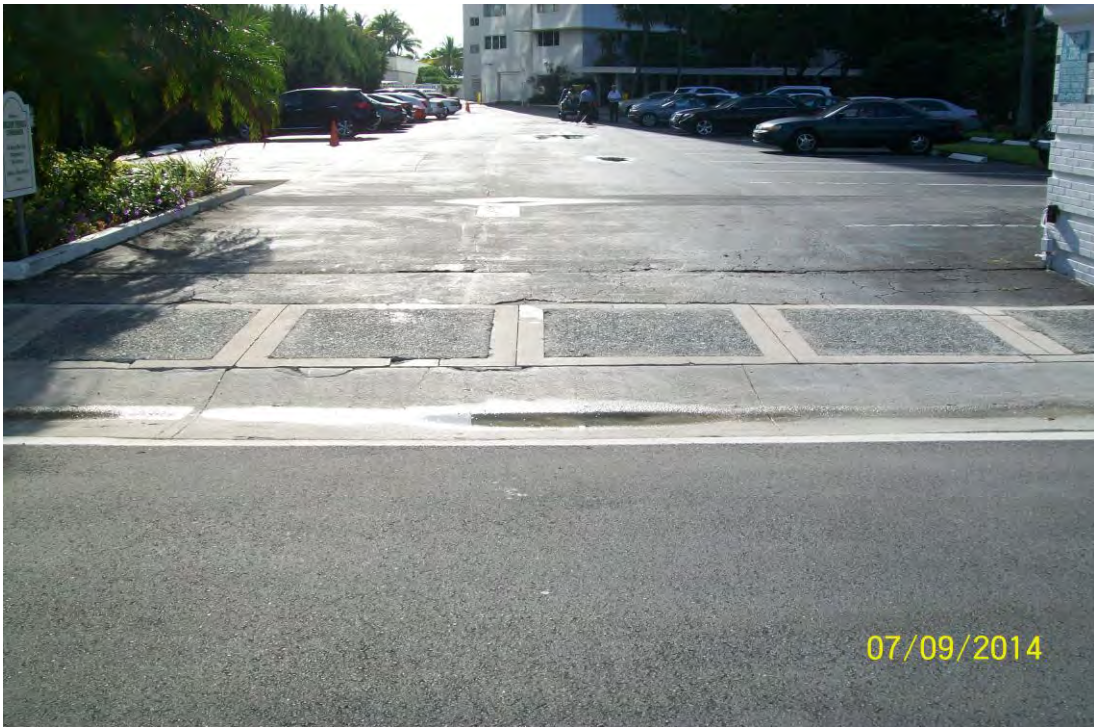
Photo 21 : Damaged sidewalk/ drive at *Carlton Terrace*, looking east.

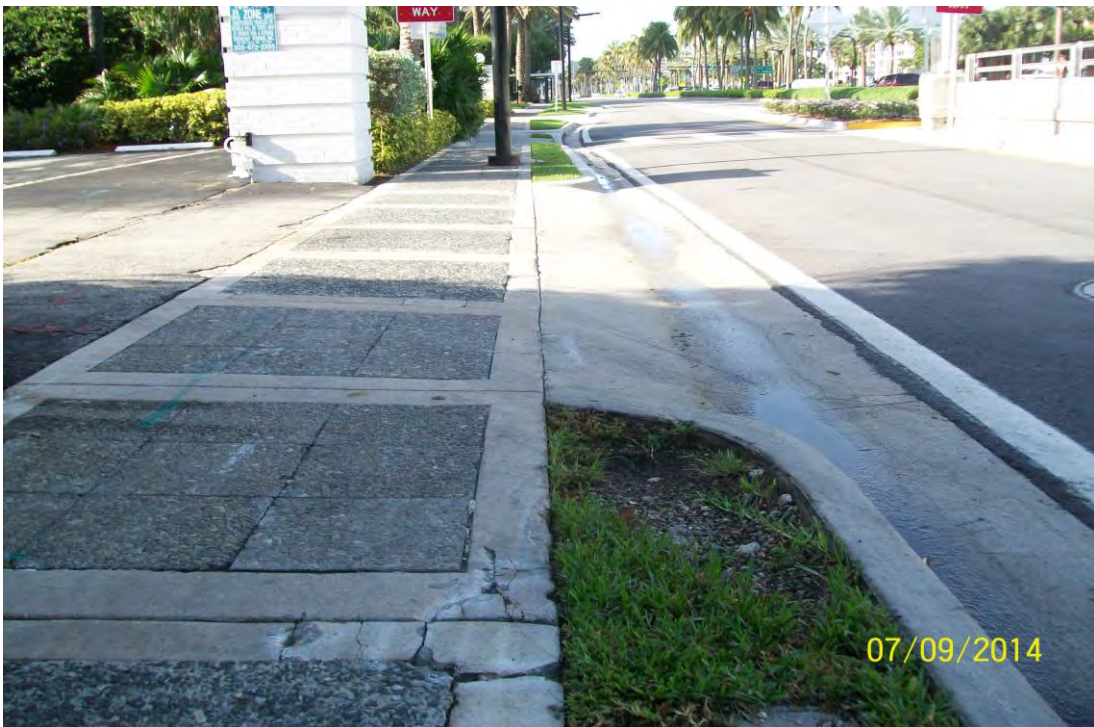
Photo 22 : Damaged sidewalk at *Carlton Terrace*, looking south.

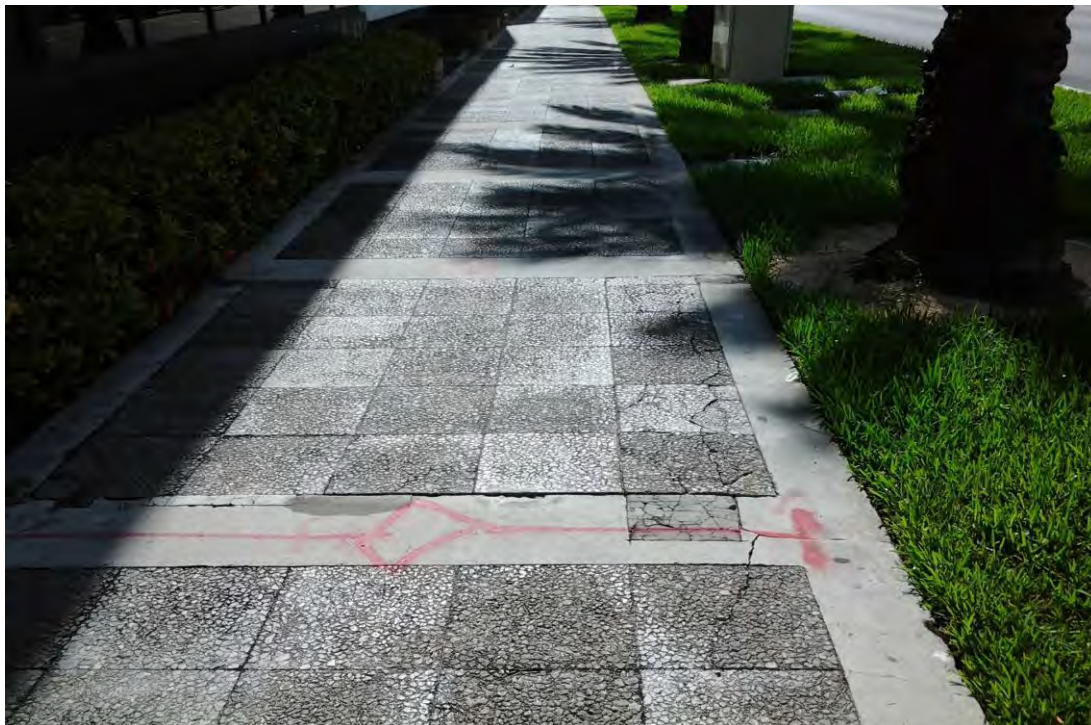
Photo 5 : Sidewalk cracking, in front of *Shops*, looking east.

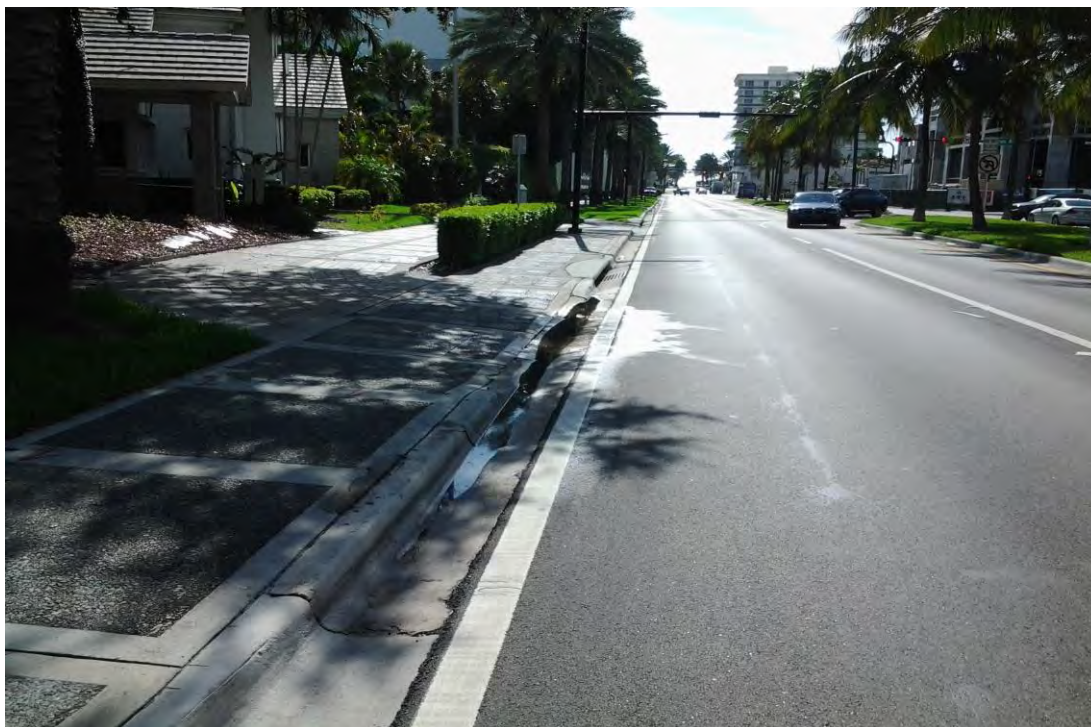
Photo 6 : Ponding in gutter on north side due to settling, looking east.

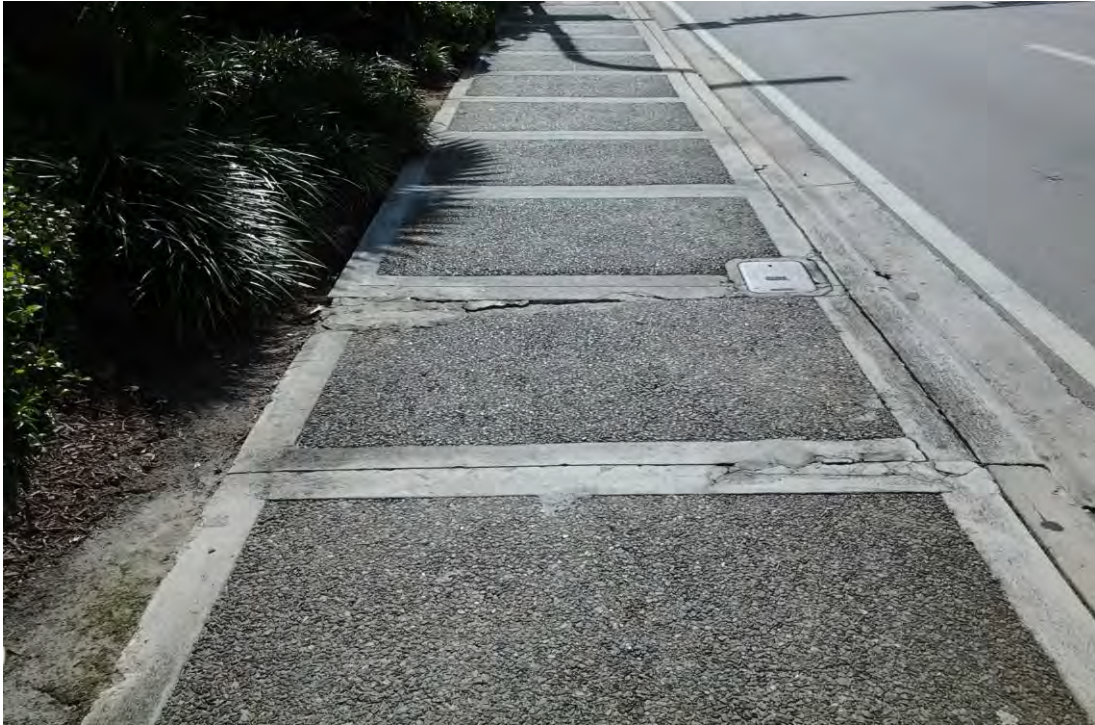
Photo 7 : Sidewalk cracking, north side of road, looking east.

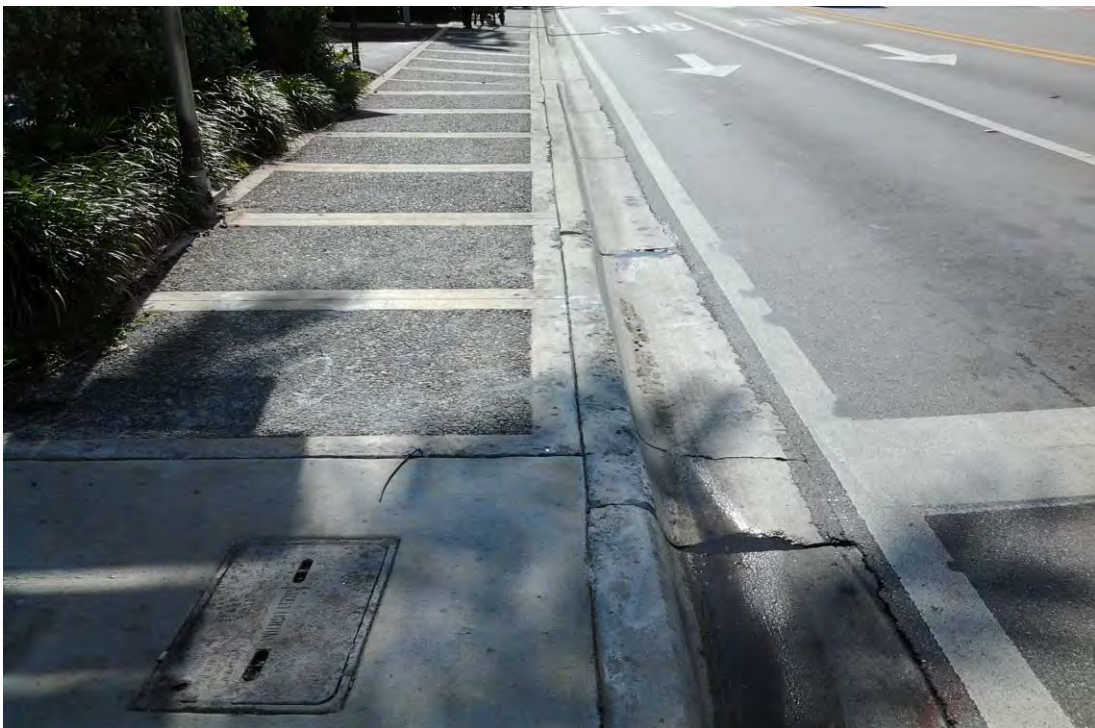
Photo 8 : Gutter separation, north side of road, looking east.

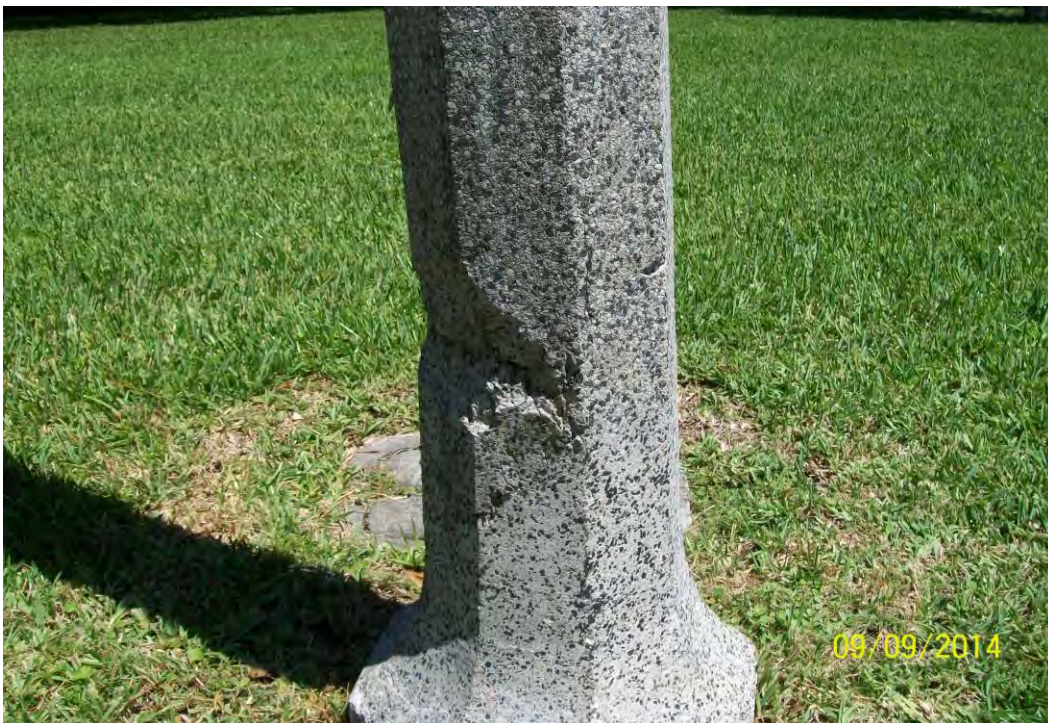
Photo 6: Damaged concrete pole base (152 Park Drive).

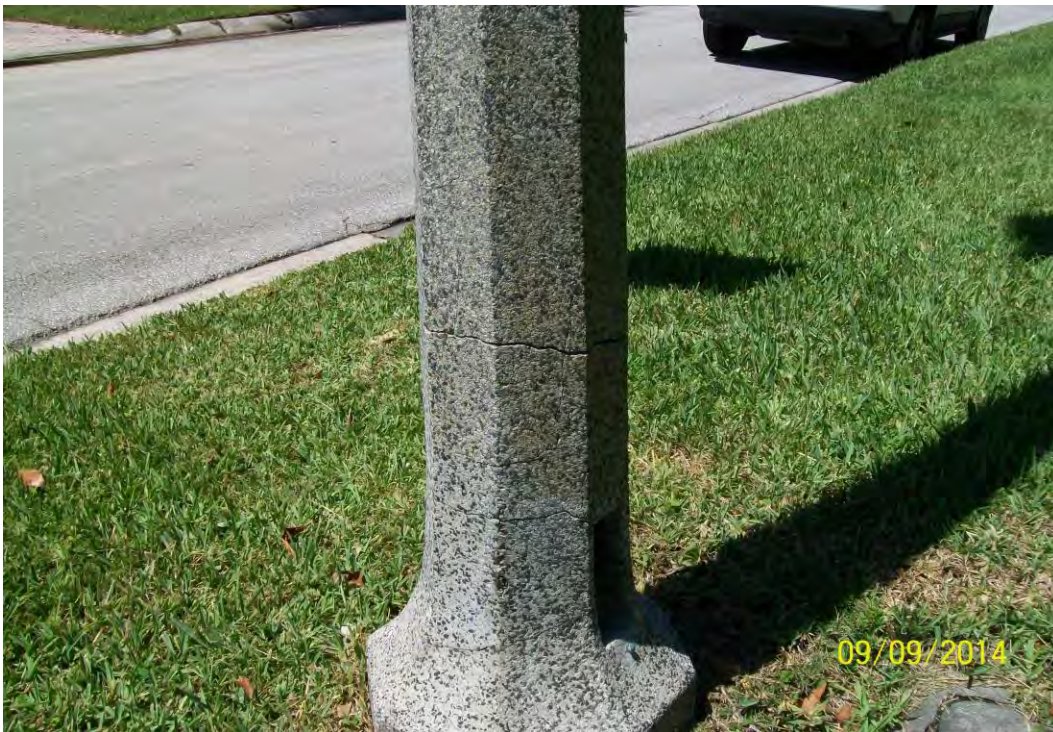
Photo 8: Cracked concrete pole base (261 Bal Cross Drive).

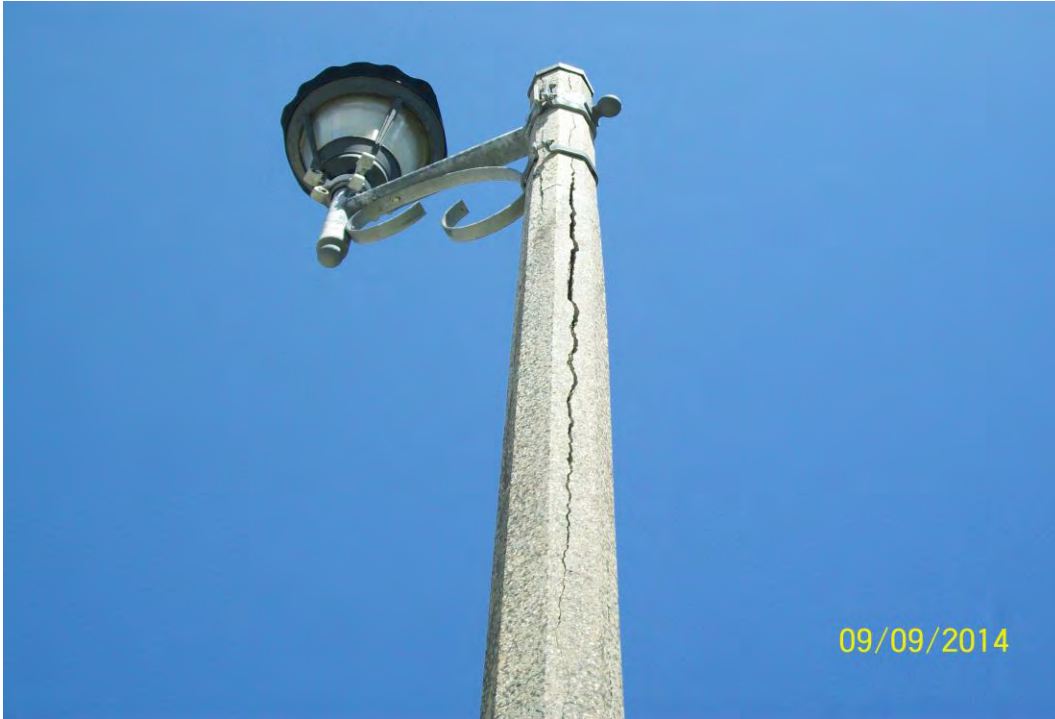
Photo 9: Cracked concrete light pole at Harbour Way East and Park Drive.

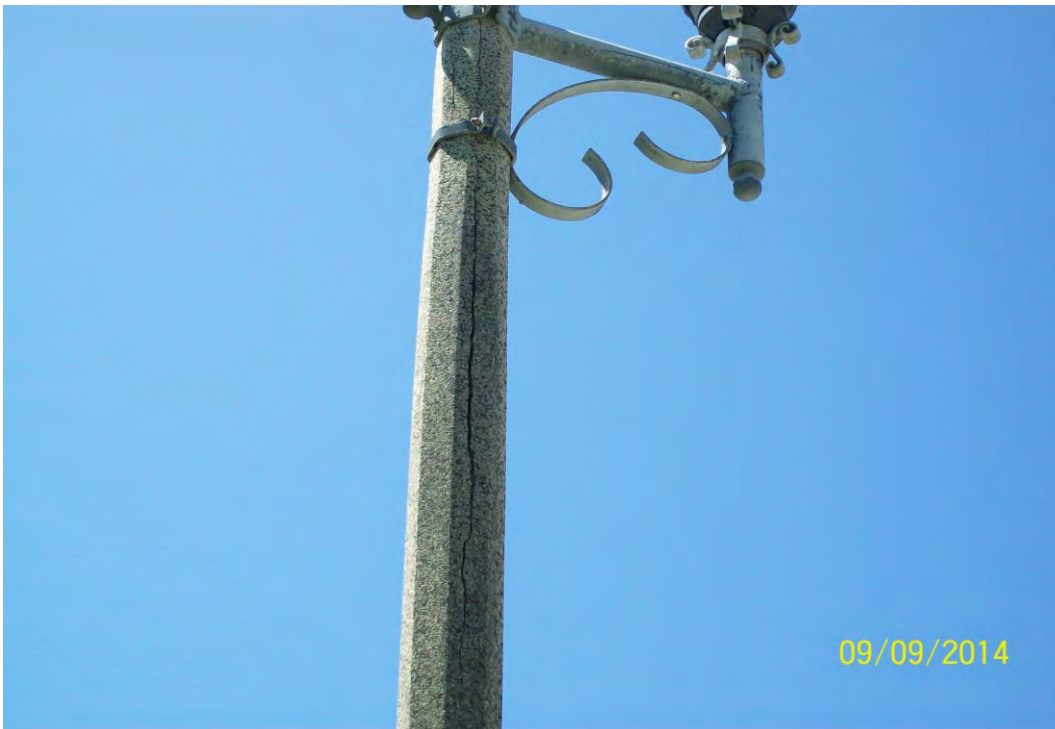
Photo 10: Longitudinal cracked concrete light pole (261 Bal Cross Drive).

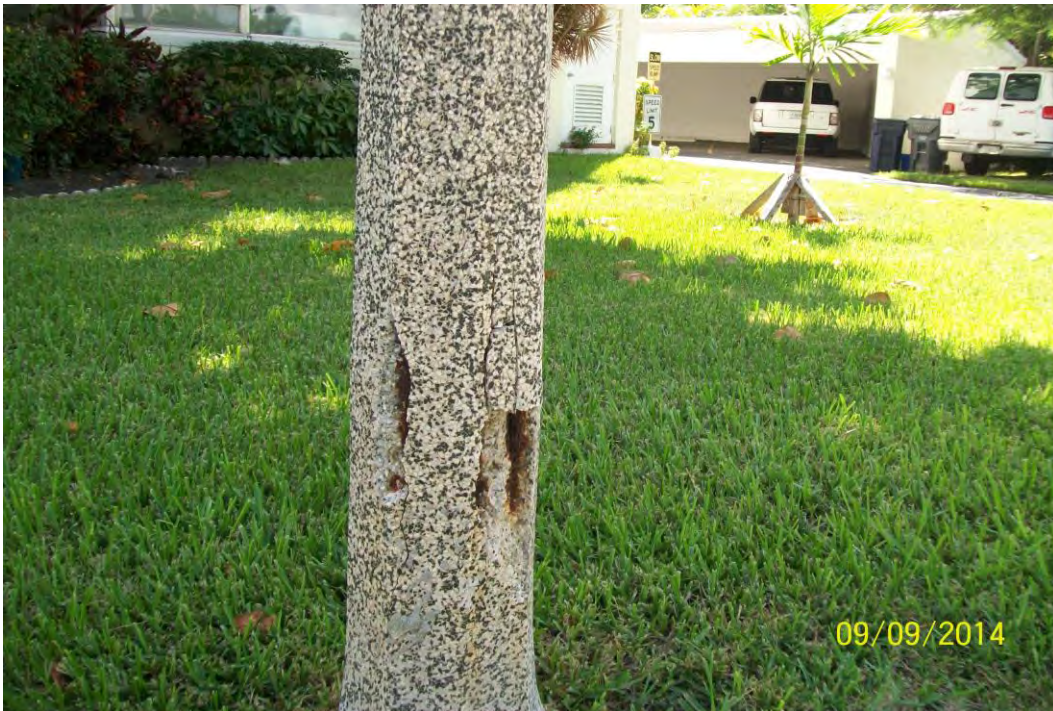
Photo 12: Damage pole base at Bal Harbour Manor and Harbour Way.

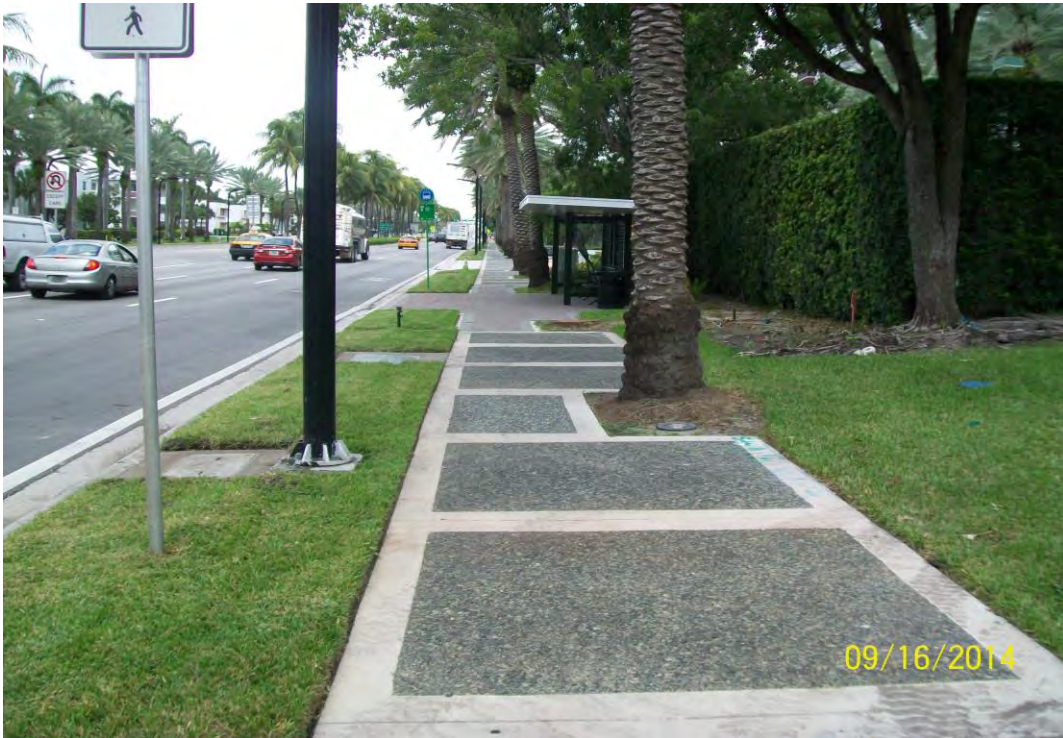
Photo 7: Existing light pole with missing base, looking north.

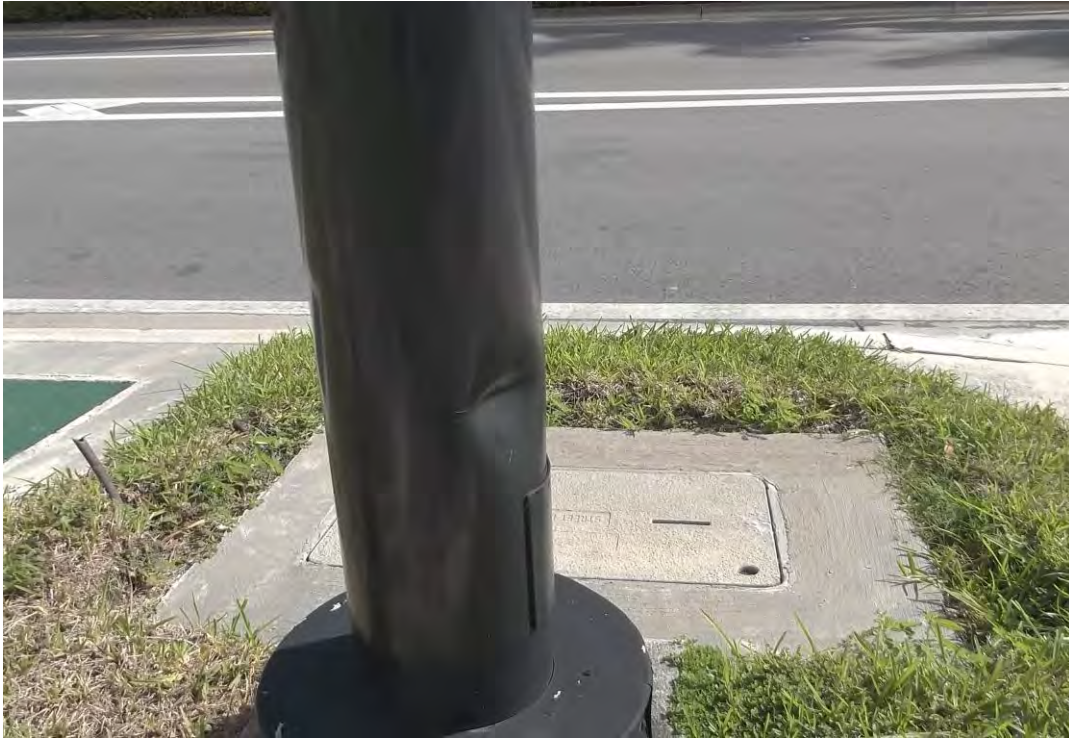
Photo 13: Existing damaged light pole.

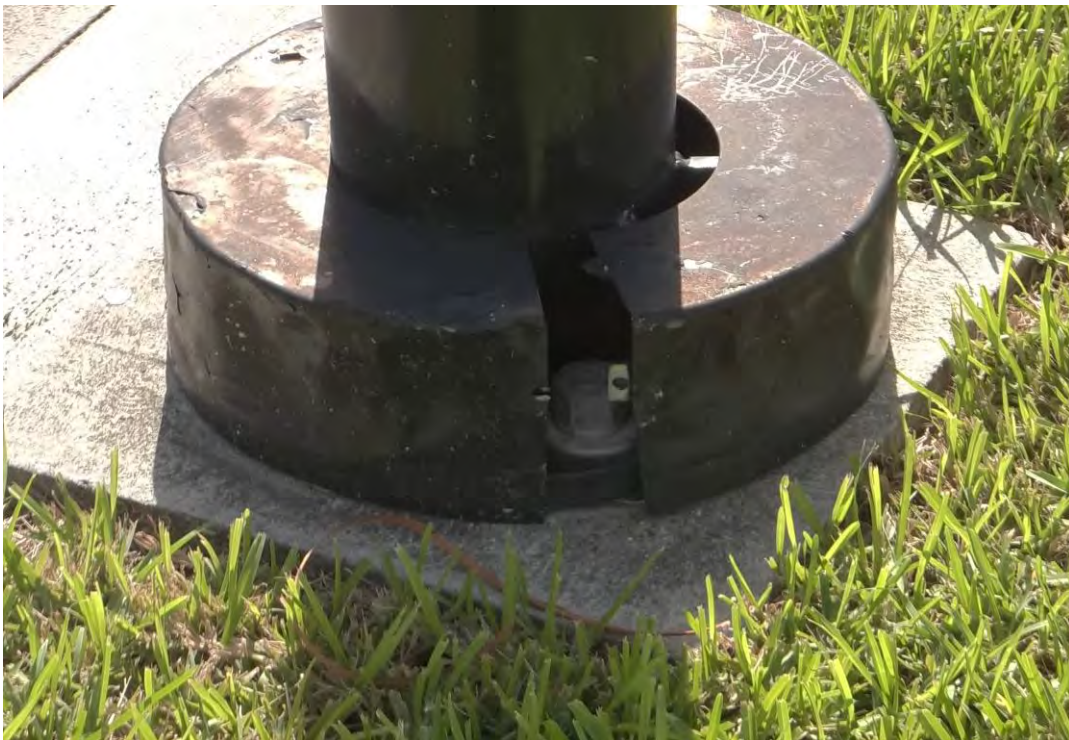
Photo 14: Existing damaged light pole base.

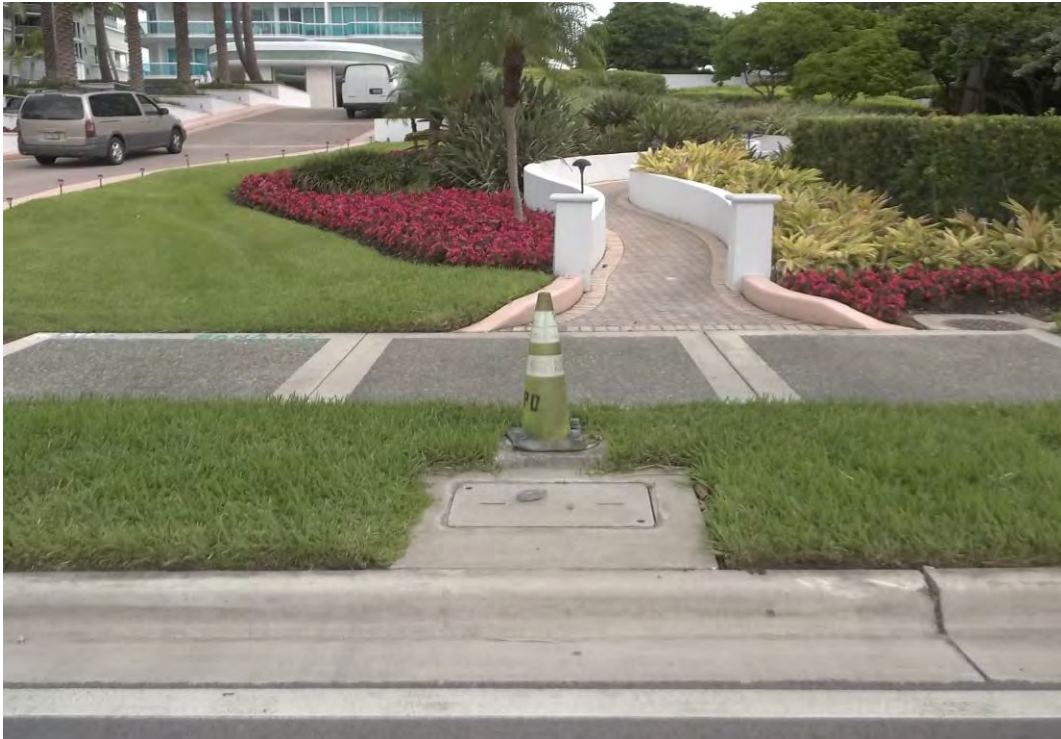
Photo 17: Missing street light behind existing pull box.
