BAL HARBOUR VILLAGE

UTILITY MASTER PLAN

FEBRUARY 2015

CRAIG A. SMITH & ASSOCIATES
7777 GLADES RD, SUITE 410
BOCA RATON, FL 33434
561.314.4445

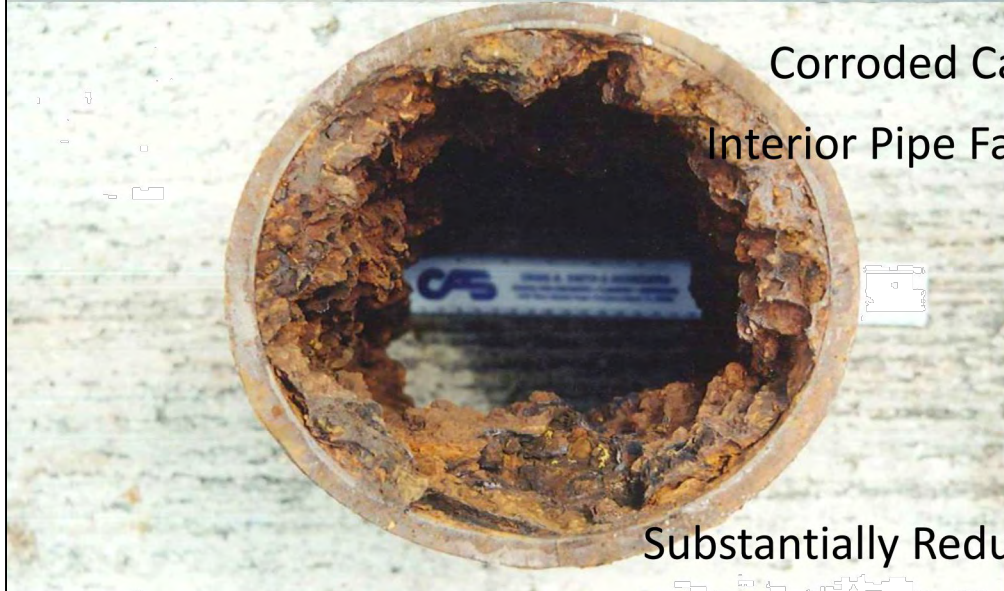
Corroded Cast Iron Pipe
Interior Pipe Failure

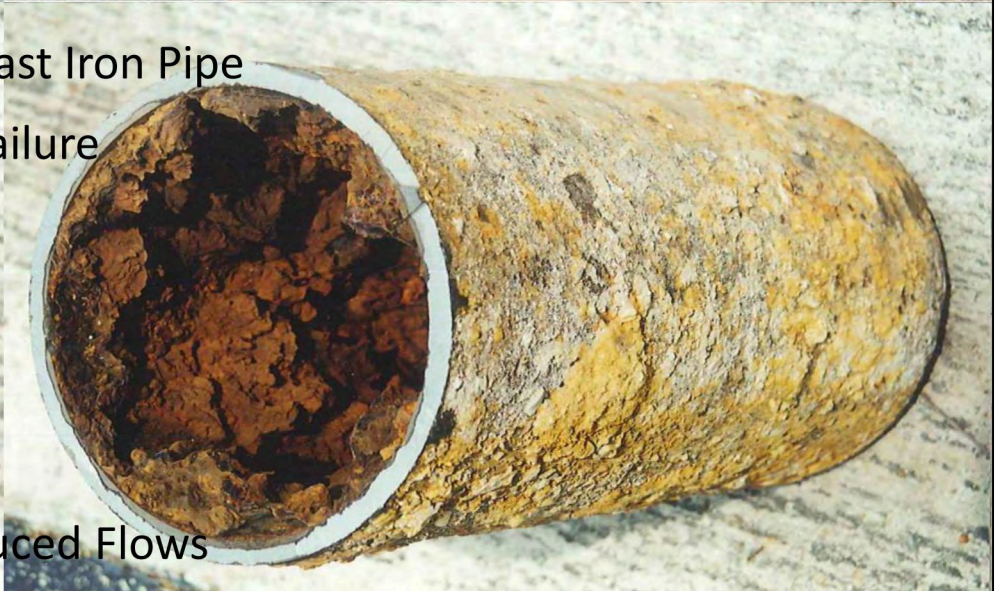
Substantially Reduced Flows

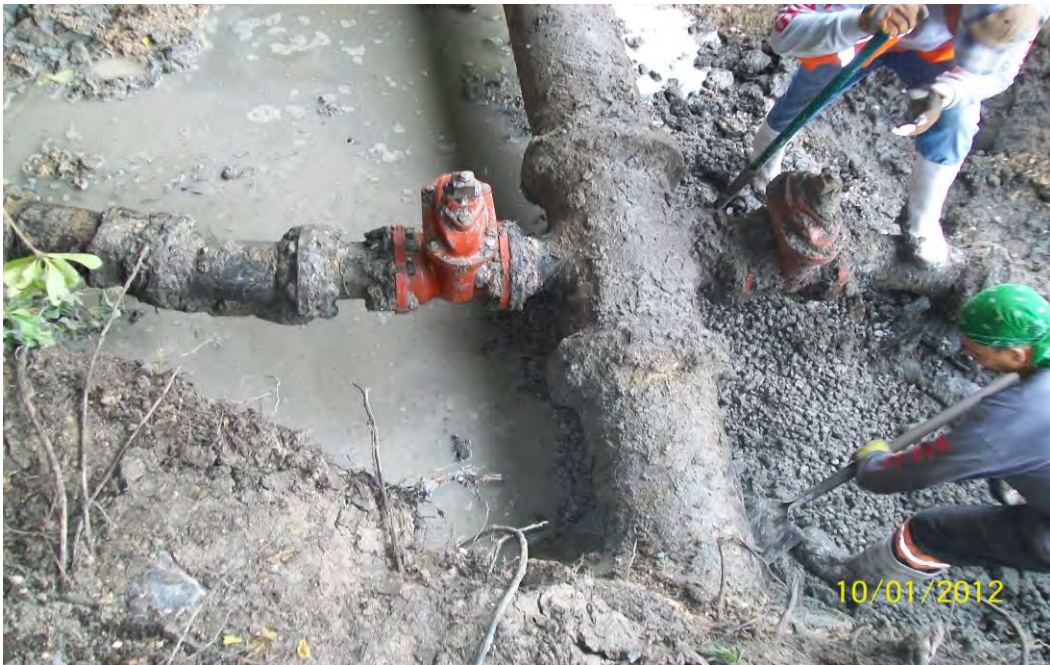
Photo 1 : Leaking Valves uncovered at Park Drive and Camden Drive.

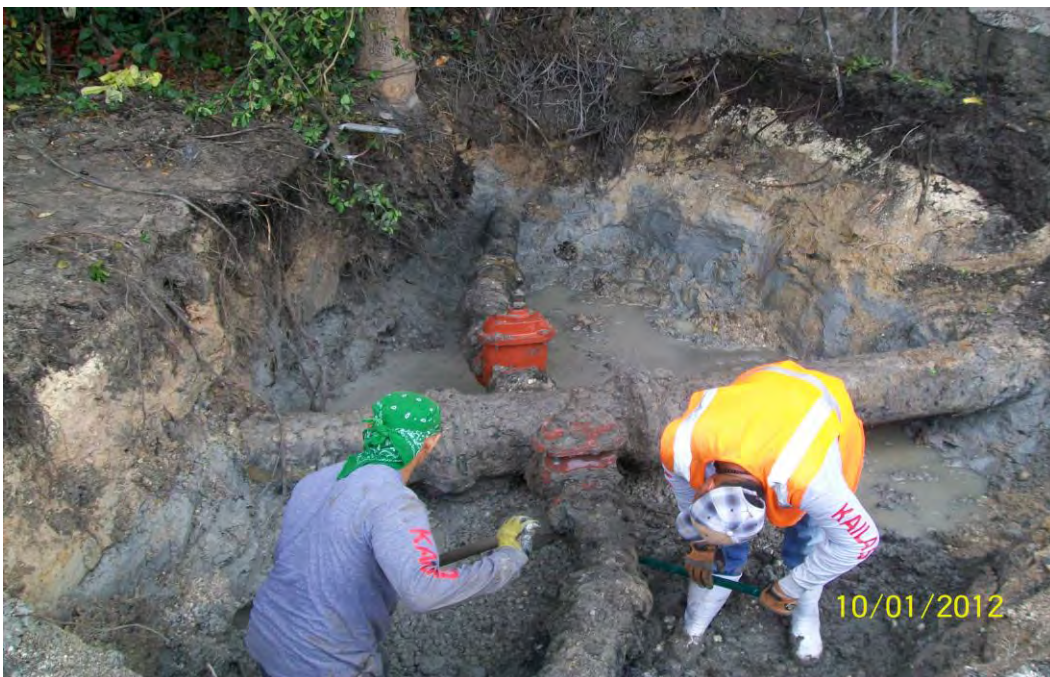
Photo 2 : Leaking Valves on 6" water main uncovered on Park Drive.

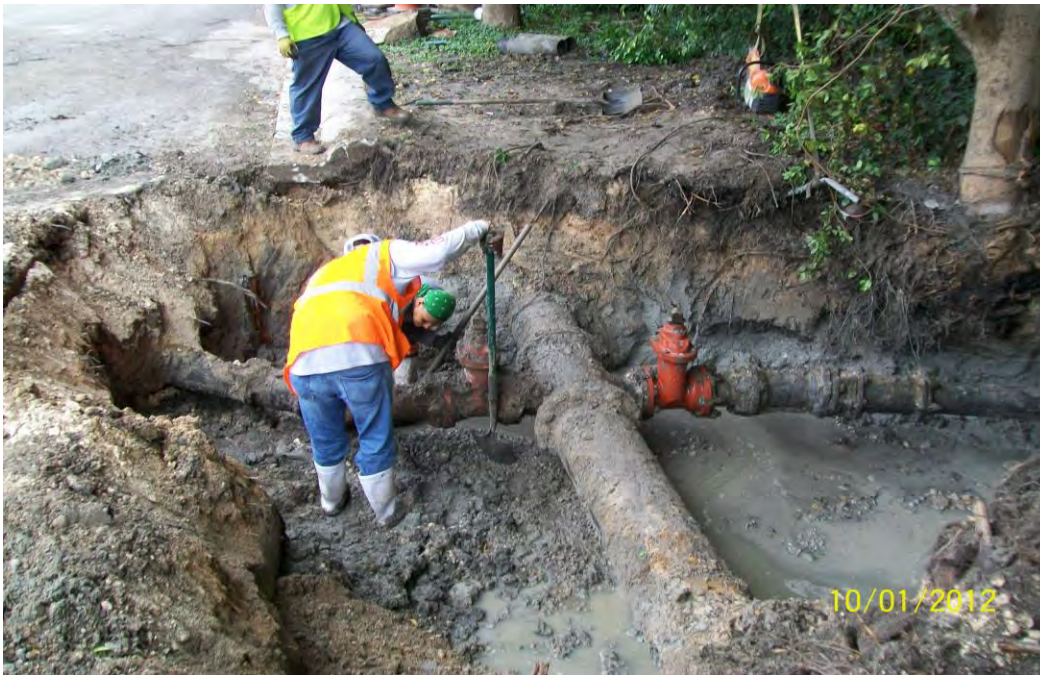
Photo 3: Thrust block removed in repair of leaking valves.

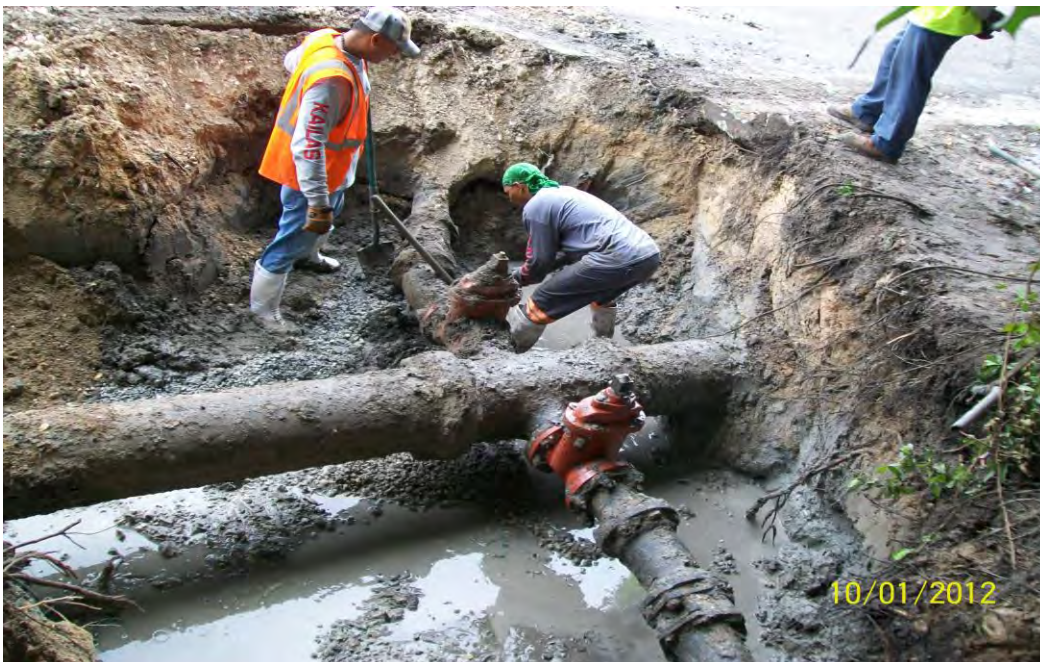
Photo 4: Exist. 6" and 12" water mains where valves were uncovered.

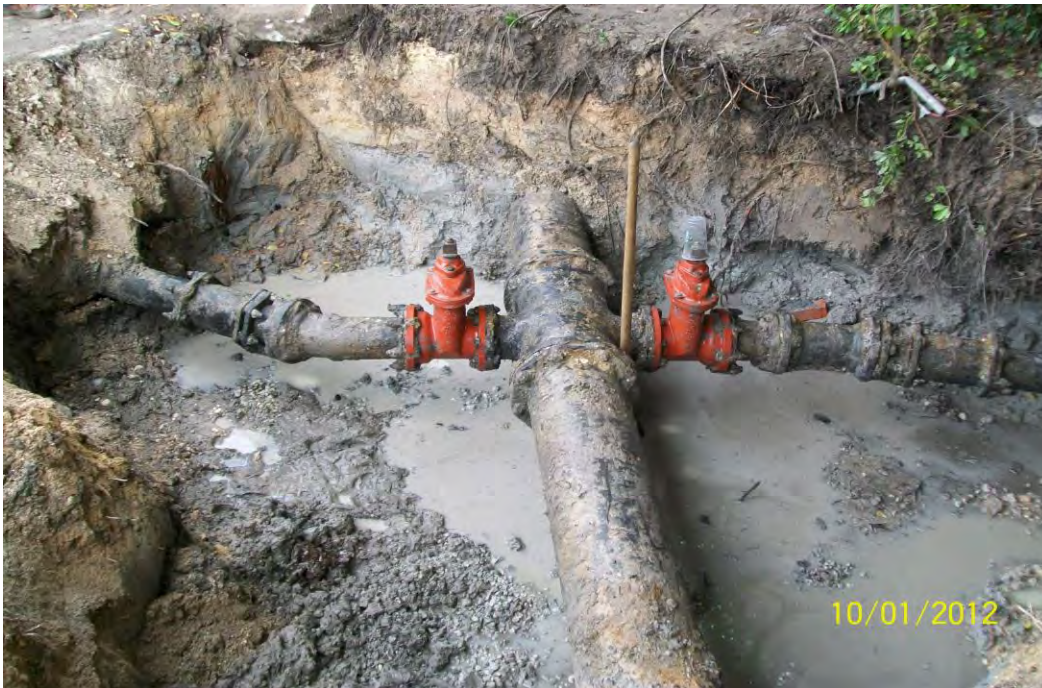
Photo 5: Existing excavated water mains on Park Drive.

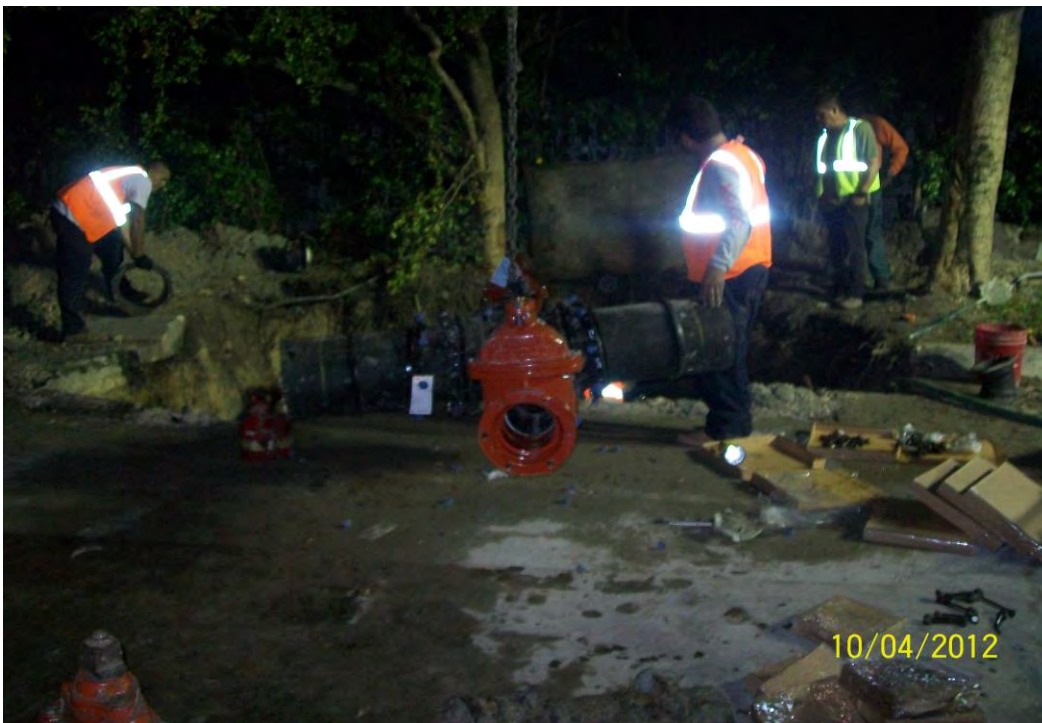
Photo 6: Night repair work on new water main assembly and fittings.

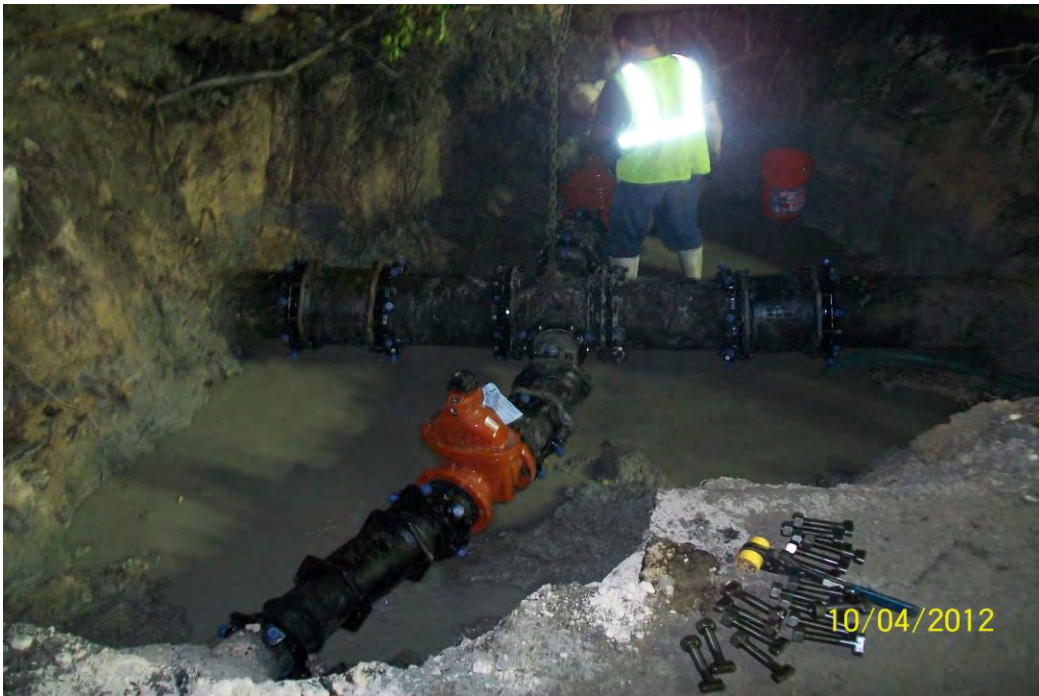
Photo 7: Installed emergency repair replacement pipe.

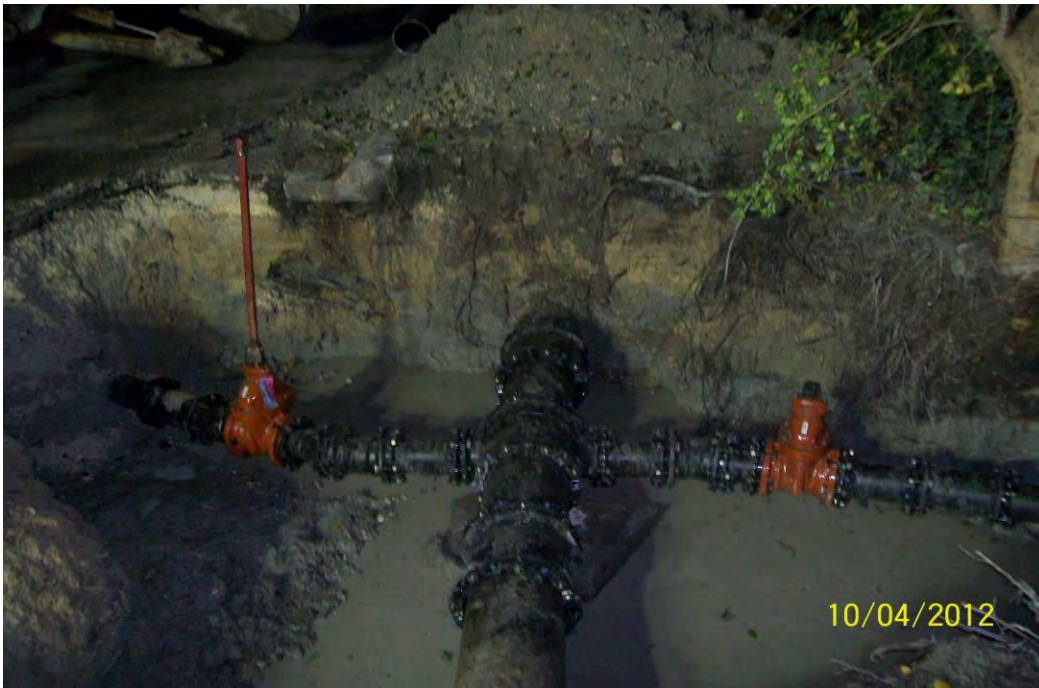
Photo 9: Completed emergency night repair of water main.

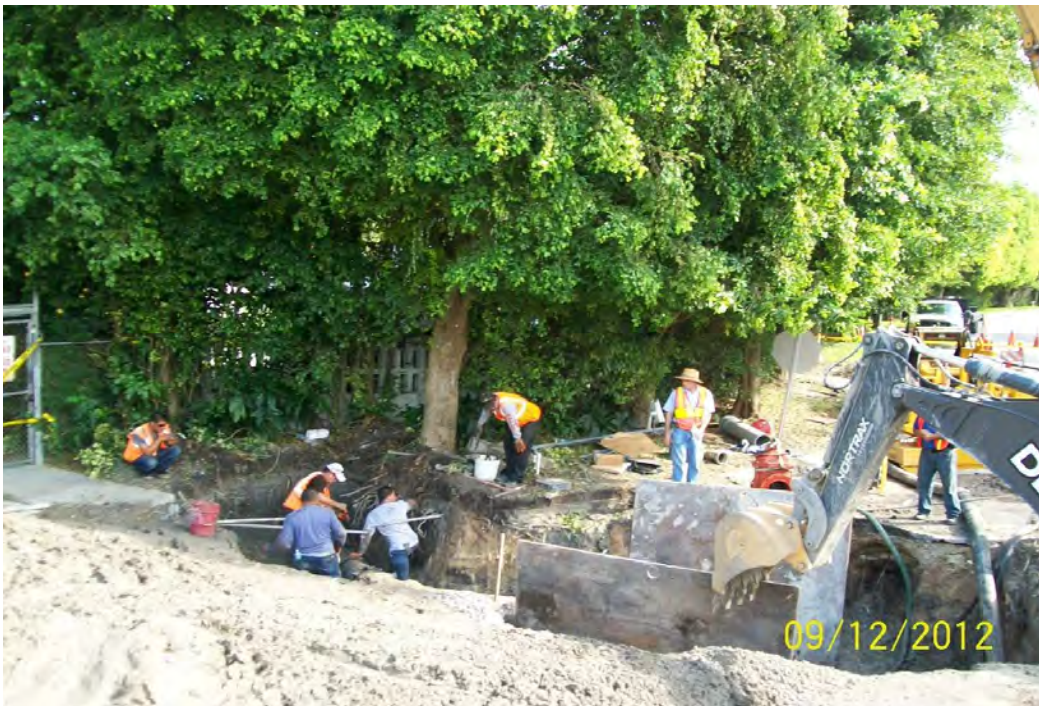
Photo 10: Water main repair on Park Drive and Balfour Drive.

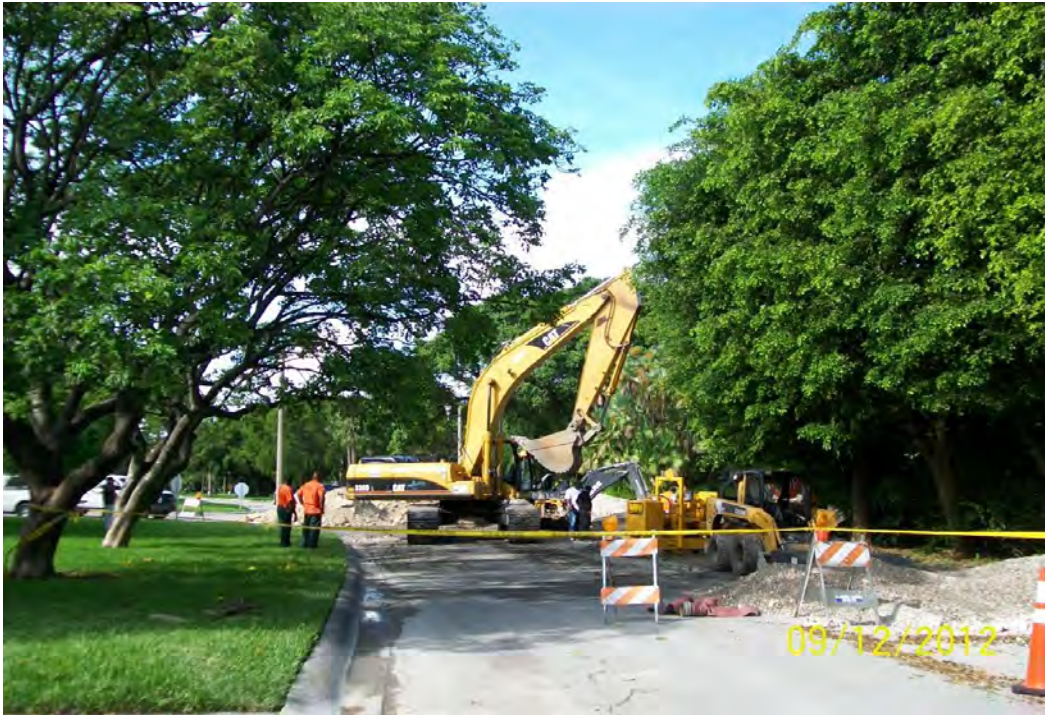
Photo 11: Water main repair on Park Drive and Balfour Drive.

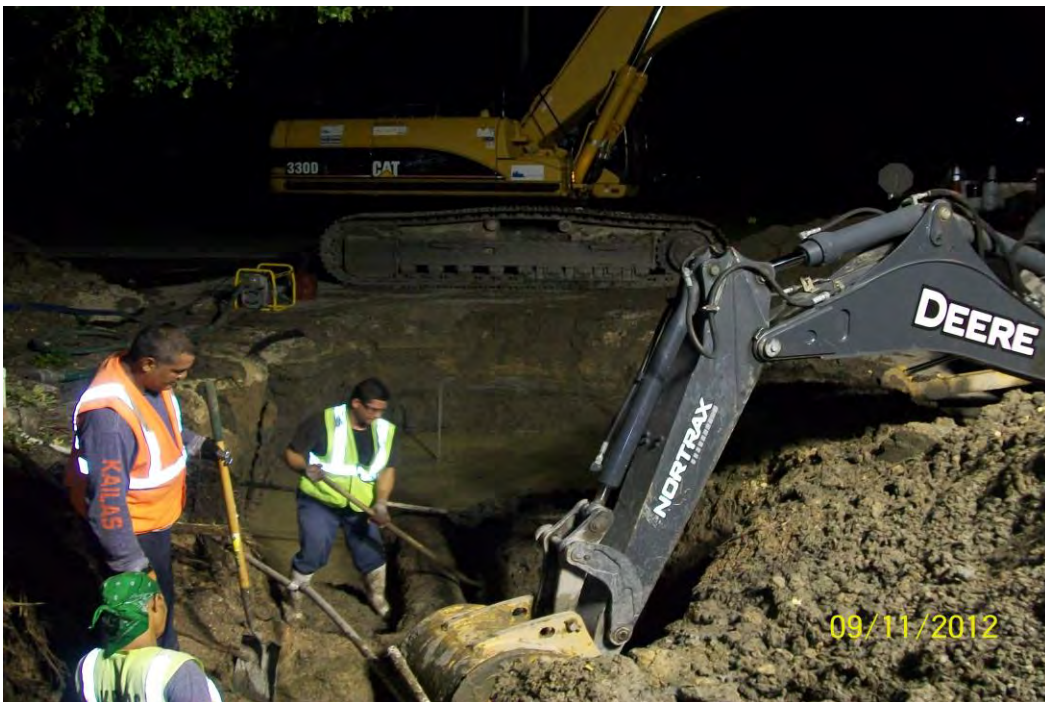
Photo 12: Night repair of water main on Park and Balfour Drive.

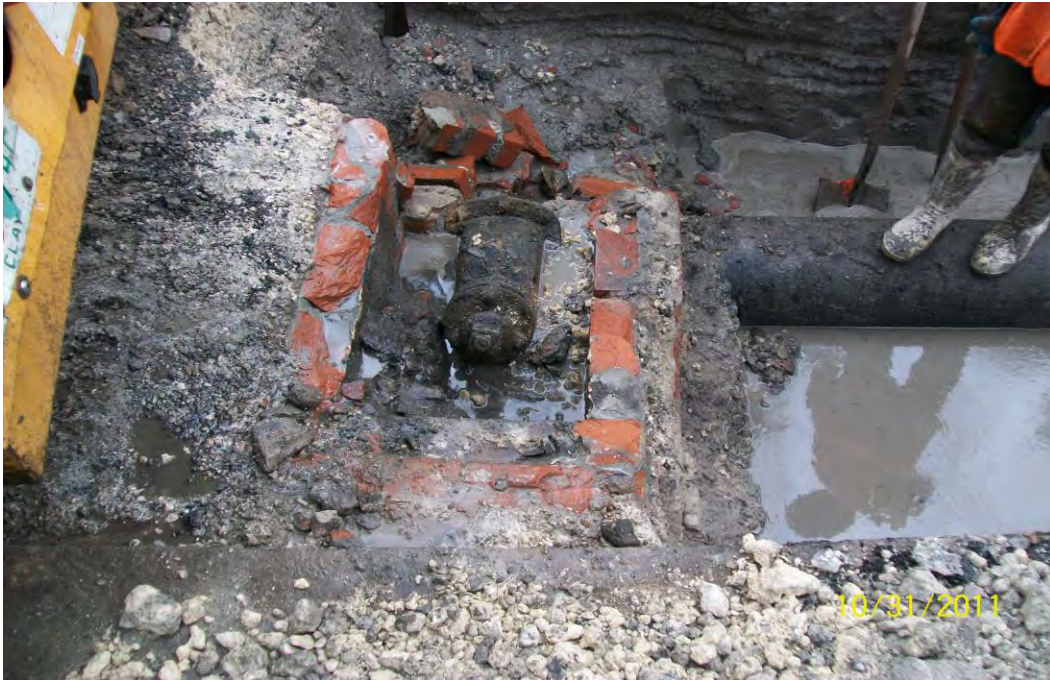
Photo 13 : Failed water main pipe uncovered on 96th Street.

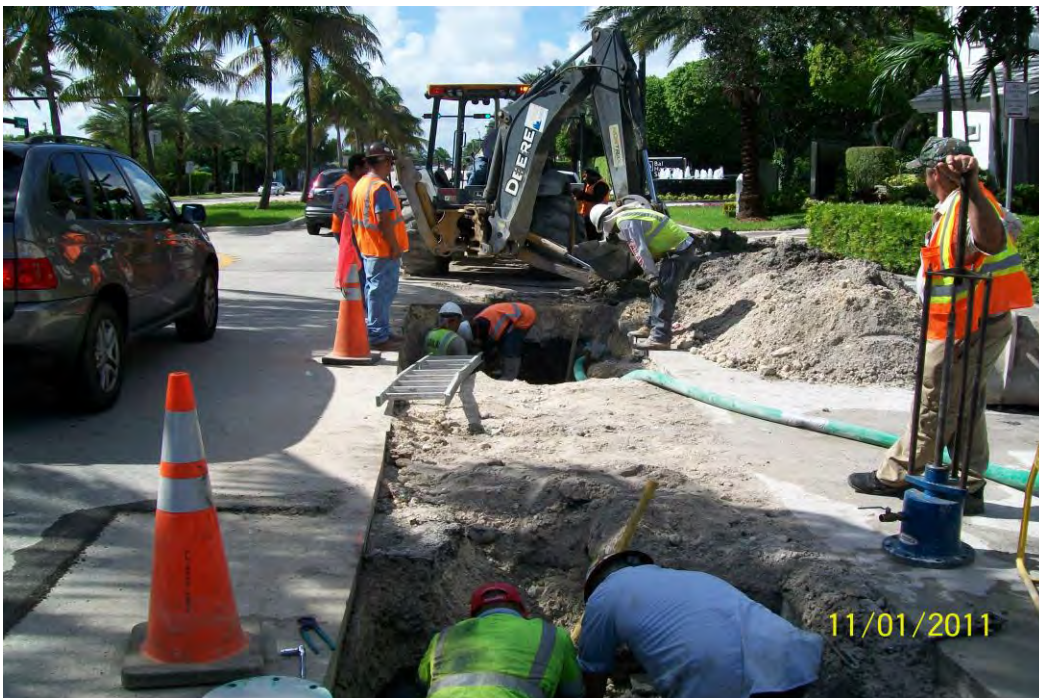
Photo 14 : Water main repair trench on north side of 96th Street.

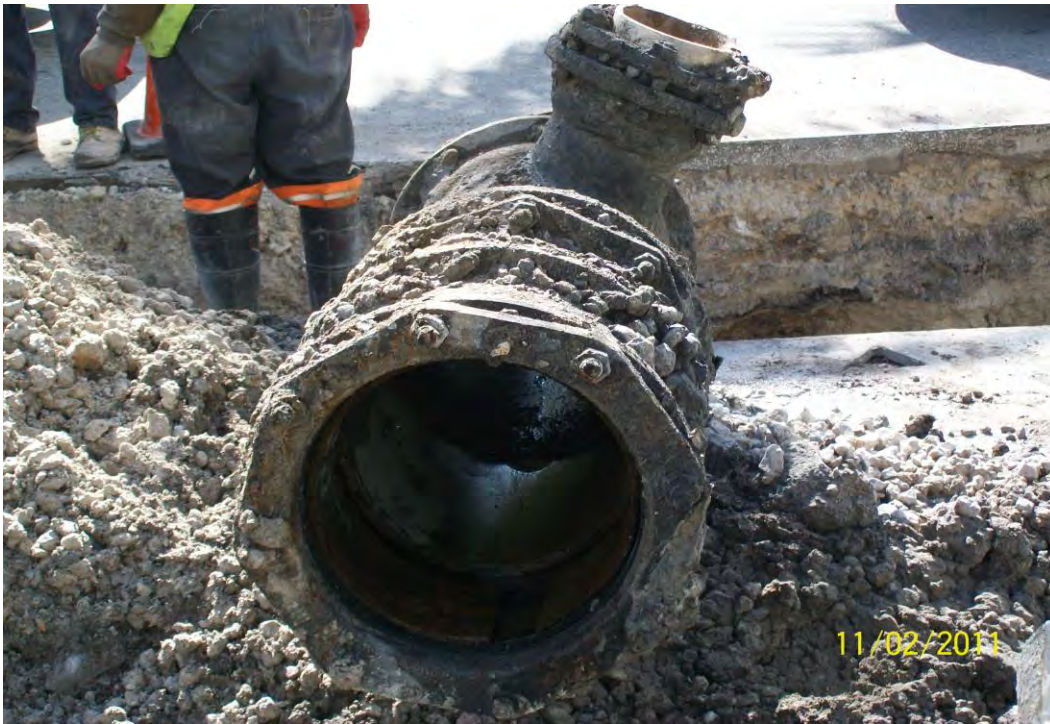
Photo 17 : Removal of existing pipe assembly.

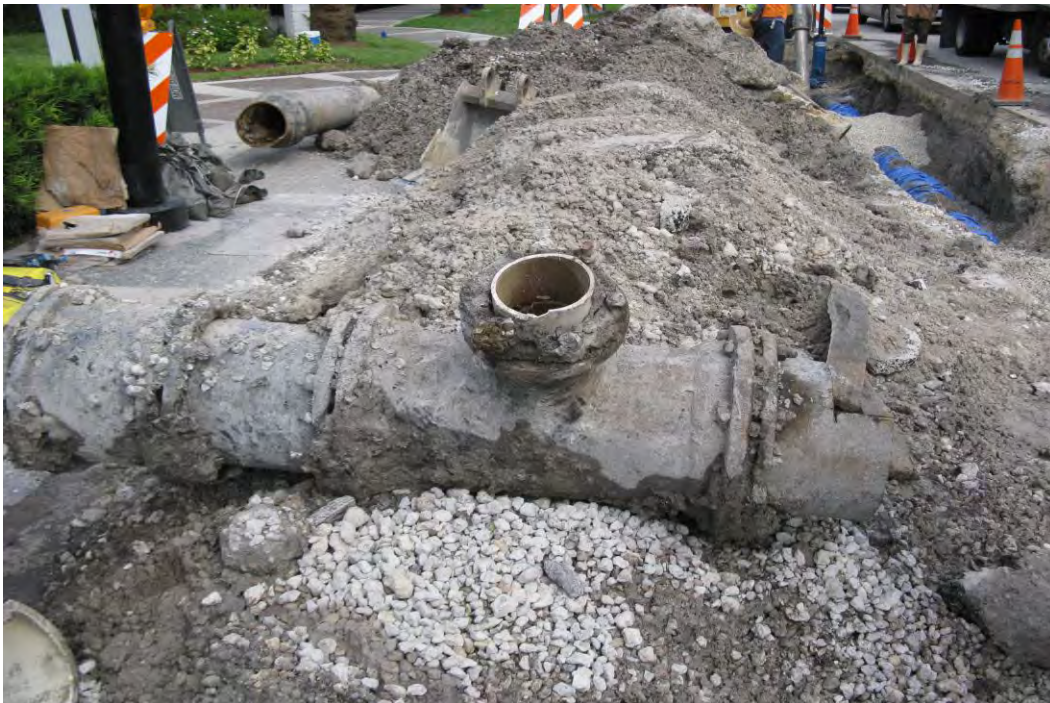
Photo 18 : Removal of existing pipe assembly.

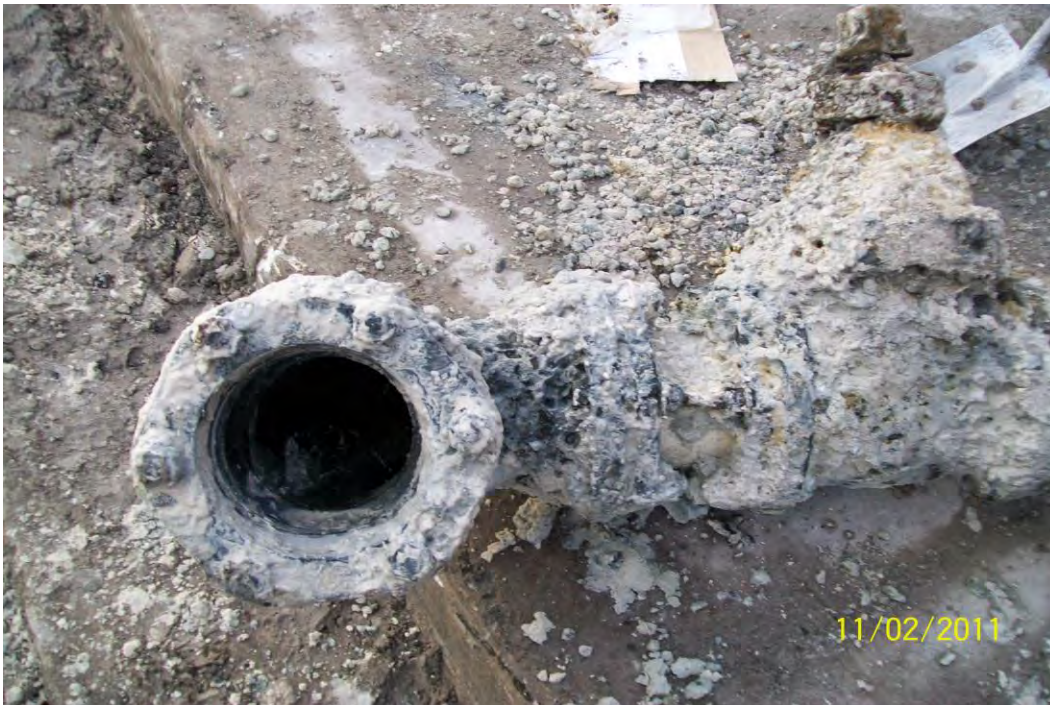
Photo 19 : Removal of existing valve assembly.

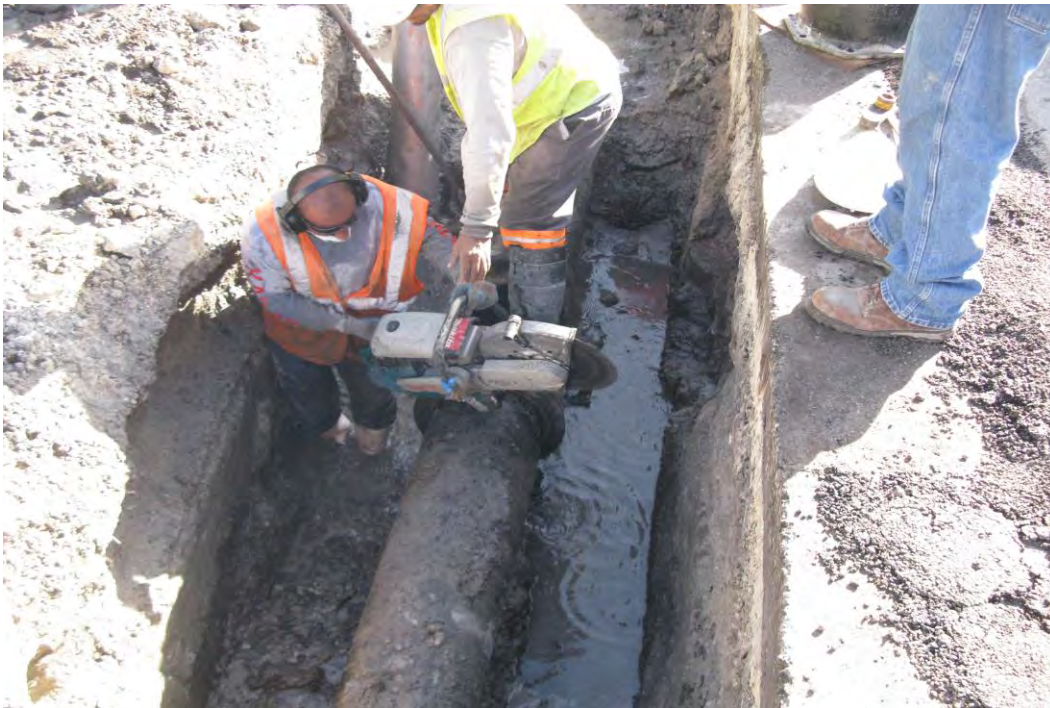
Photo 20 : Removal of existing 12" water main pipe on 96th Street.

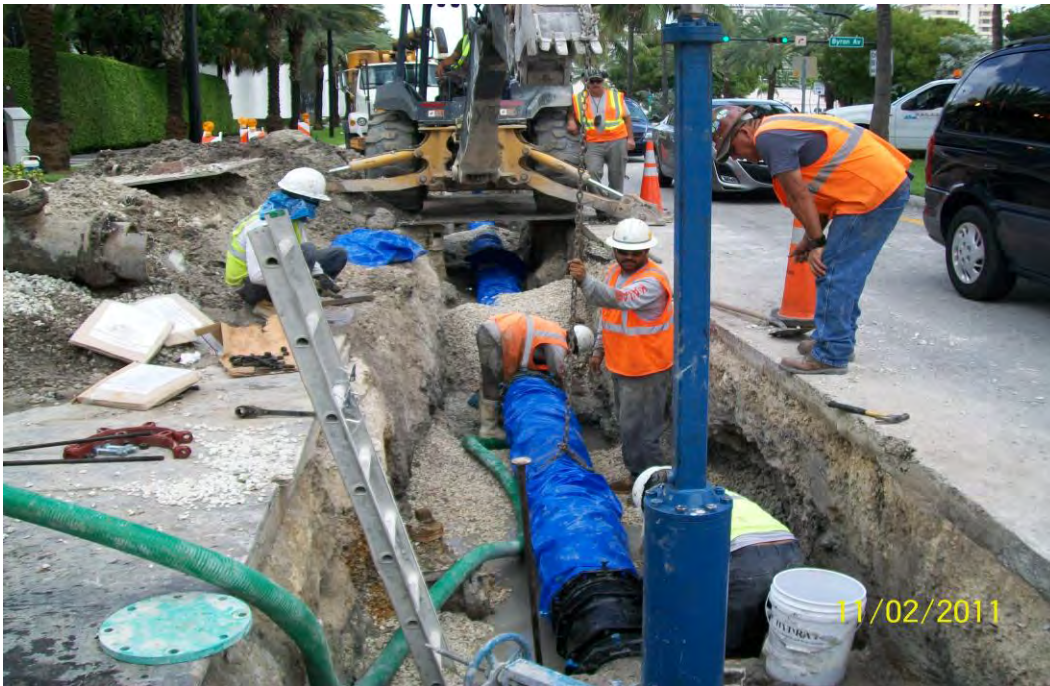
Photo 21 : Repaired 12" water main on 96th Street.

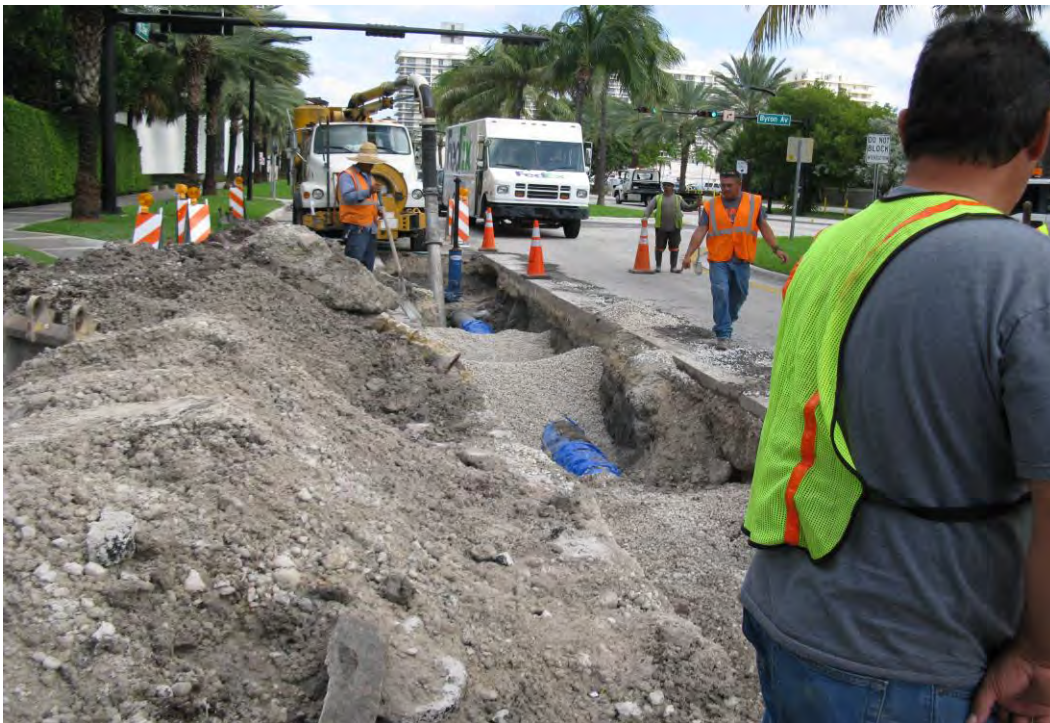
Photo 22 : Backfilled water main trench on north side of 96th Street.

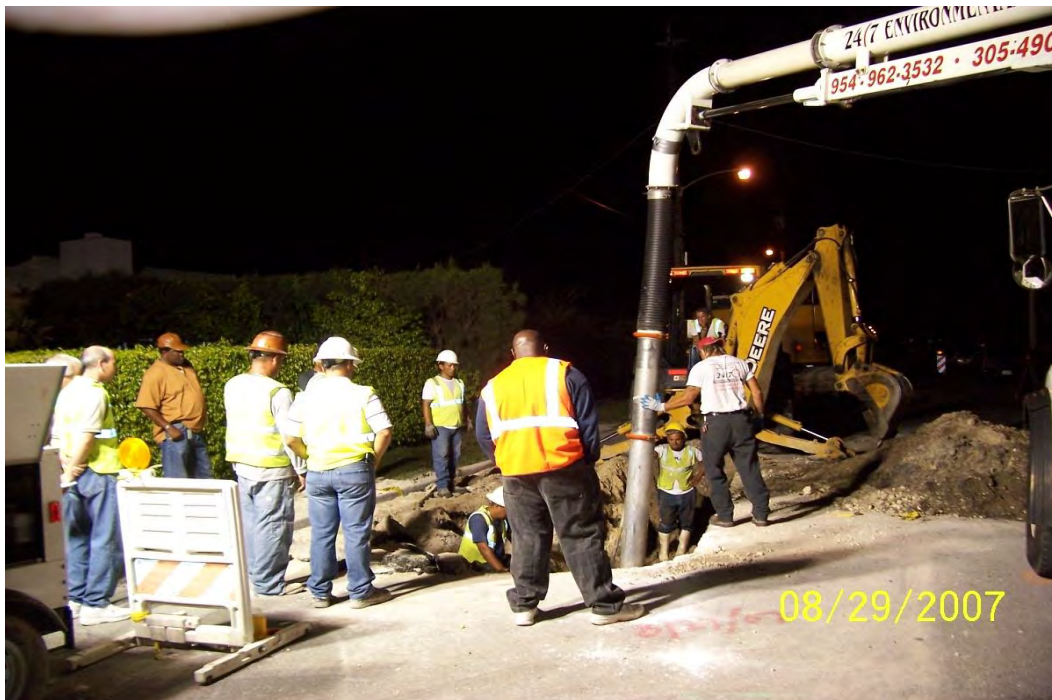
Photo 1 : Sanitary Sewer Force Main repairs on Byron Avenue.

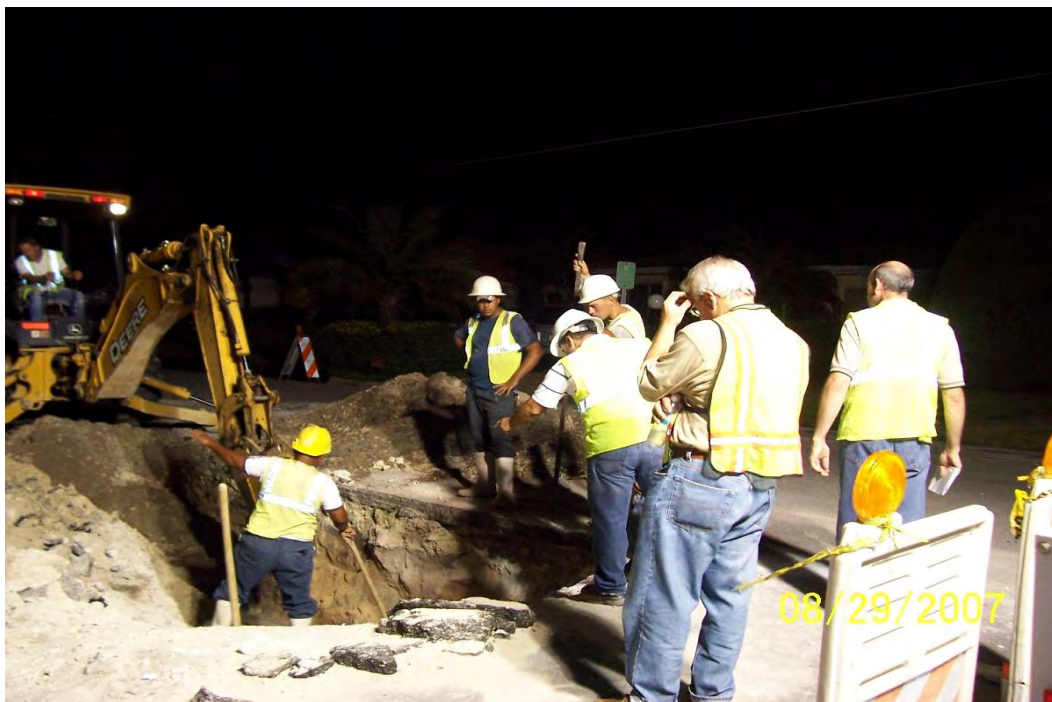
Photo 2 : Sanitary Sewer Force Main repairs on Byron Avenue.

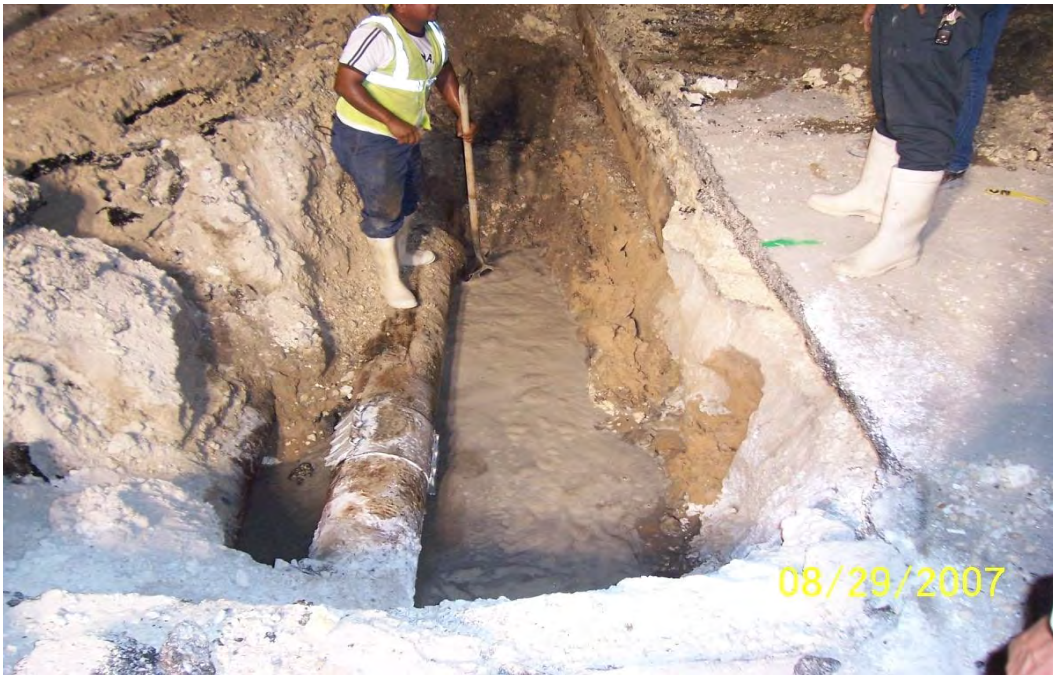
Photo 3: Sanitary Sewer Force Main repairs on Byron Avenue.

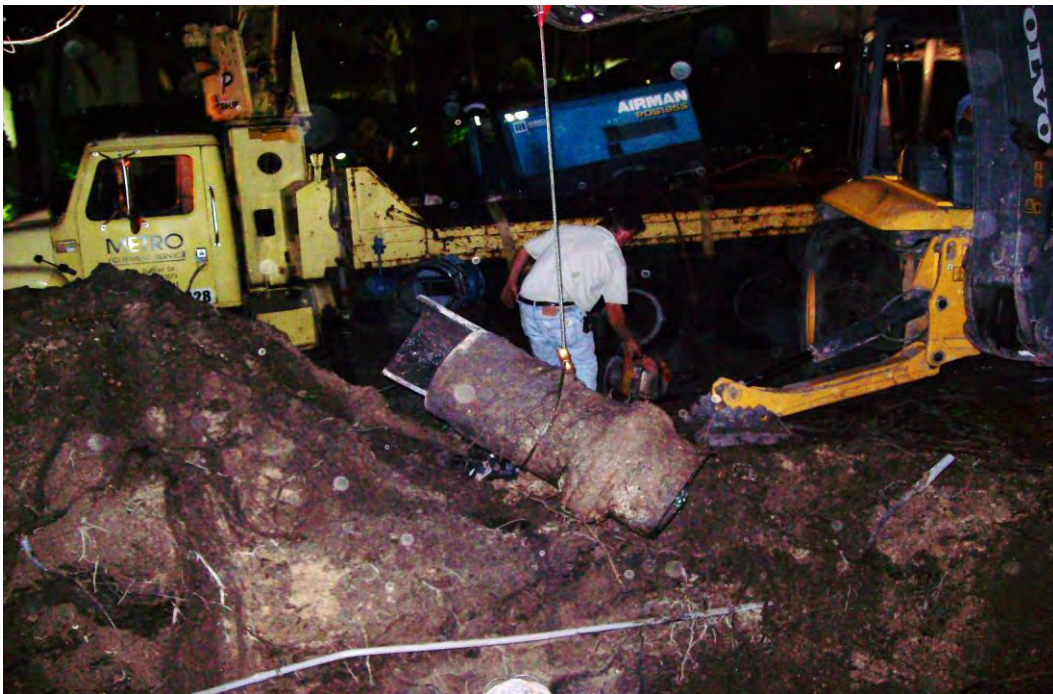
Photo 4: Sanitary Sewer Force Main repairs on Collins Avenue.

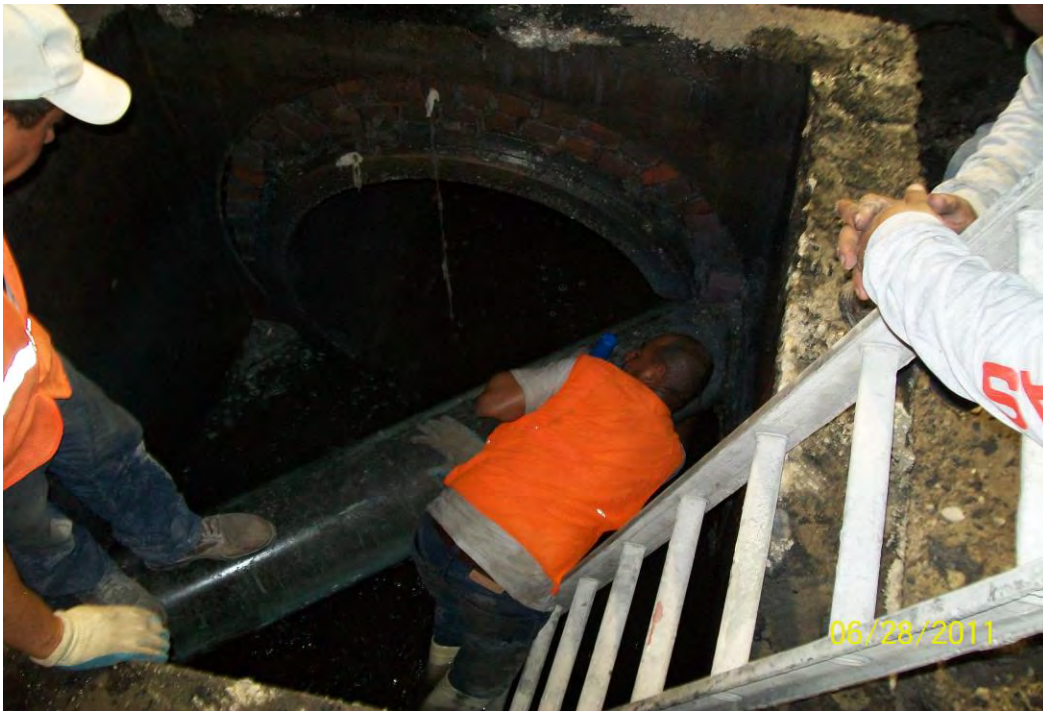
Photo 5: Sanitary Sewer Force Main repair on 96th Street.

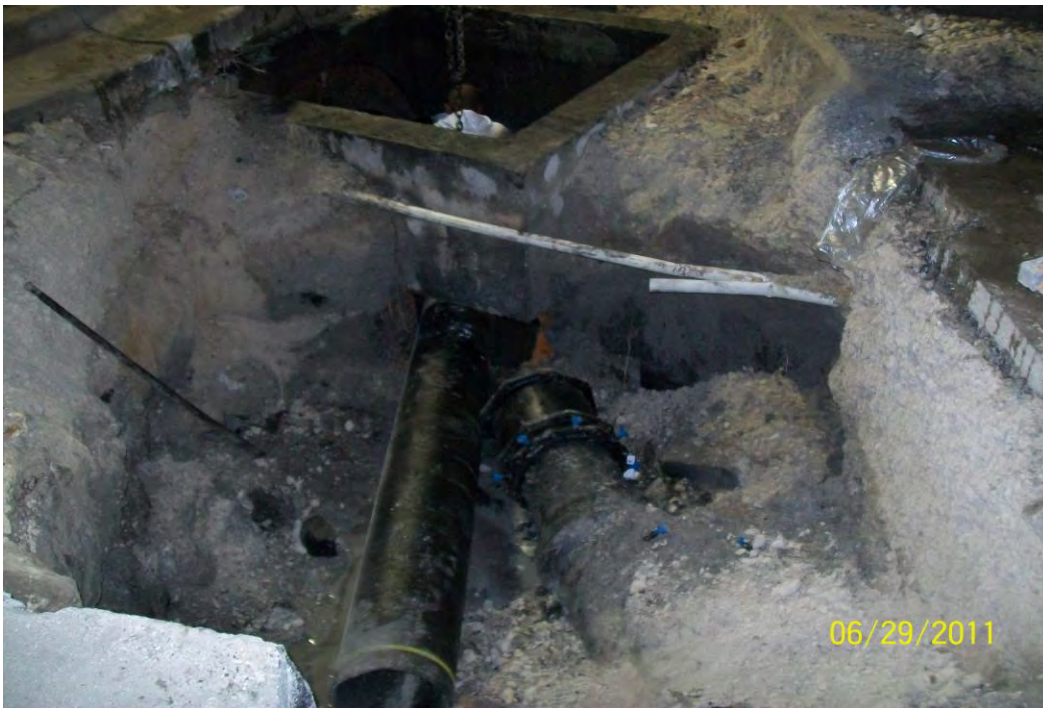
Photo 6: Force Main repair inside Drainage Conflict Structure.

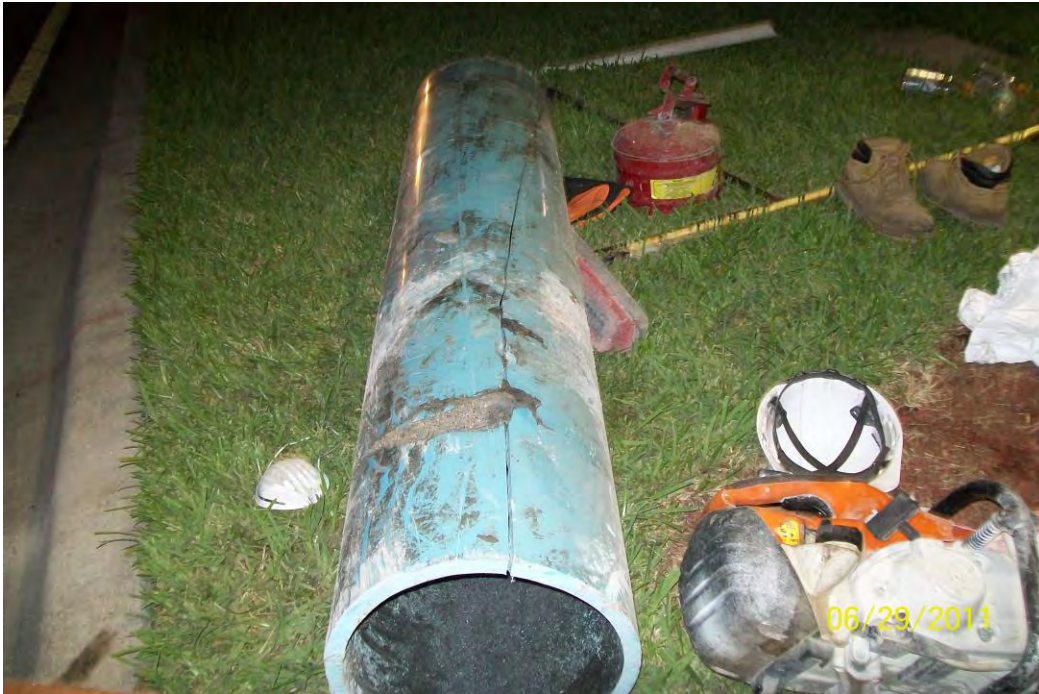
Photo 7: Longitudinal crack of PVC Sanitary Force Main.

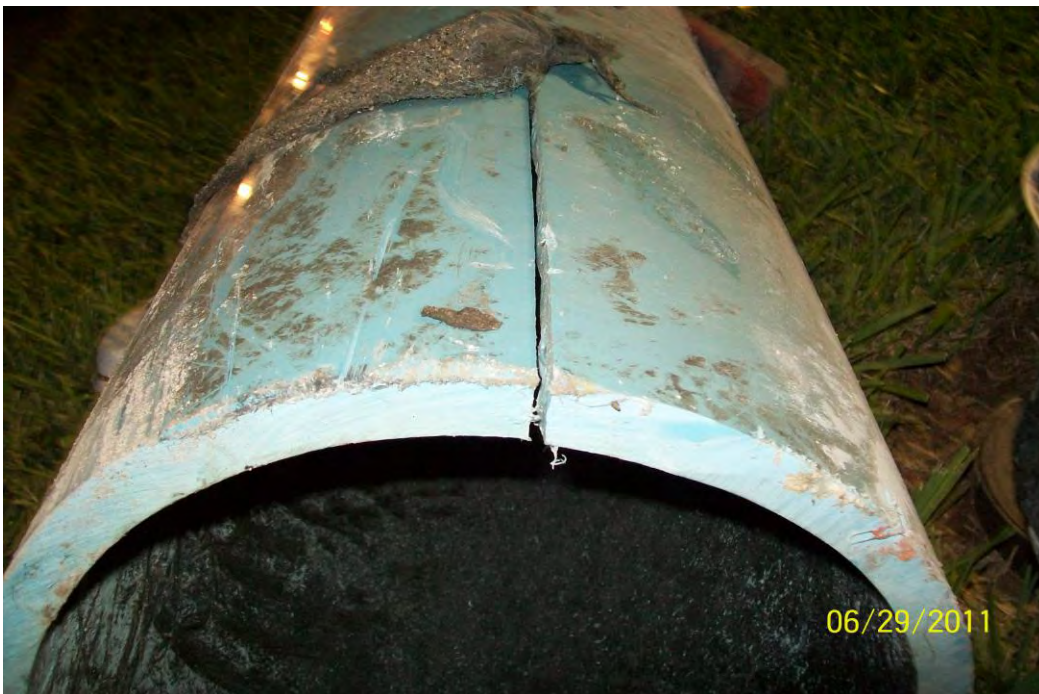
Photo 8: Longitudinal crack of PVC Sanitary Force Main.

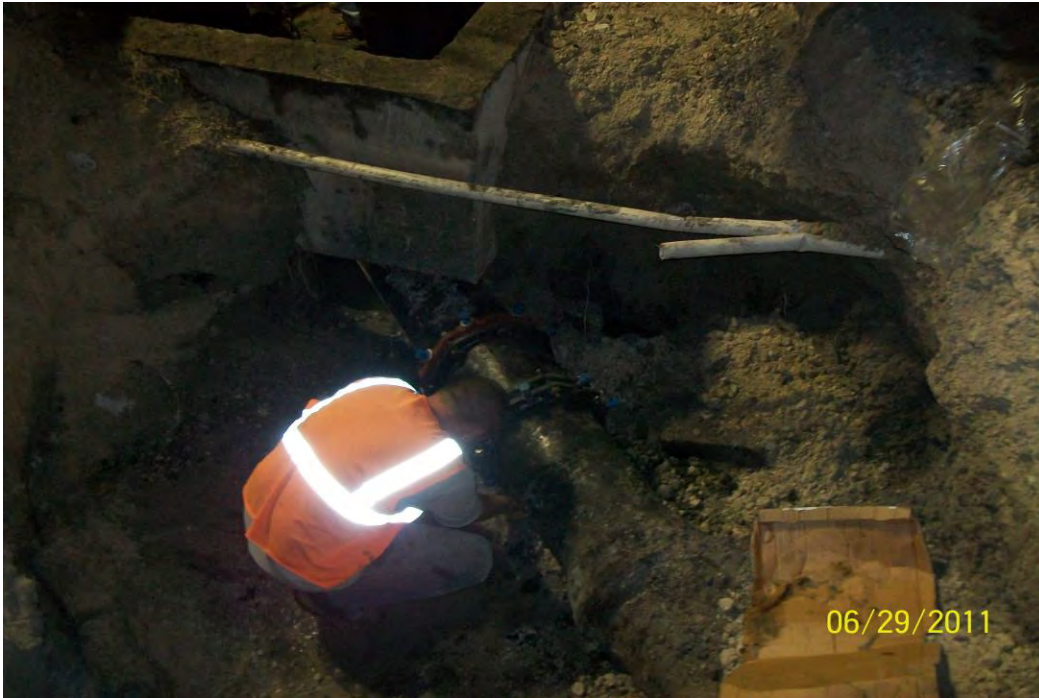
Photo 9: Sanitary Sewer Force Main repair on 96th Street.

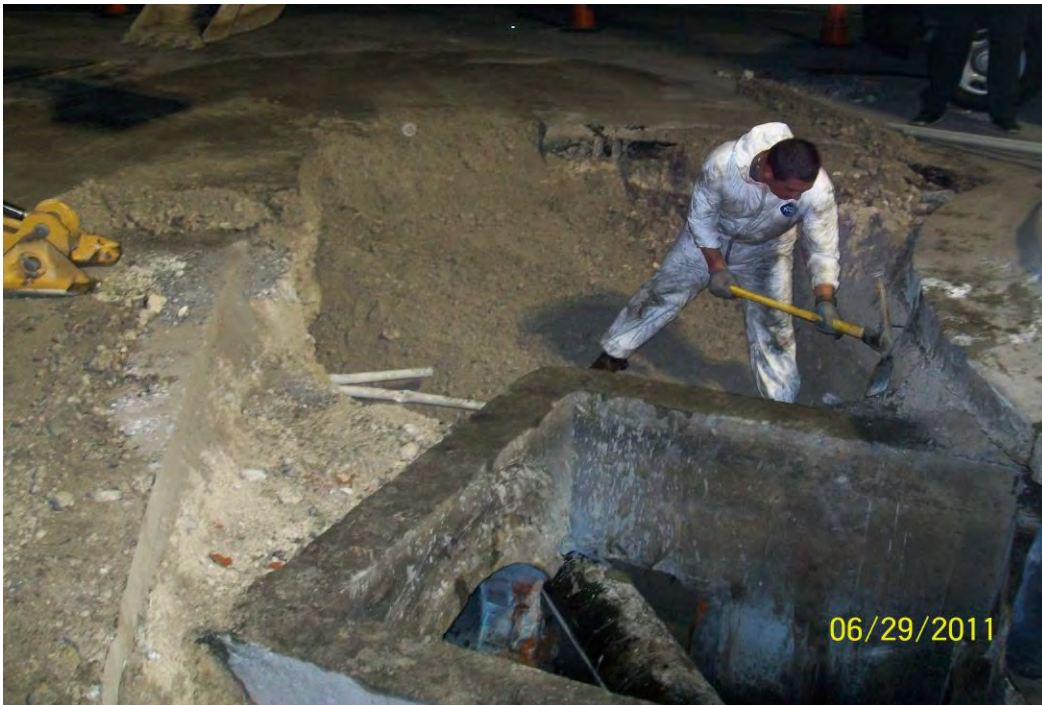
Photo 11: Sanitary Sewer Force Main repair on 96th Street.
