BAL HARBOUR VILLAGE

UTILITY MASTER PLAN

FEBRUARY 2015

CRAIG A. SMITH & ASSOCIATES
7777 GLADES RD, SUITE 410
BOCA RATON, FL 33434
561.314.4445

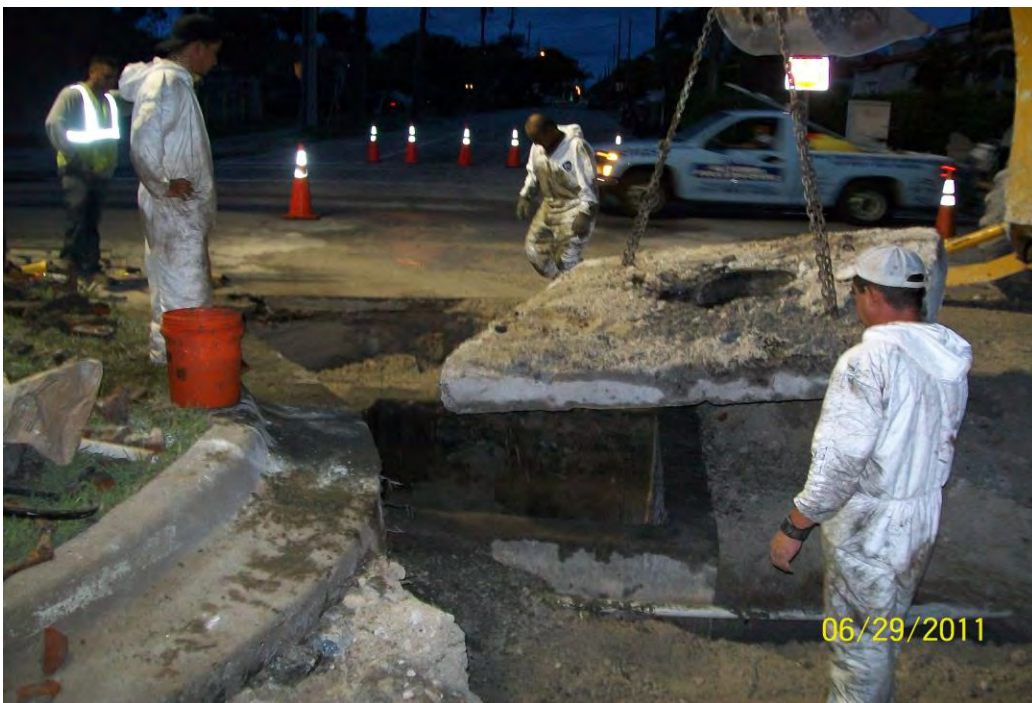
Photo 12: Sanitary Sewer Force Main repair on 96th Street.

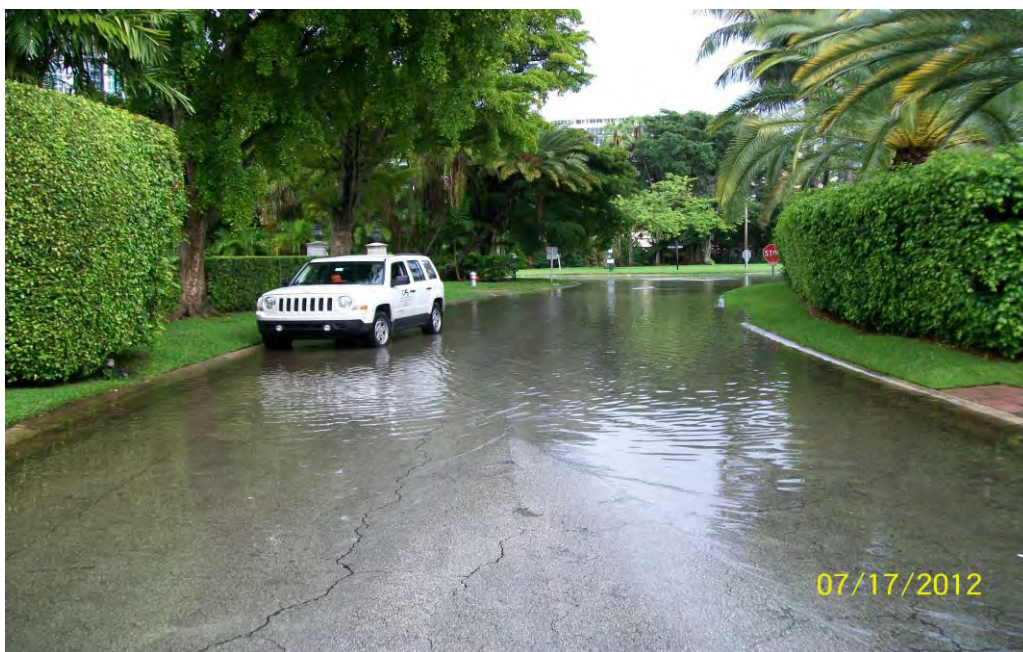
Photo 1 : 276-284 Bal Bay Drive, looking south.

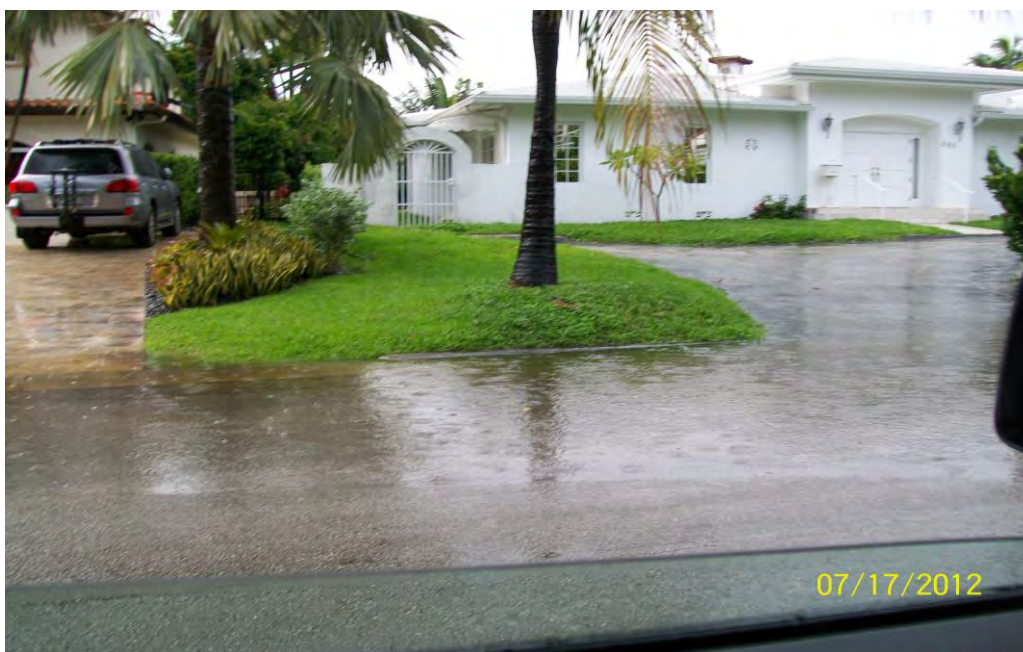
Photo 2: 276 Bal Cross Drive, looking west.

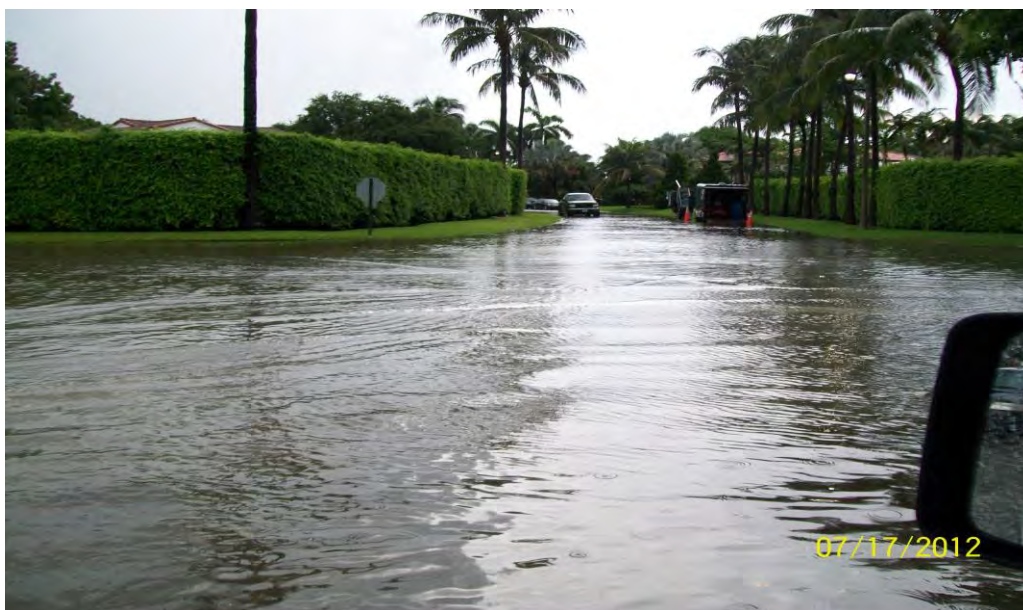
Photo 3: Intersection of Park Road and Bal Cross Drive, looking southwest.

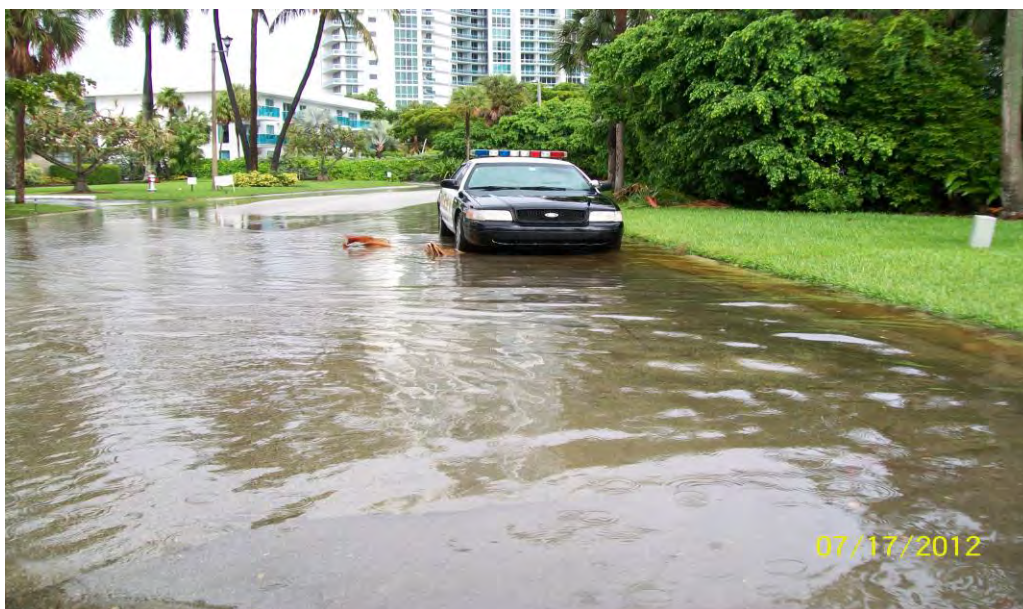
Photo 4: Bal Cross Drive and Park Road, looking east.

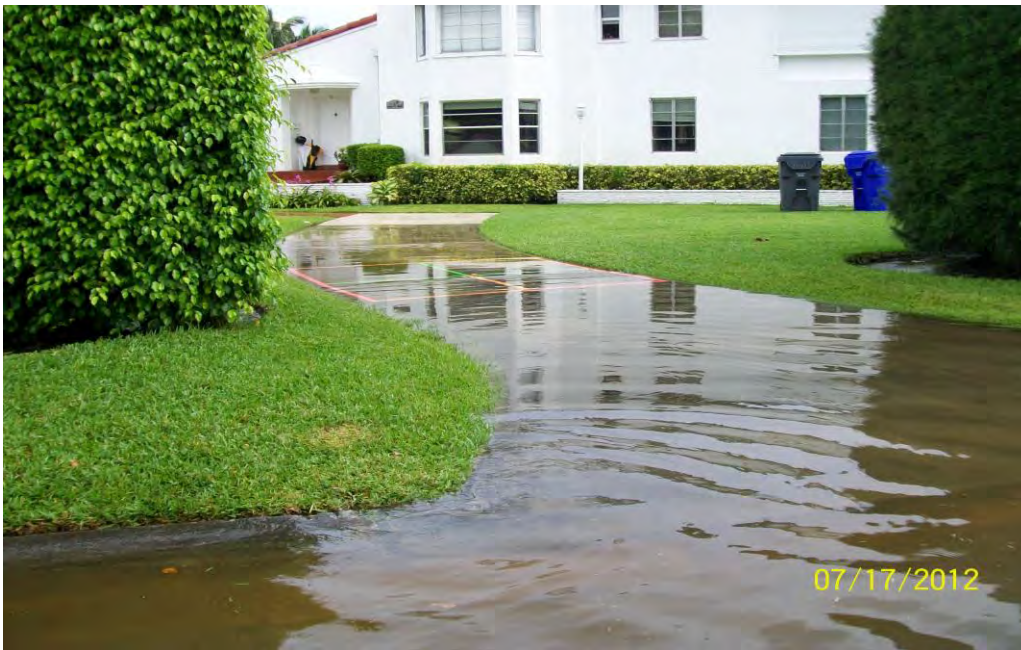
Photo 5: 271 Bal Cross Drive, looking east.

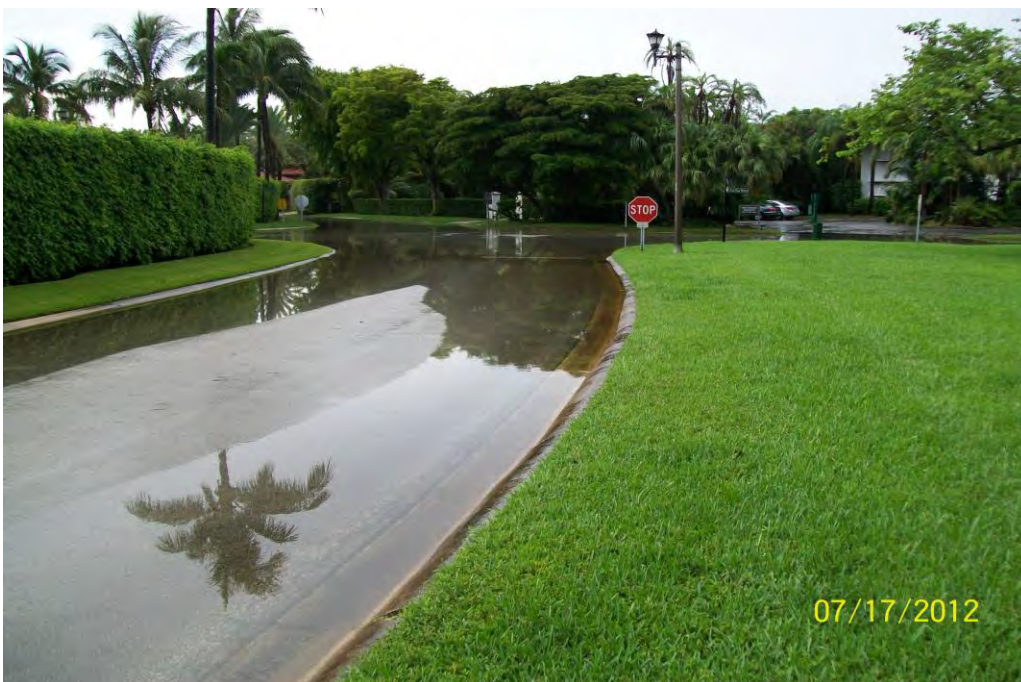
Photo 6: Park Drive, looking north to Bal Bay Drive.

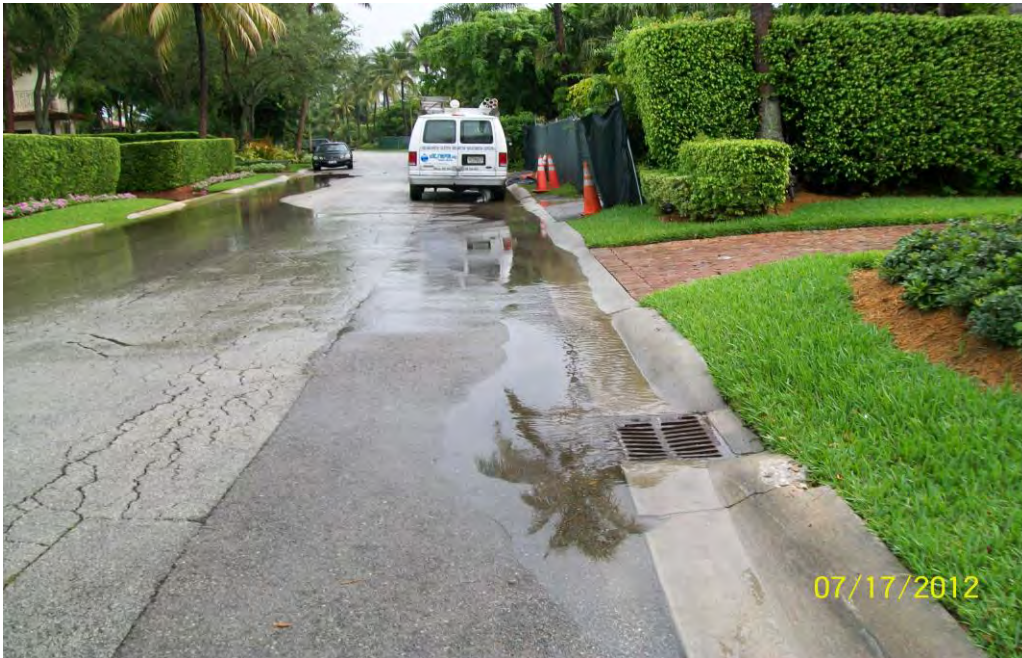
Photo 7: Camden Drive, looking south.

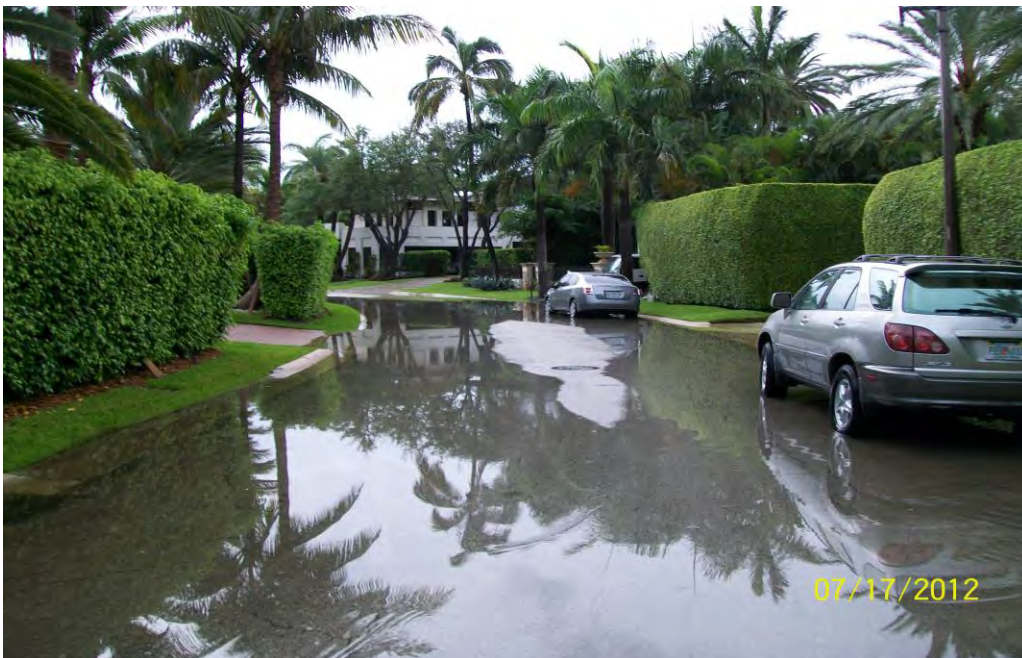
Photo 8: 275-279 Bal Bay Drive, looking north.

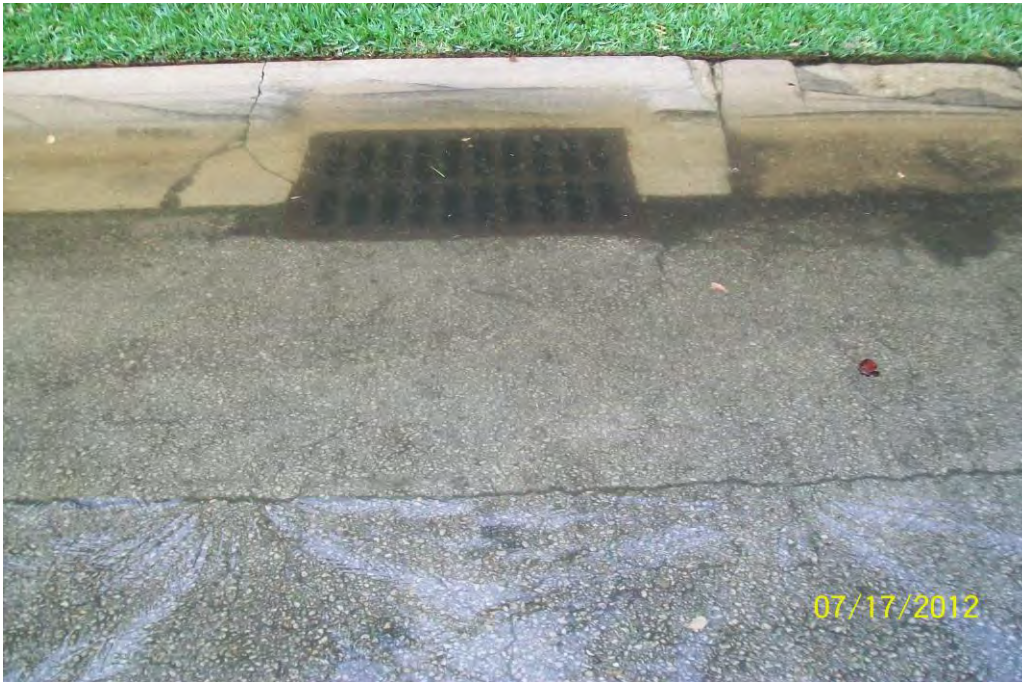
Photo 9: Catch Basin at 265 Bal Bay Drive, looking south.

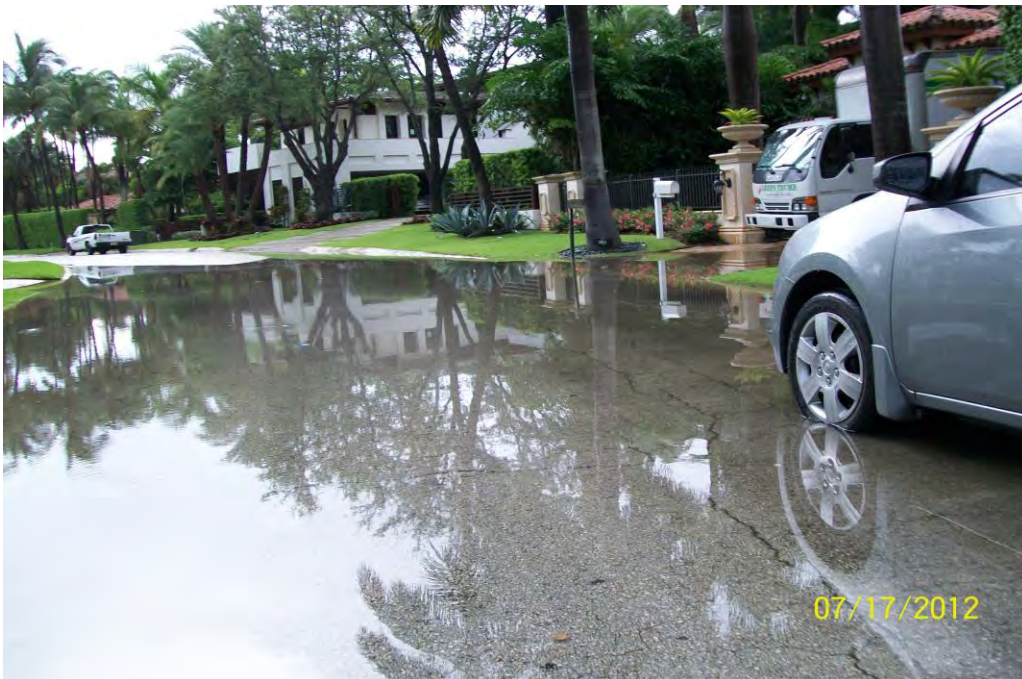
Photo 10: 259-251 Bal Bay Drive, looking west.

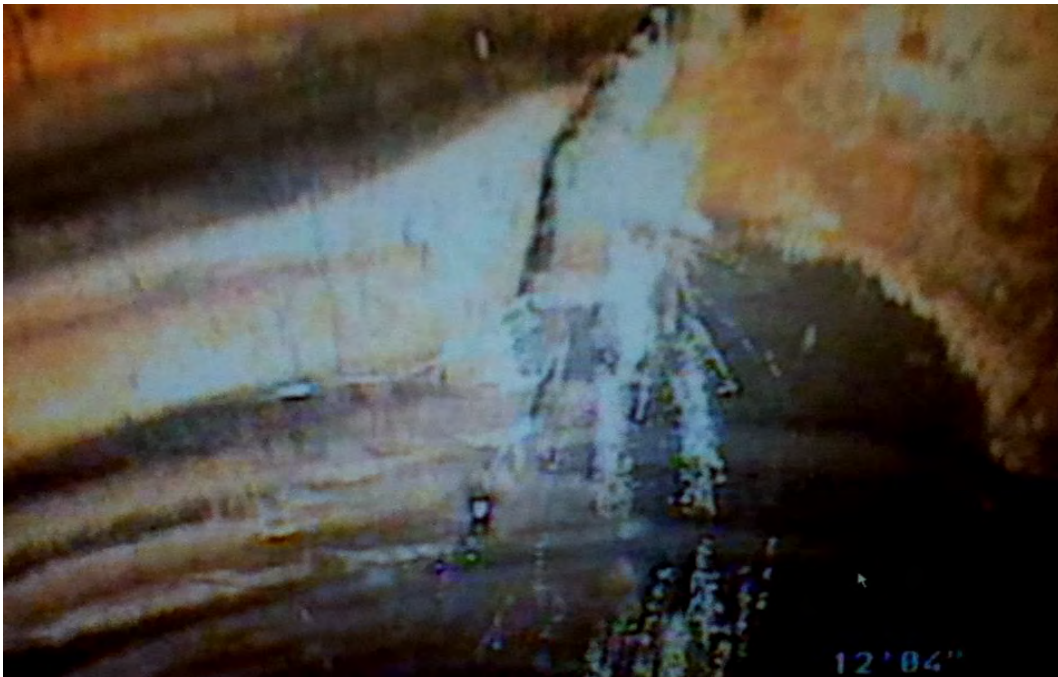
Photo 12: Longitudinal crack at top of stormwater pipe.

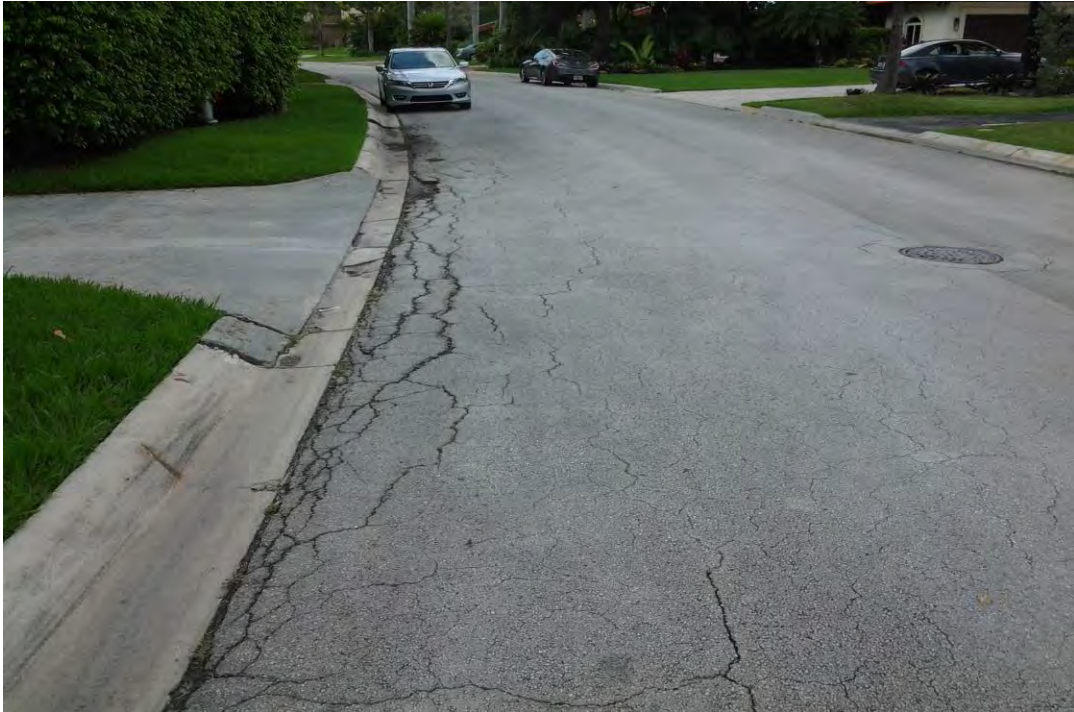
The current conditions of the Village roadways are indicated in the photographs found in Exhibit R-12. After thirty five years without repairs road surface deterioration has occurred; resulting in surface cracking and settling. Pavement systems primarily fail due to fatigue and a lack of maintenance. According to the American Association of State Highway and Transportation Officials (AASHTO) Road Test, heavily loaded vehicles, such as moving trucks and construction vehicles and equipment, can do more than 10,000 times the damage done by a normal passenger car.

Photo 1 : Bal Cross Drive, road and curb settling, looking south.

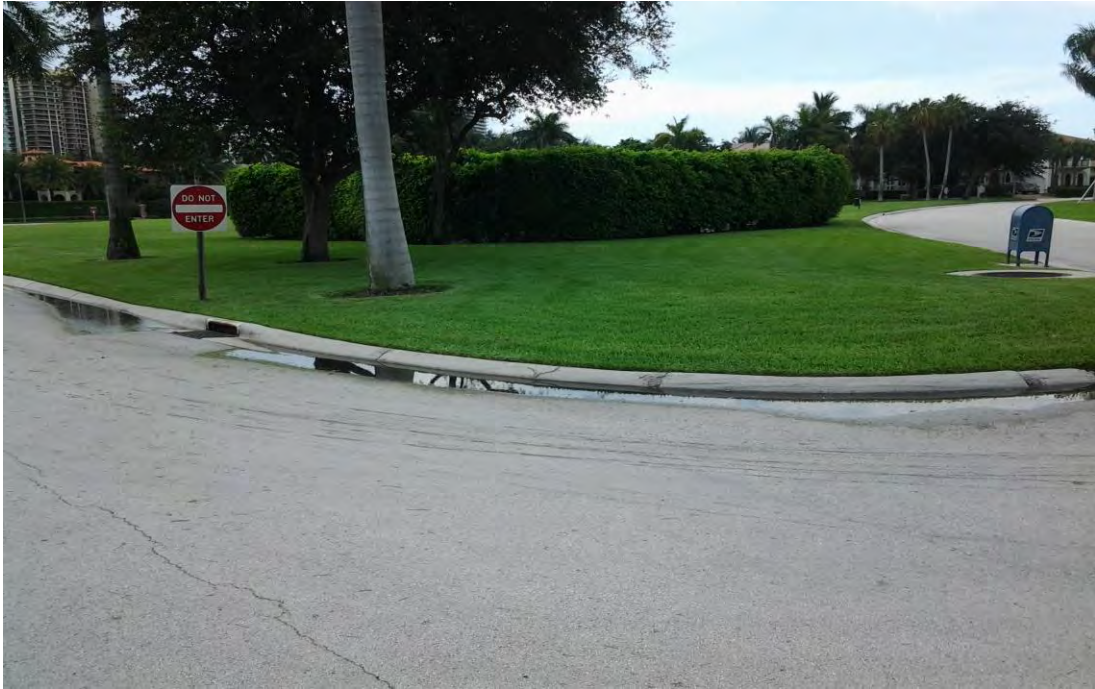
Photo 5 : Harbour Way, road settling and ponding, looking southeast.

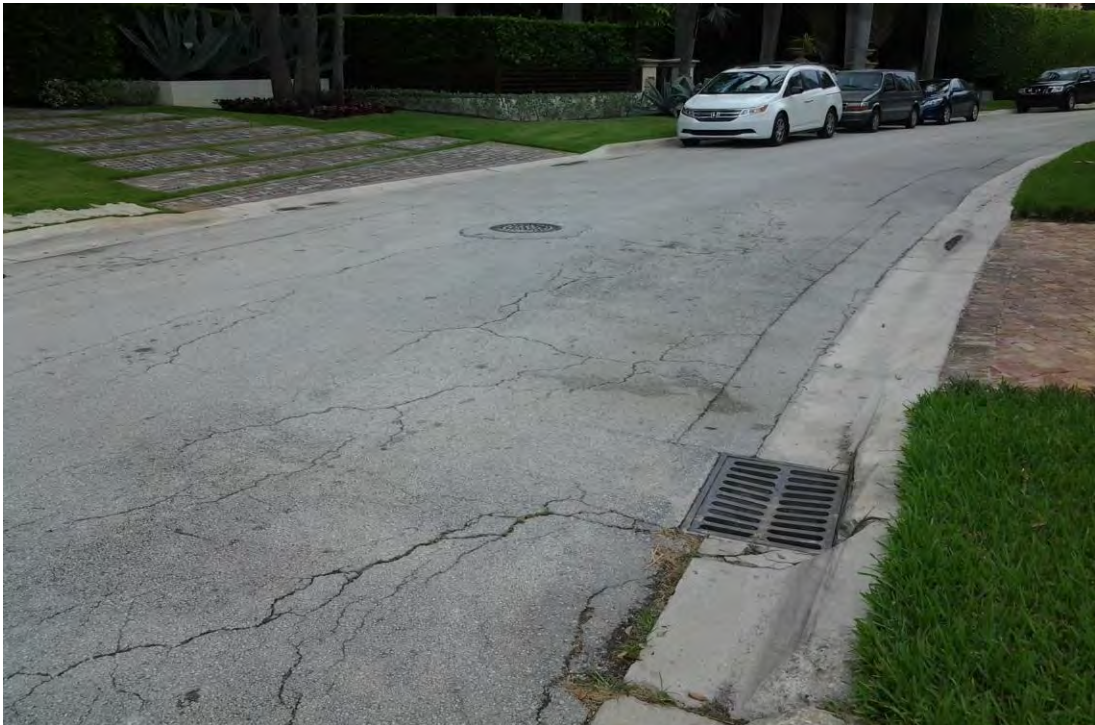
Photo 6 : Bal Bay Drive, road and curb settling, looking northeast.

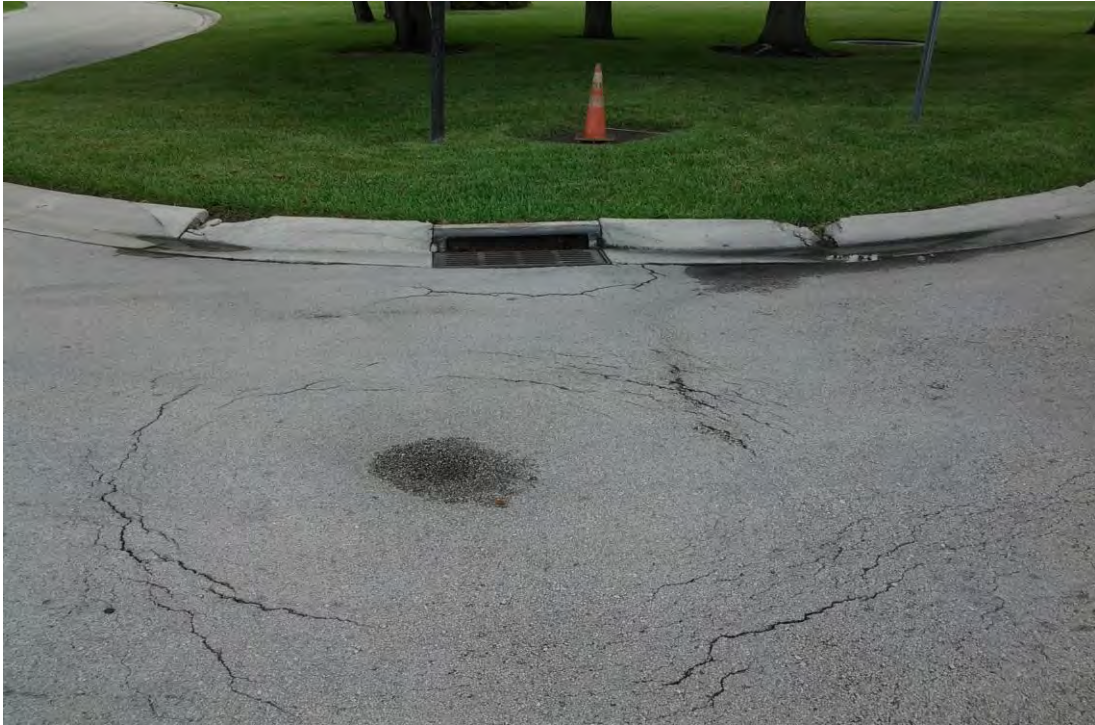
Photo 9 : Bal Bay Drive, curb and roadway settling, looking northeast.

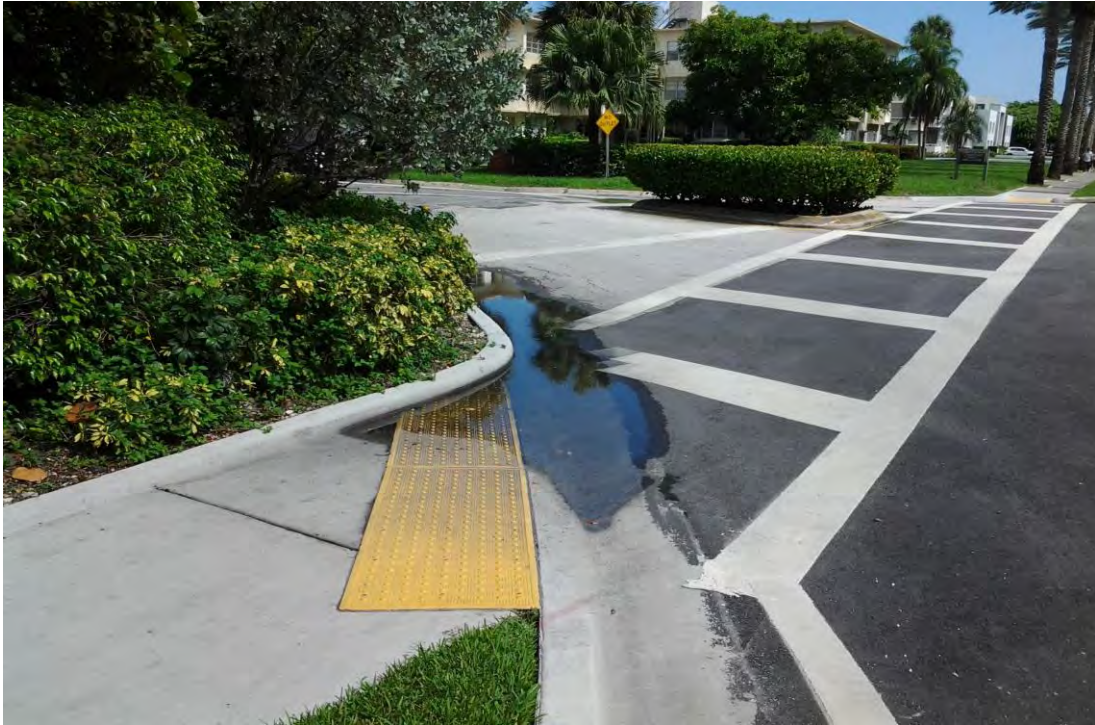
Photo 1 : Standing water at Balfour Drive intersection, looking north.

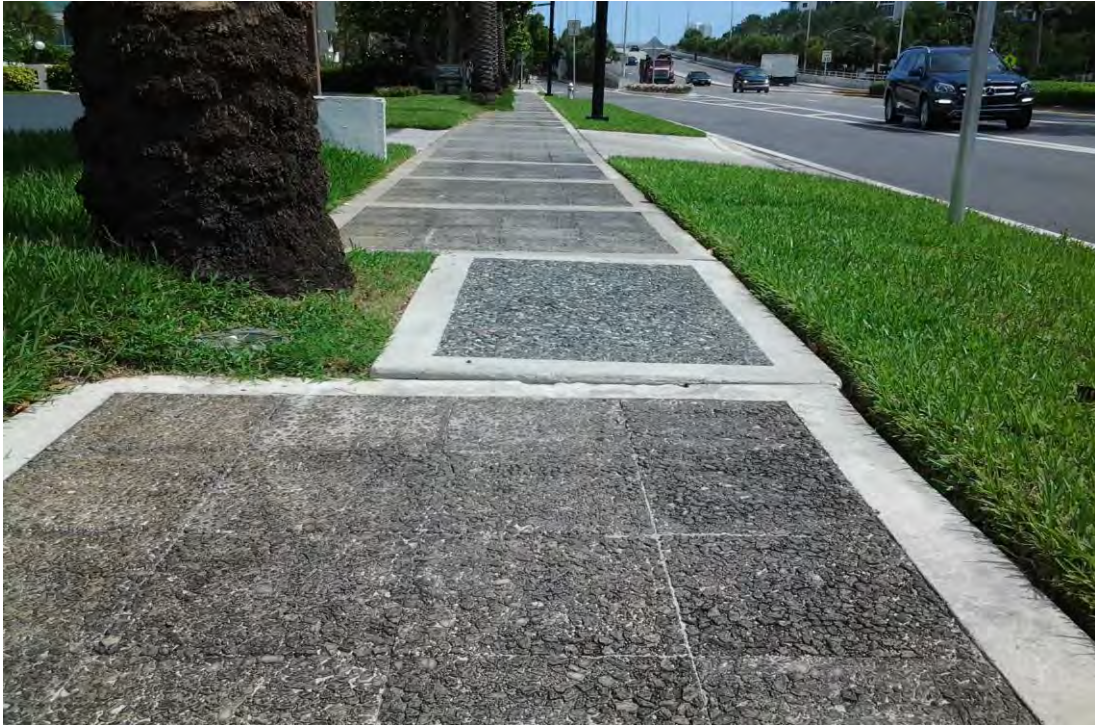
Photo 5 : Settling sidewalk at *Bal Bridge South*, looking north.

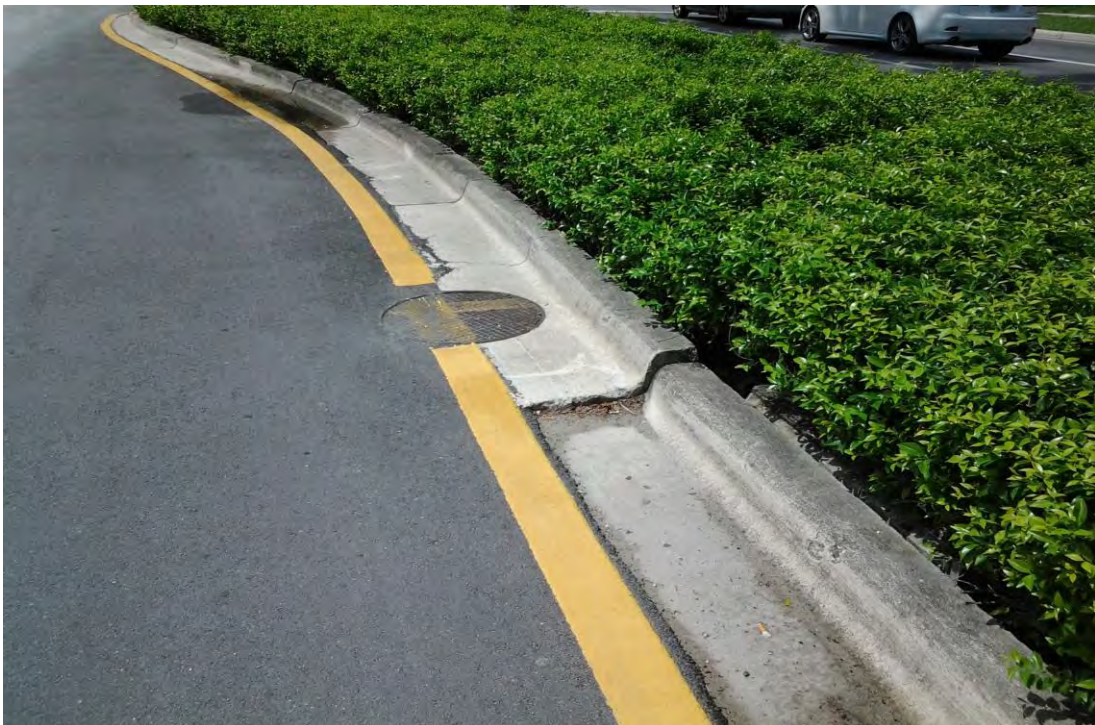
Photo 6 : Curb settling in northbound median, looking south.

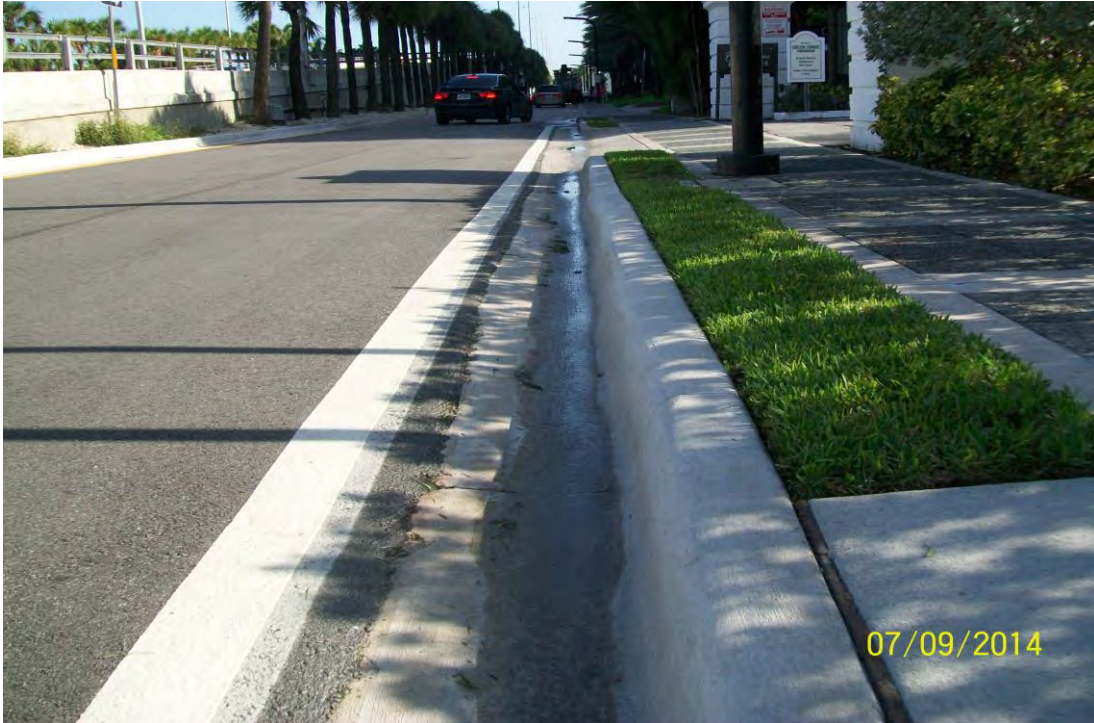
Photo 17 : Standing water in gutter south of *Carlton Terrace*, looking north.

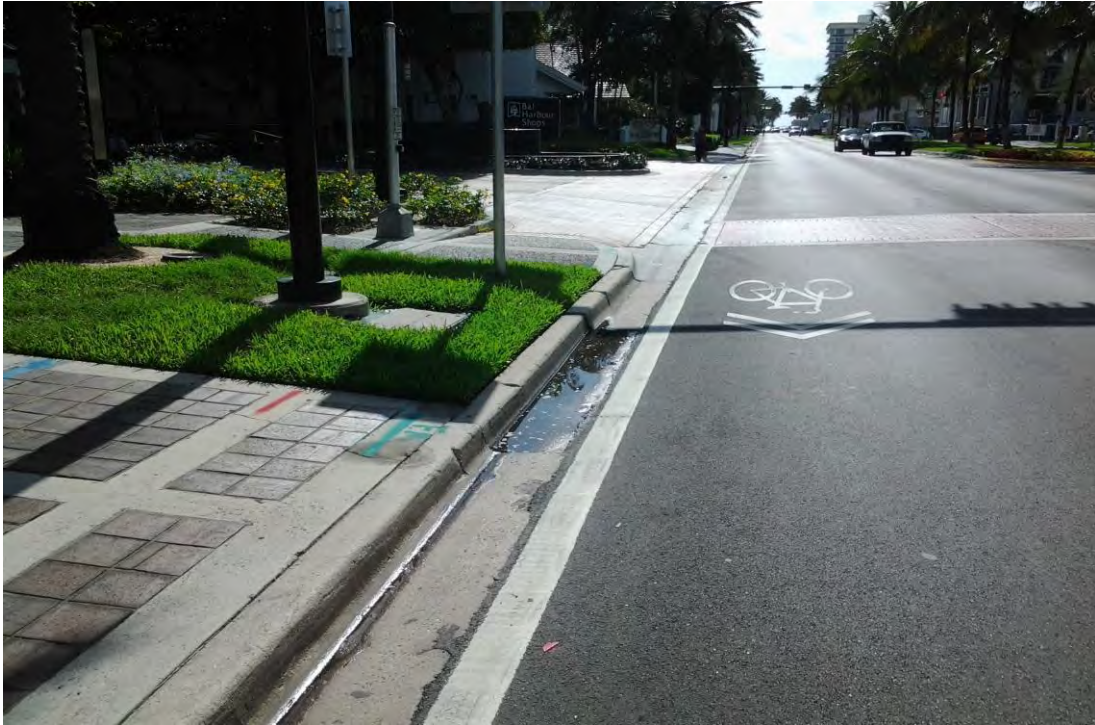
Photo 1 : 96th Street, curb & gutter ponding, looking east.

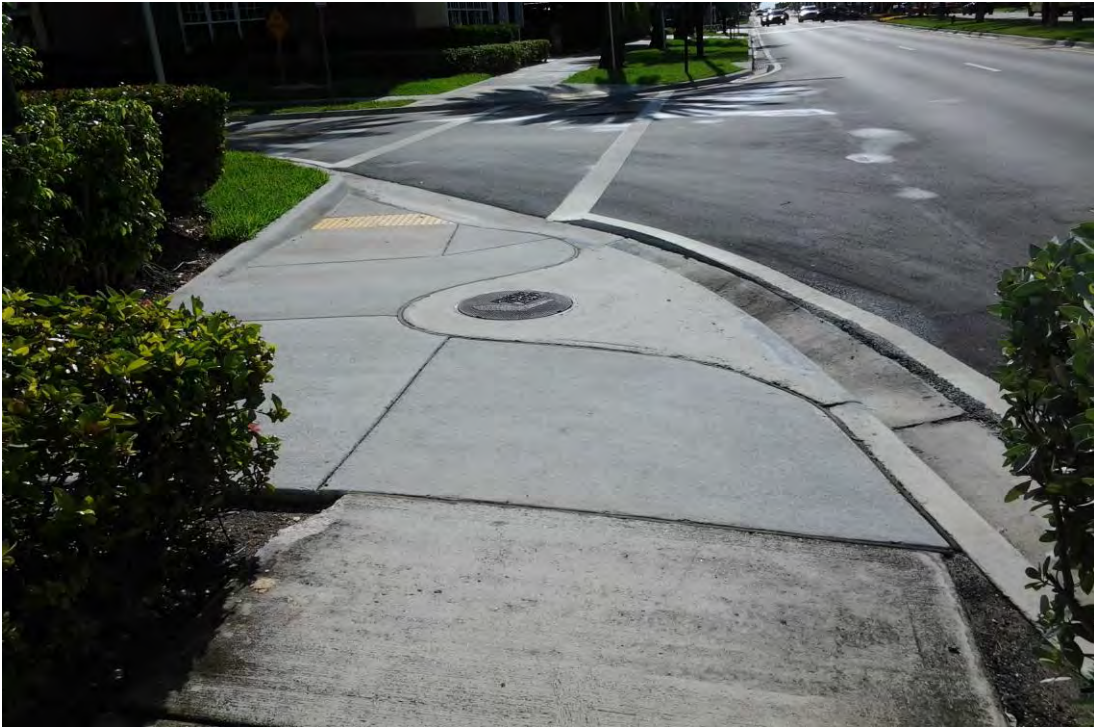
Photo 3 : Non-uniform styles of sidewalk, north side of road, looking east.

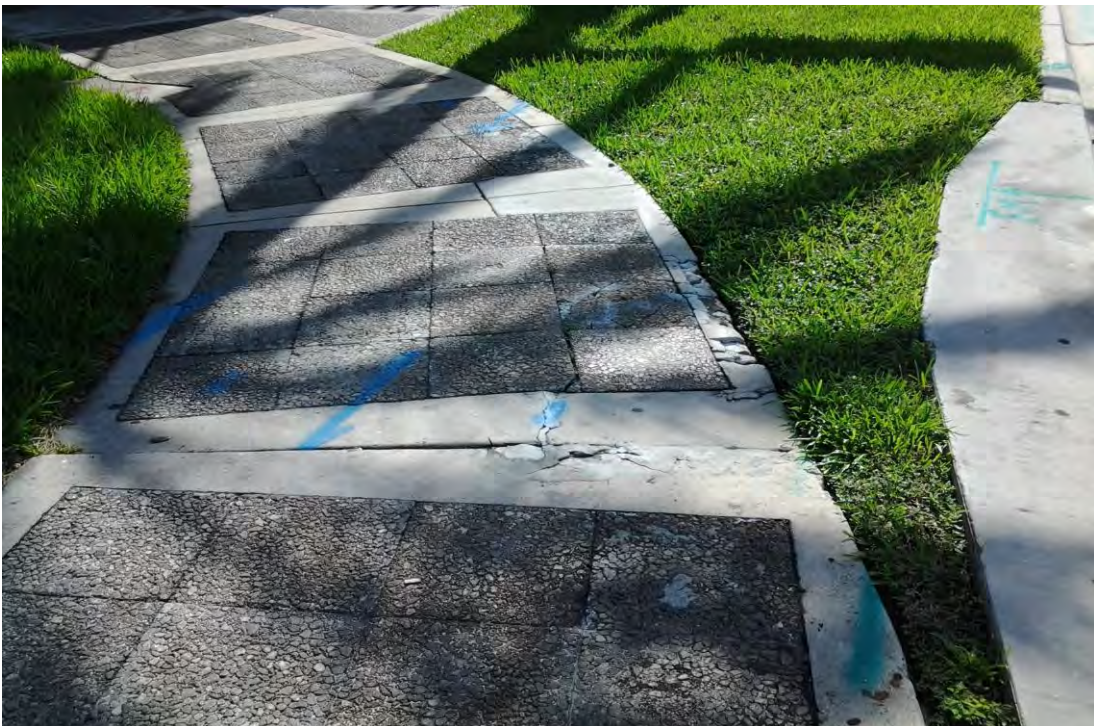
Photo 4 : Sidewalk settling, north side of road, looking east.

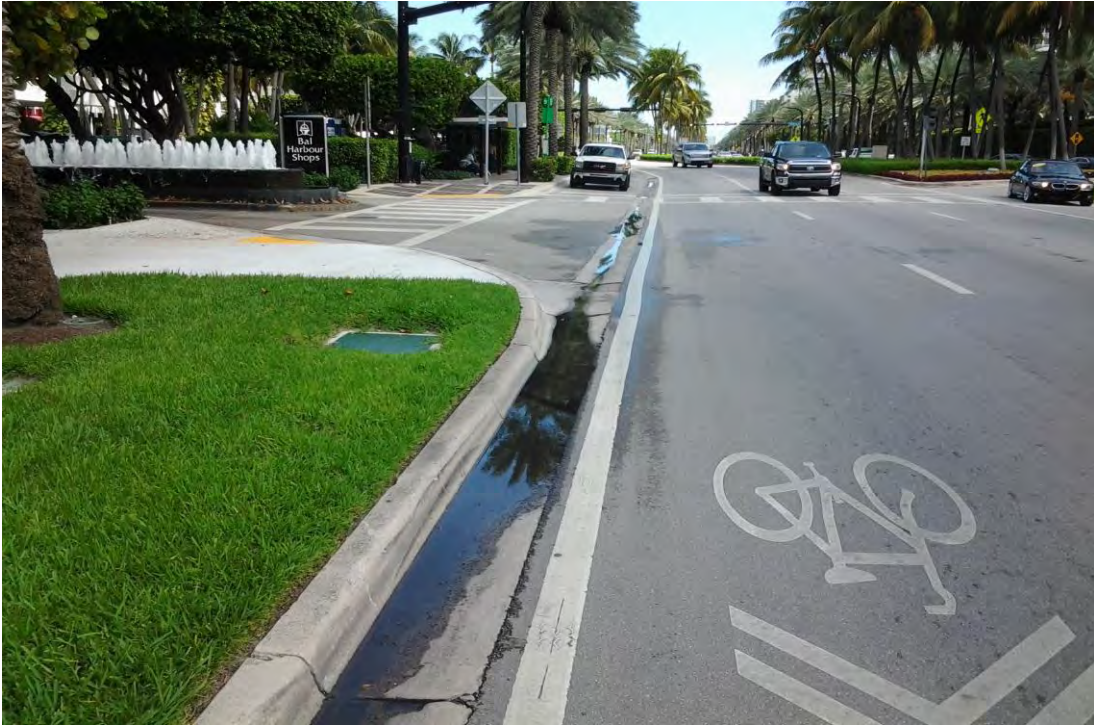
Photo 9 : Ponding at Harding Avenue and 96th Street, looking north.

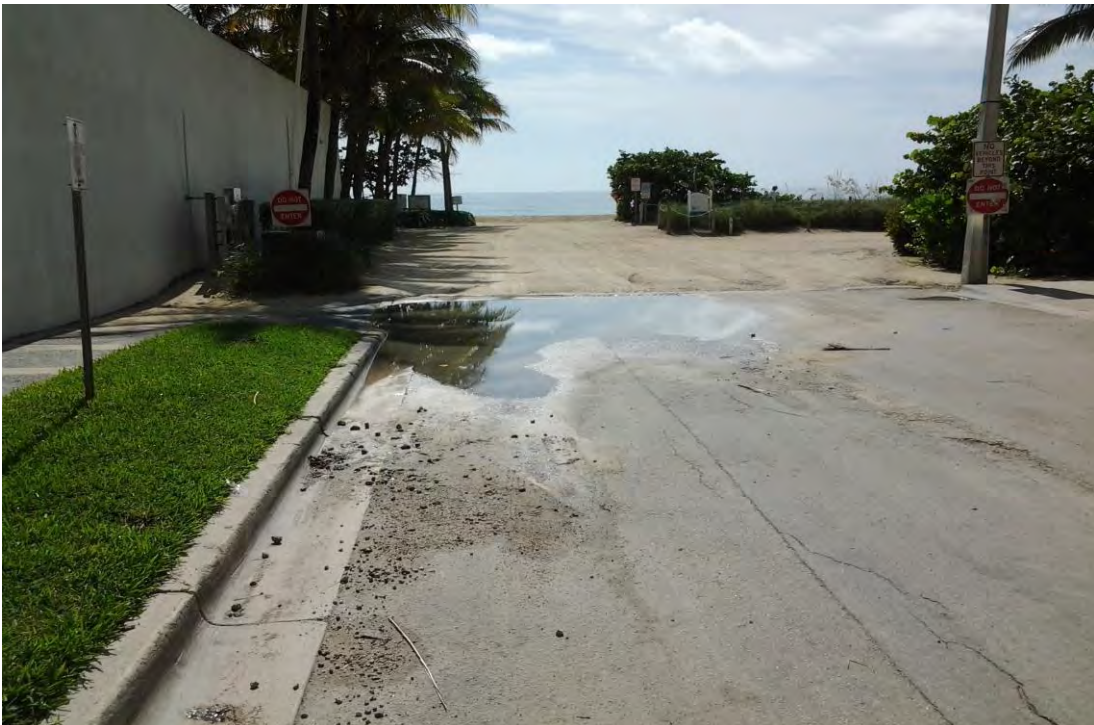
Photo 10 : Ponding at easternmost end of 96th Street, looking east.

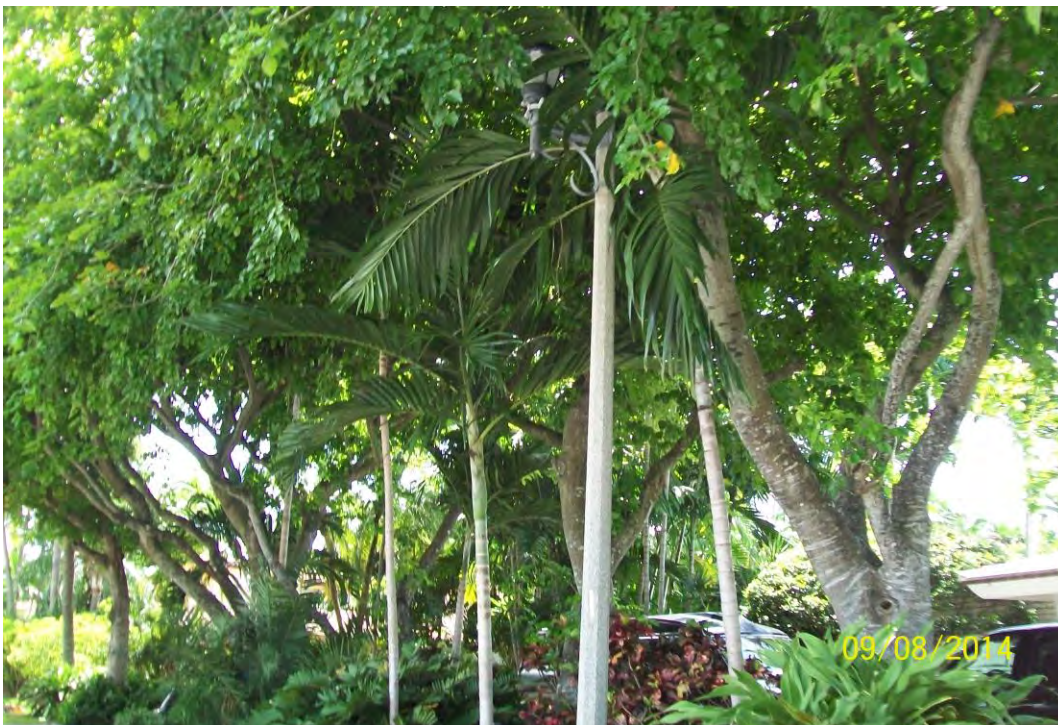
Photo 2: Light pole obscured by landscaping (134 Bal Bay Drive).

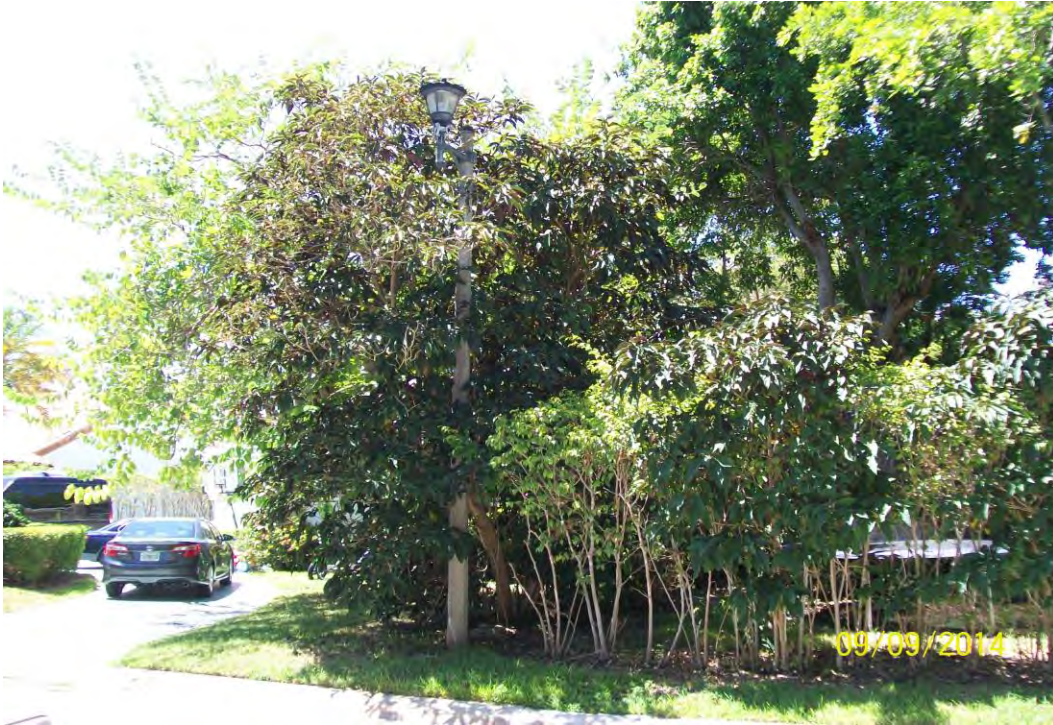
Photo 3: Light pole obscured by landscaping (150 Camden Drive).

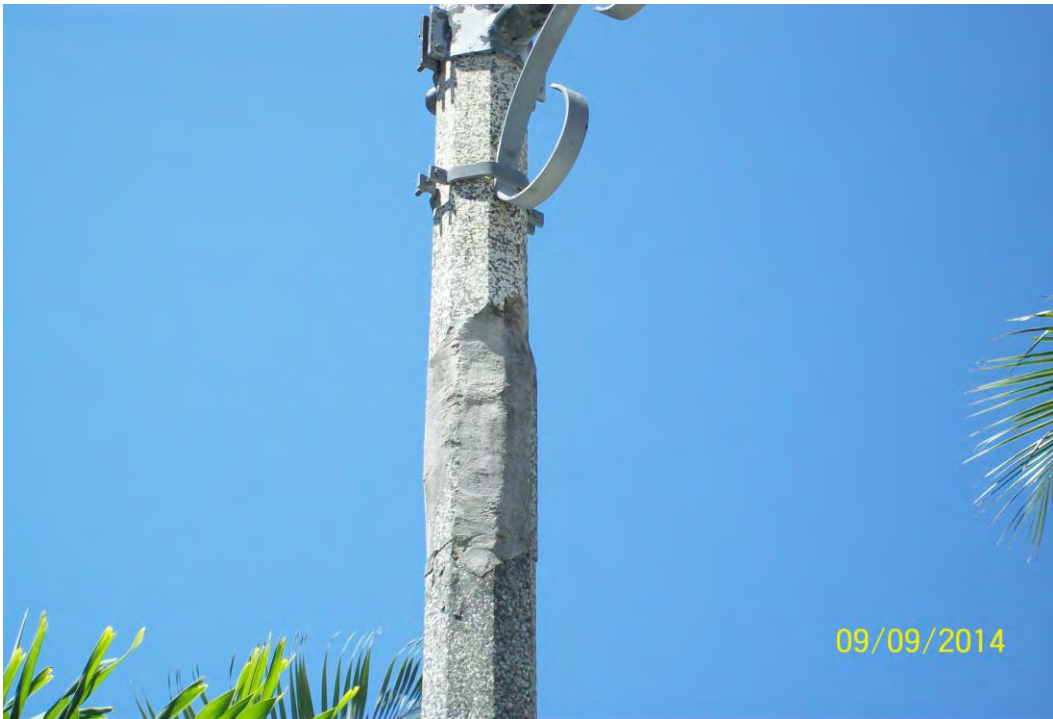
Photo 4: Repaired concrete light pole (126 Bal Cross Drive).

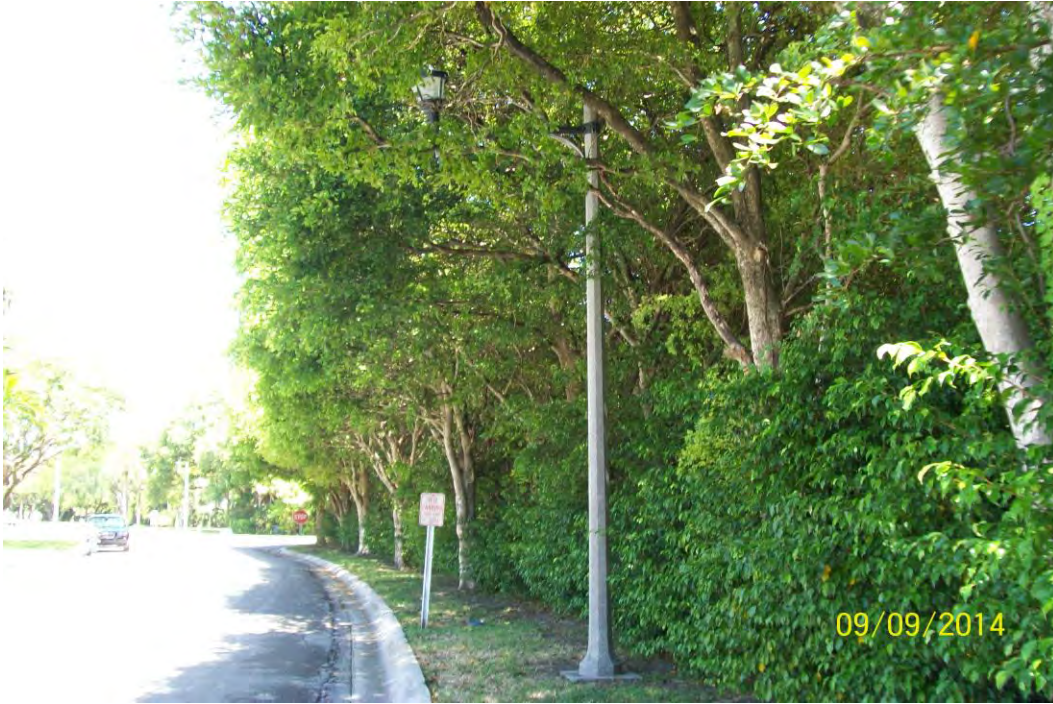
Photo 5: Light pole obscured by landscaping (80 Park Drive).

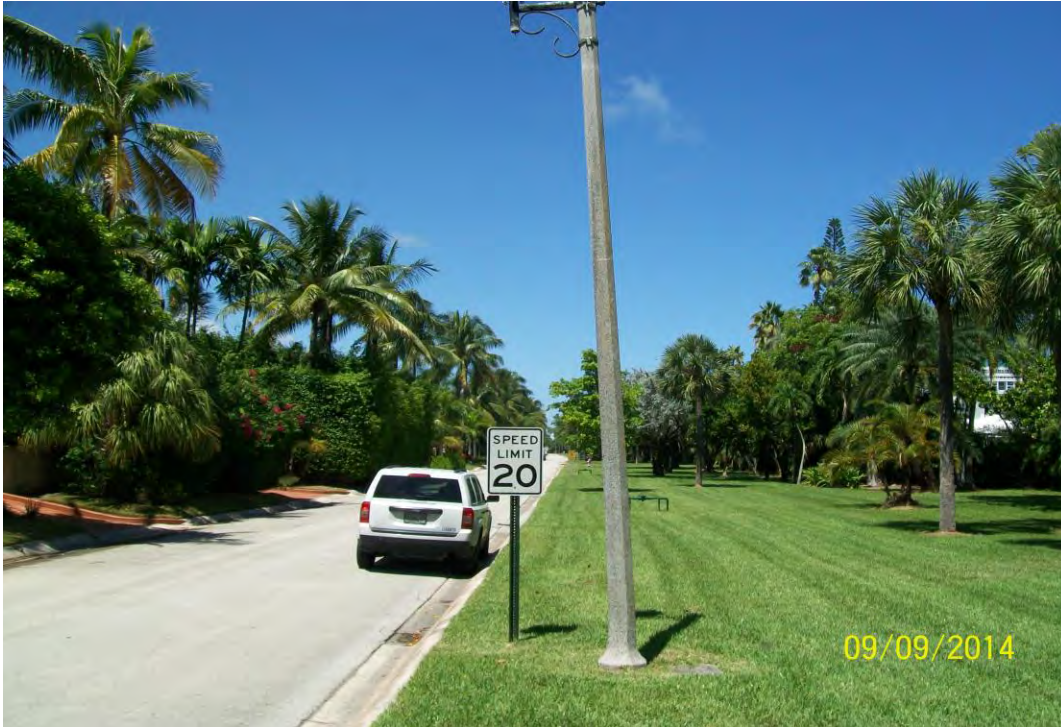
The current conditions of the Village street light system are indicated in the photographs found in Exhibit M-10. Stress cracks and damage from wind, rain, saltwater, and vehicles have been found on many of the existing concrete poles. Repair patches were evident on a number of light poles. It was also observed that the integrity of the foundations of several poles has been compromised; causing the poles to lean. If not properly maintained this will eventually lead to a public hazard. Difficulty in accessing replacement parts for a thirty year old system is another reason for installing a new street light system.

Photo 7: Leaning concrete light pole (152 Park Drive).
