BAL HARBOUR VILLAGE

UTILITY MASTER PLAN

FEBRUARY 2015

CRAIG A. SMITH & ASSOCIATES
7777 GLADES RD, SUITE 410
BOCA RATON, FL 33434
561.314.4445

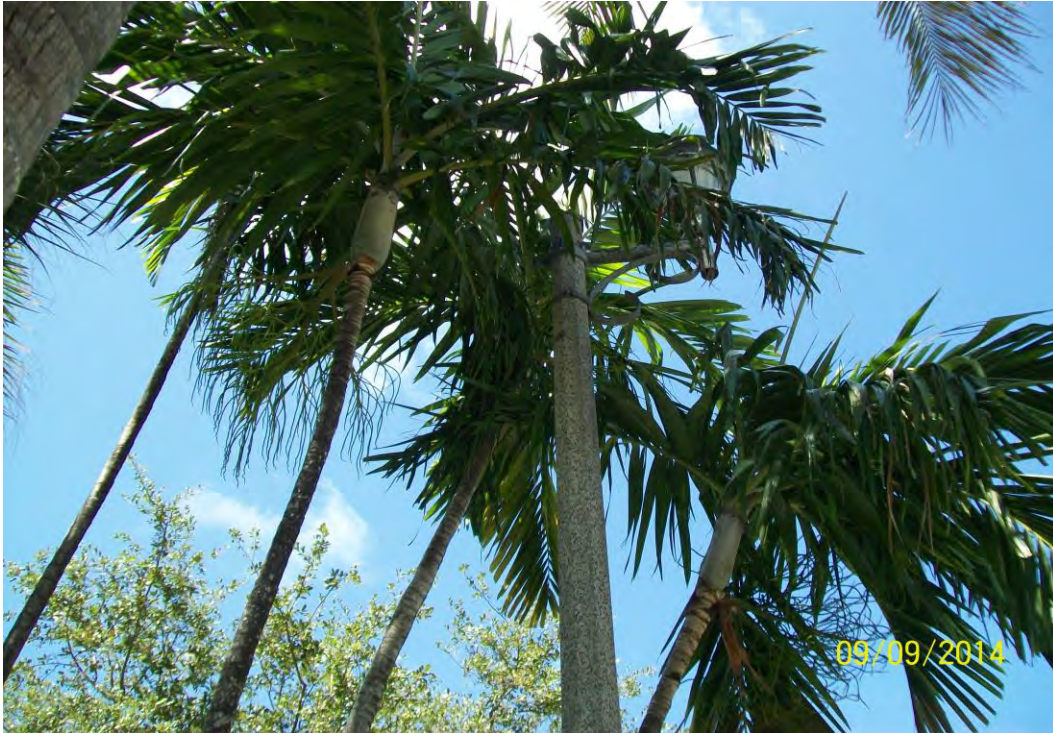
Photo 11: Light pole obscured by landscaping (216 Bal Cross Drive).

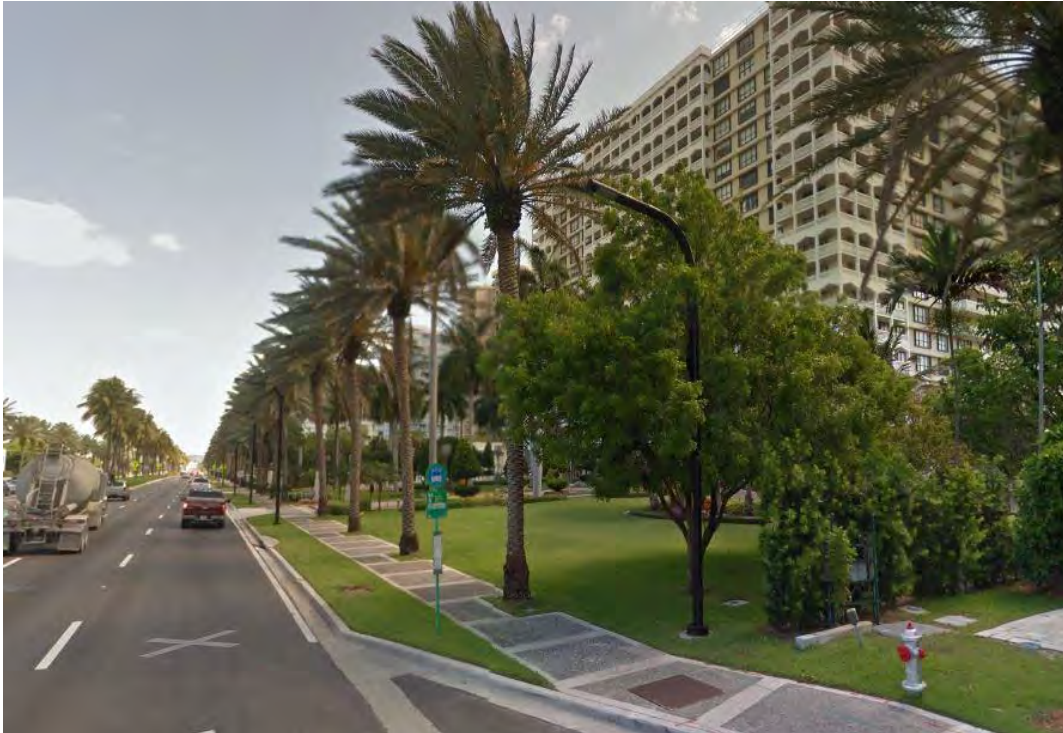
Photo 3: Existing light pole obscured by landscaping, looking north.

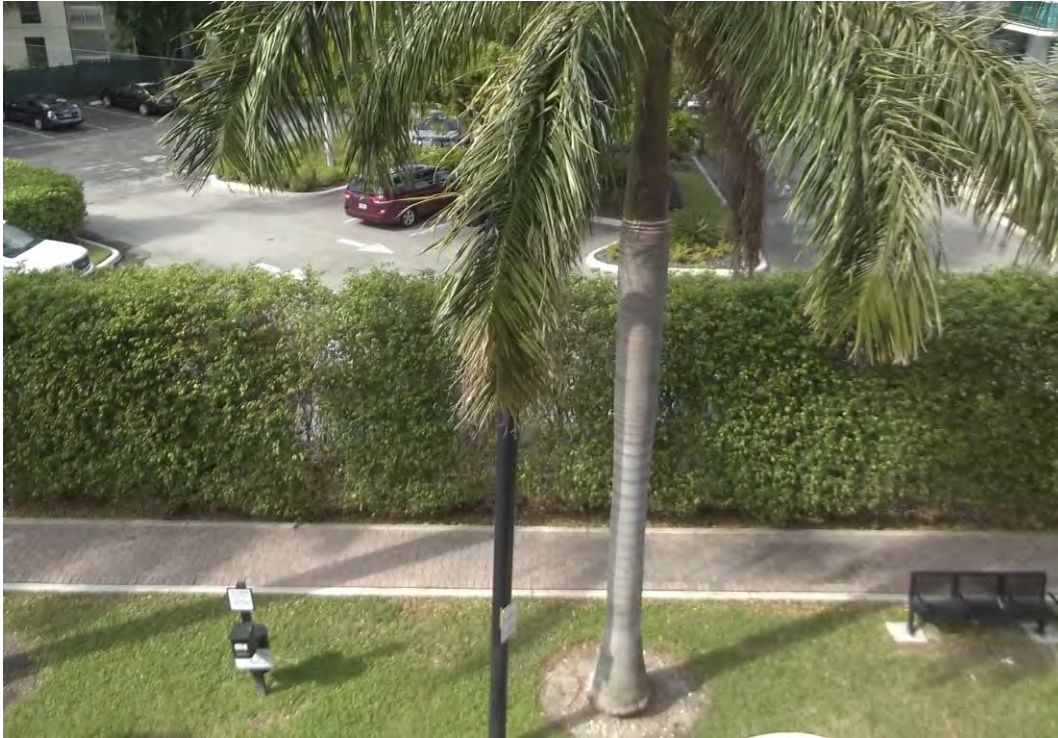
Photo 11: Existing light pole obscured by landscaping.

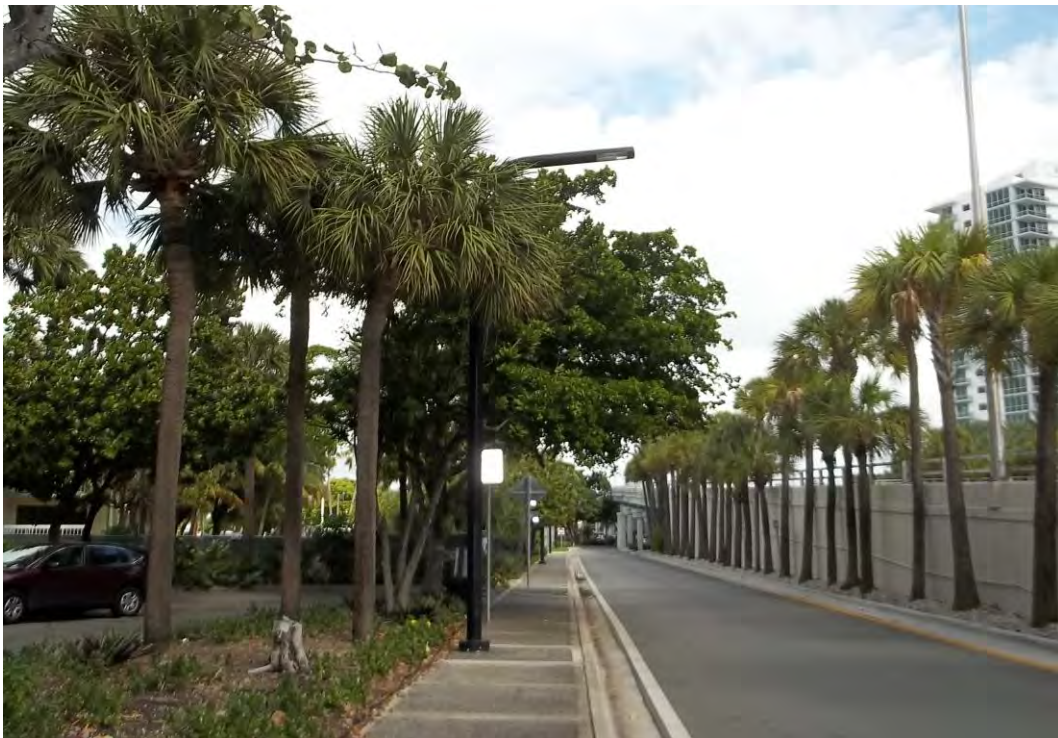
Photo 12: Existing light pole obscured by landscaping on the west side of Collins Avenue, looking north.

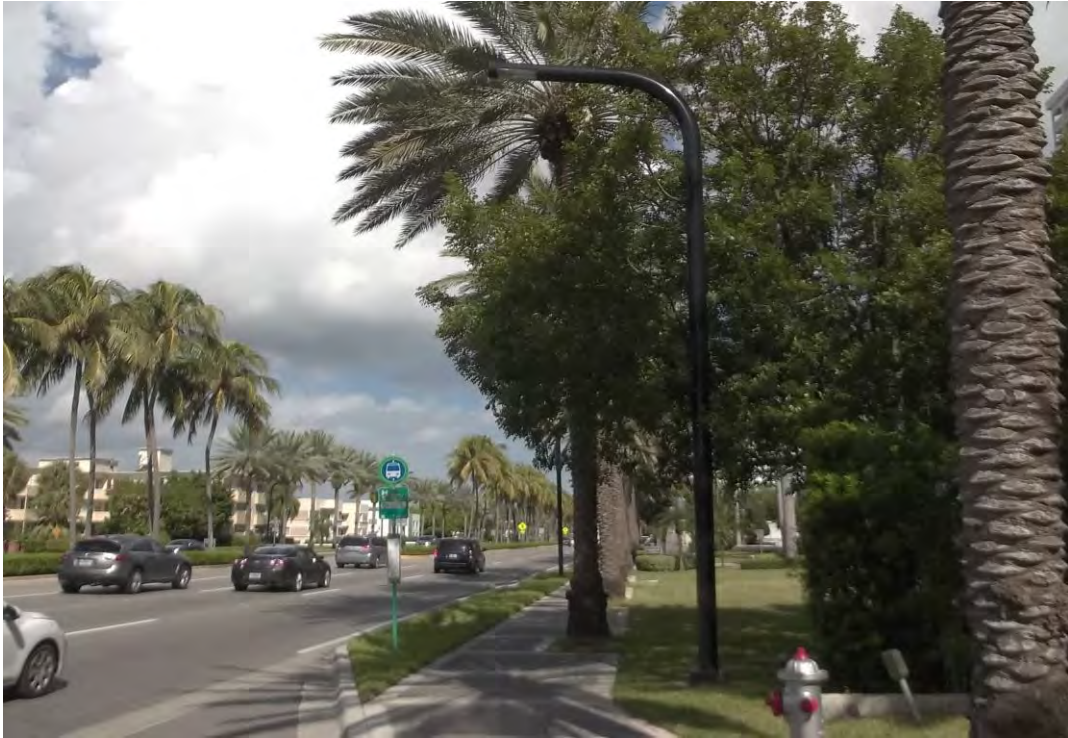
Photo 15: Existing light pole obscured by landscaping, looking south.

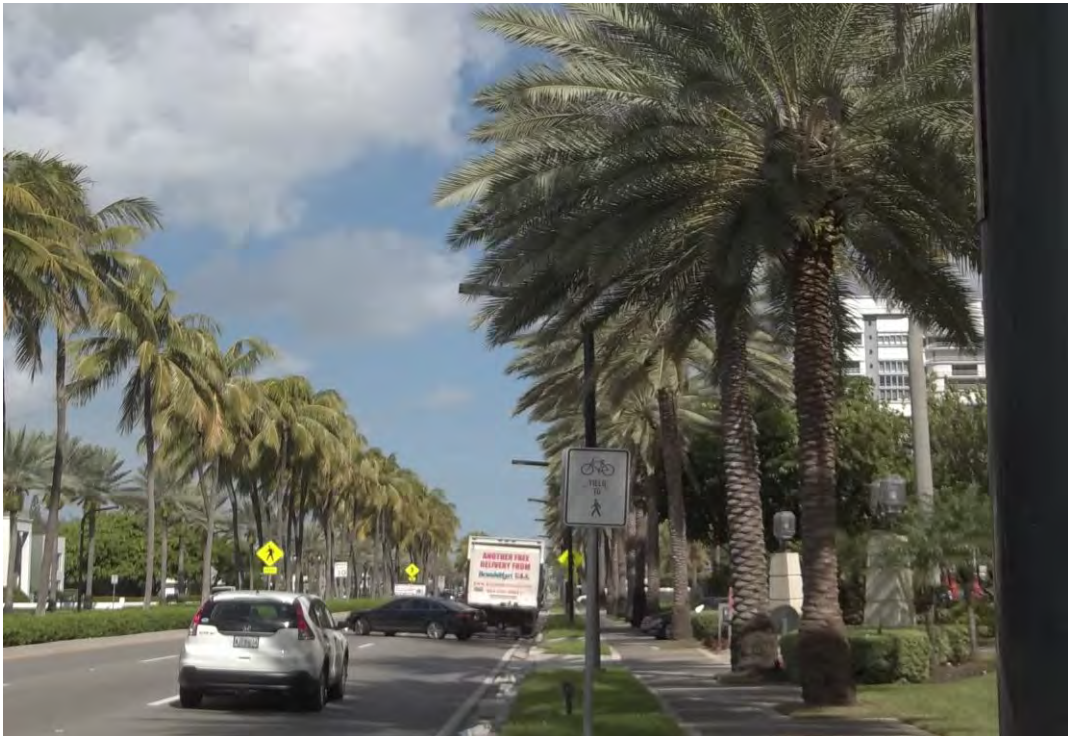
Photo 16: Existing light pole obscured by landscaping.

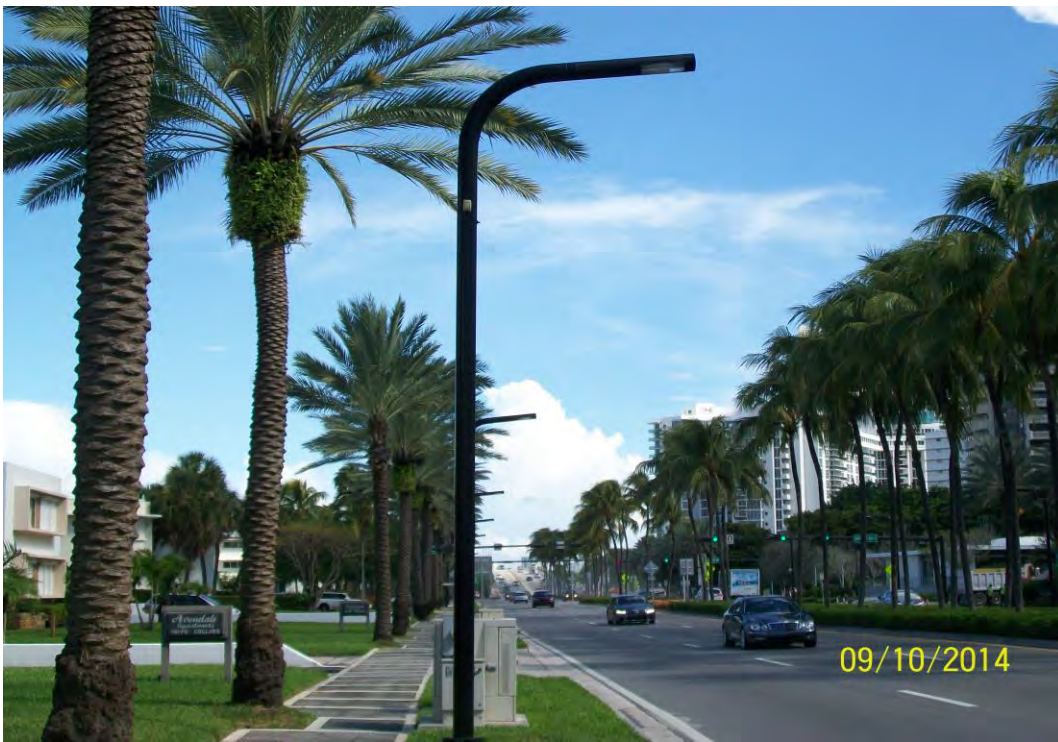
Photo 20: Existing light poles at *Avondale Apartments*, looking north.

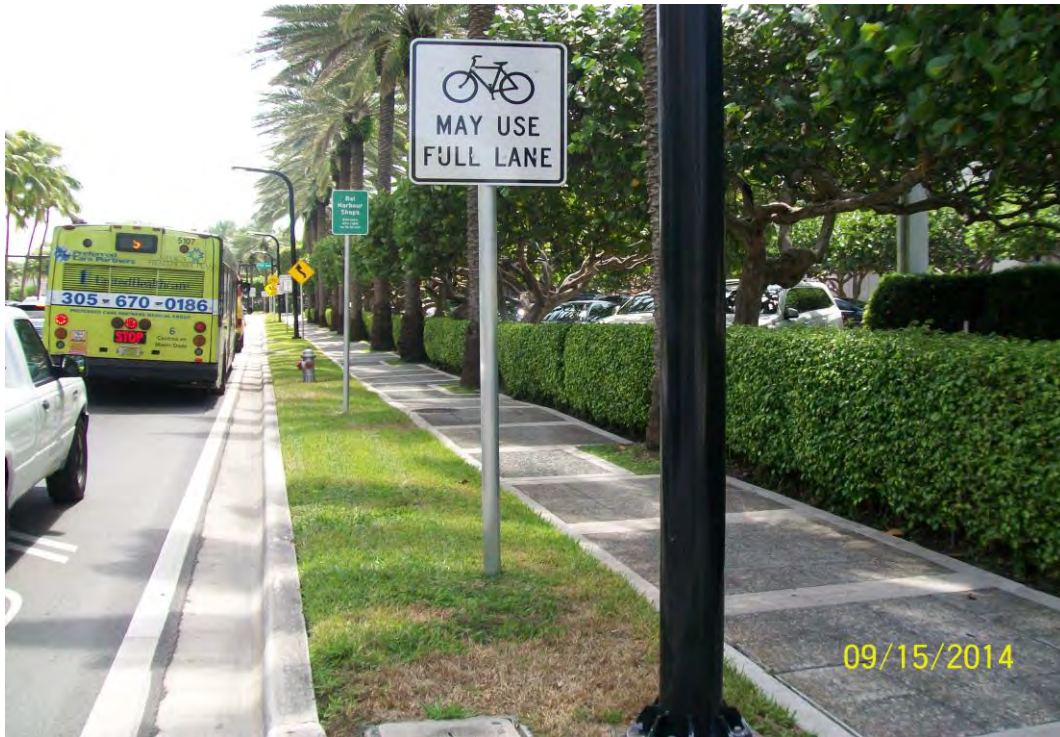
Photo 21: Street light poles adjacent to *The Shops*, looking south.

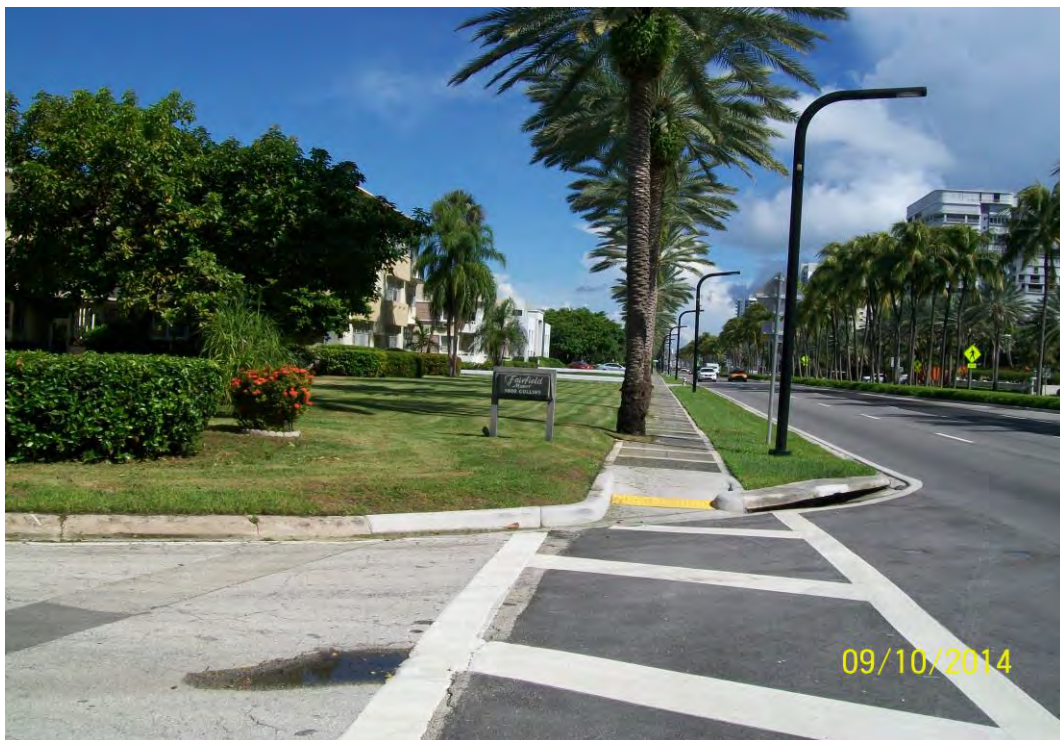
Photo 22: Street lights adjacent to *Fairfield Manor*, looking north.

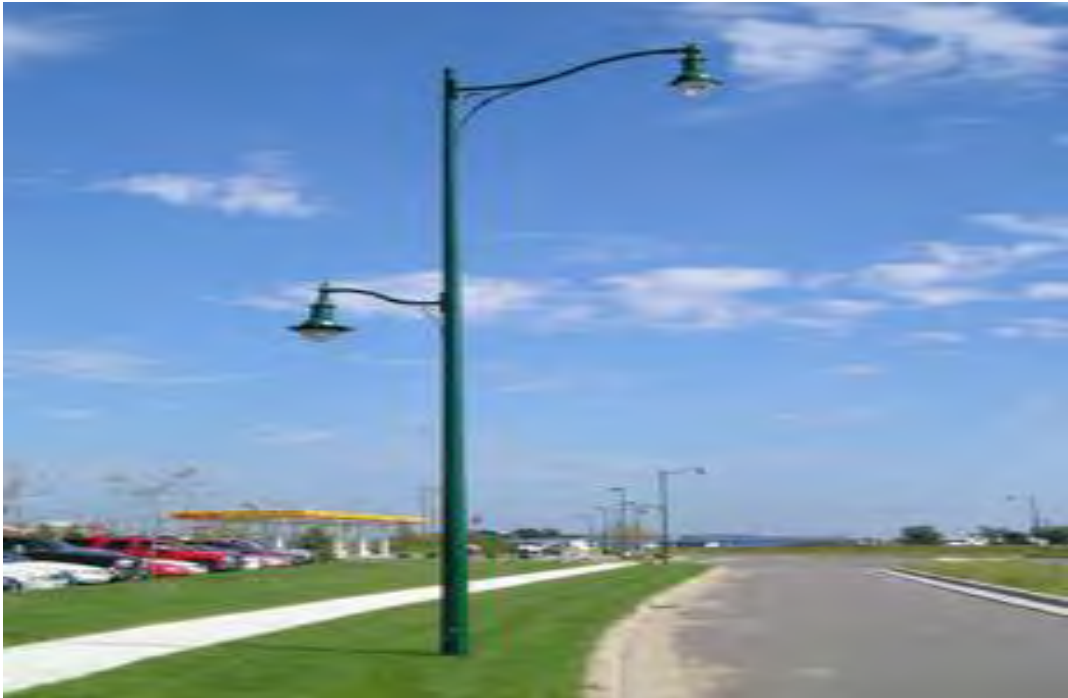
Photo 1: Proposed roadway/pedestrian light post configuration.

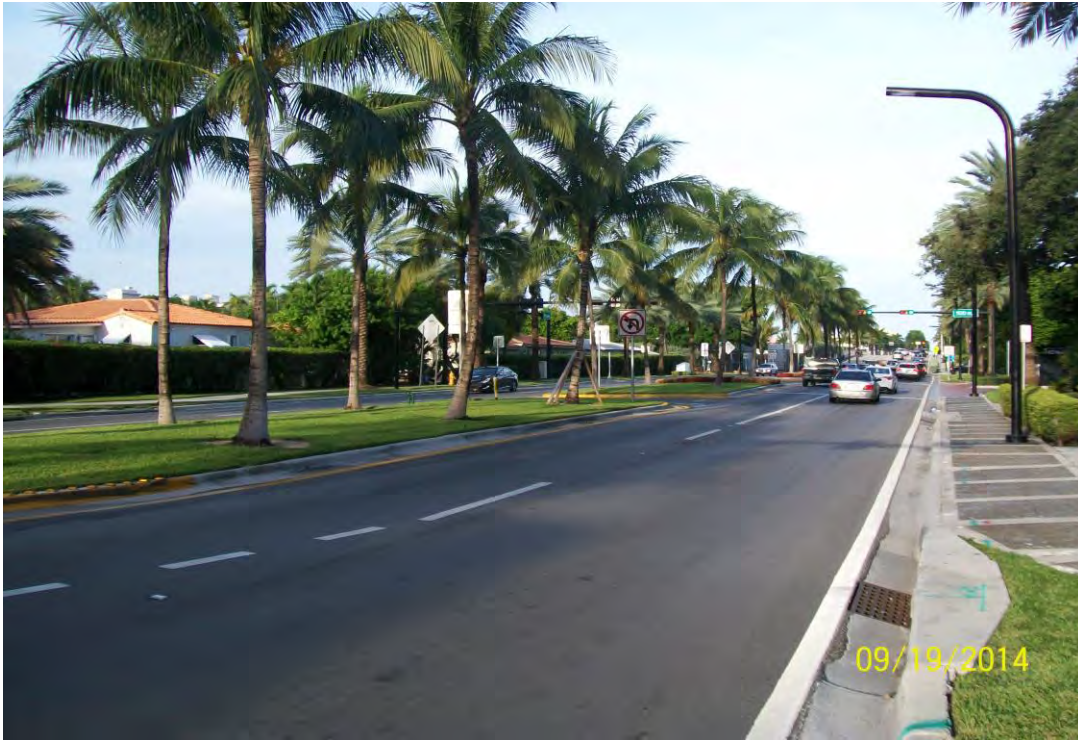
Photo 3: Existing light pole, looking west.

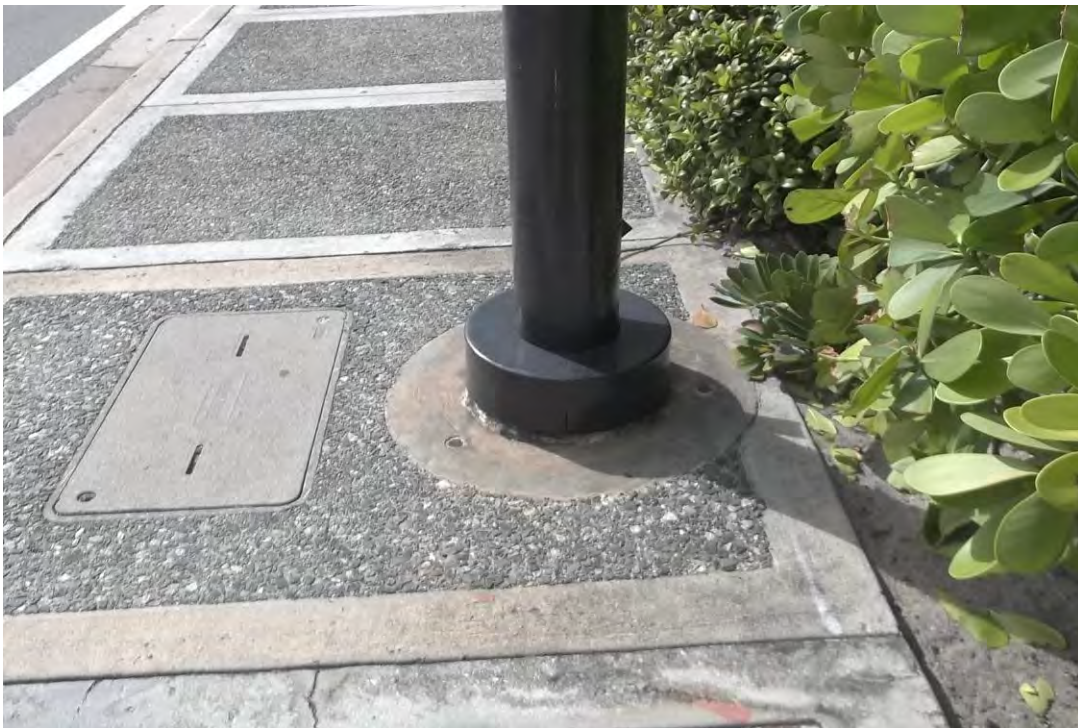
Photo 4: Existing light pole pedestal and pull box, located in sidewalk.

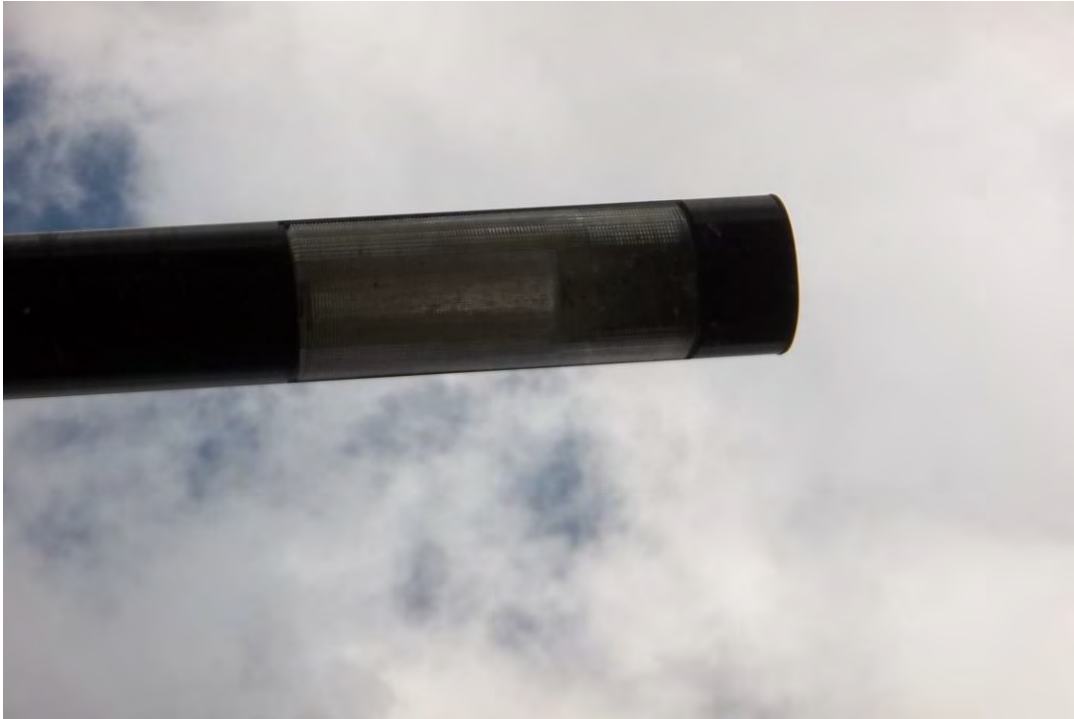
Photo 5: Existing light pole mast arm and light.

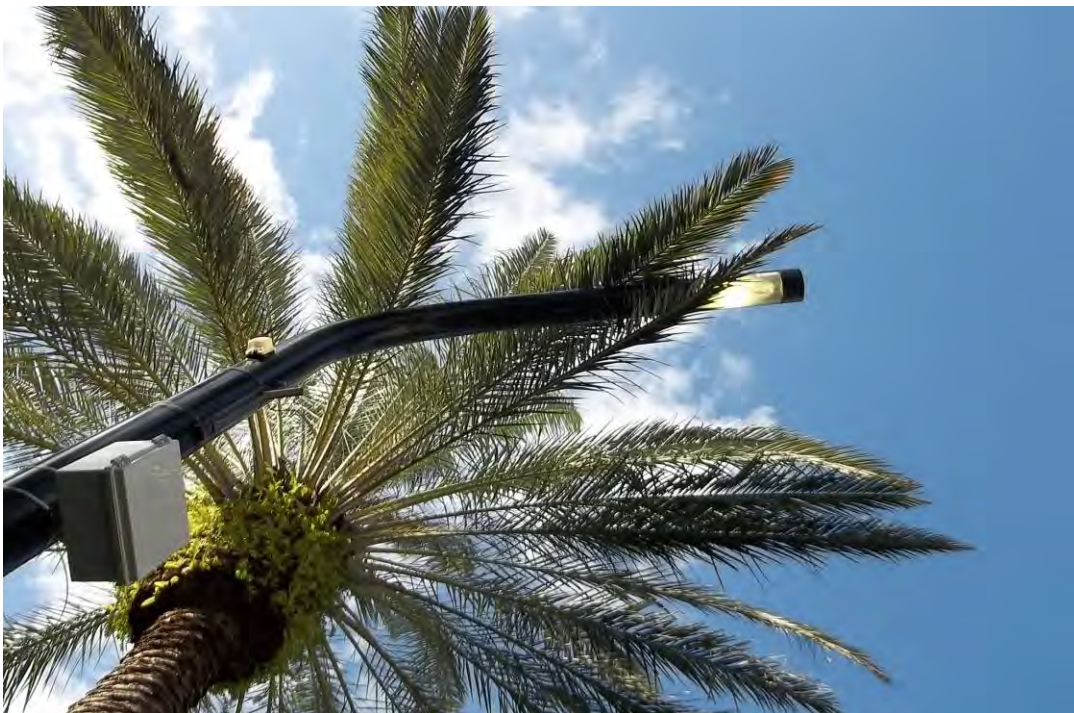
Photo 6: Existing light pole obscured by landscaping.

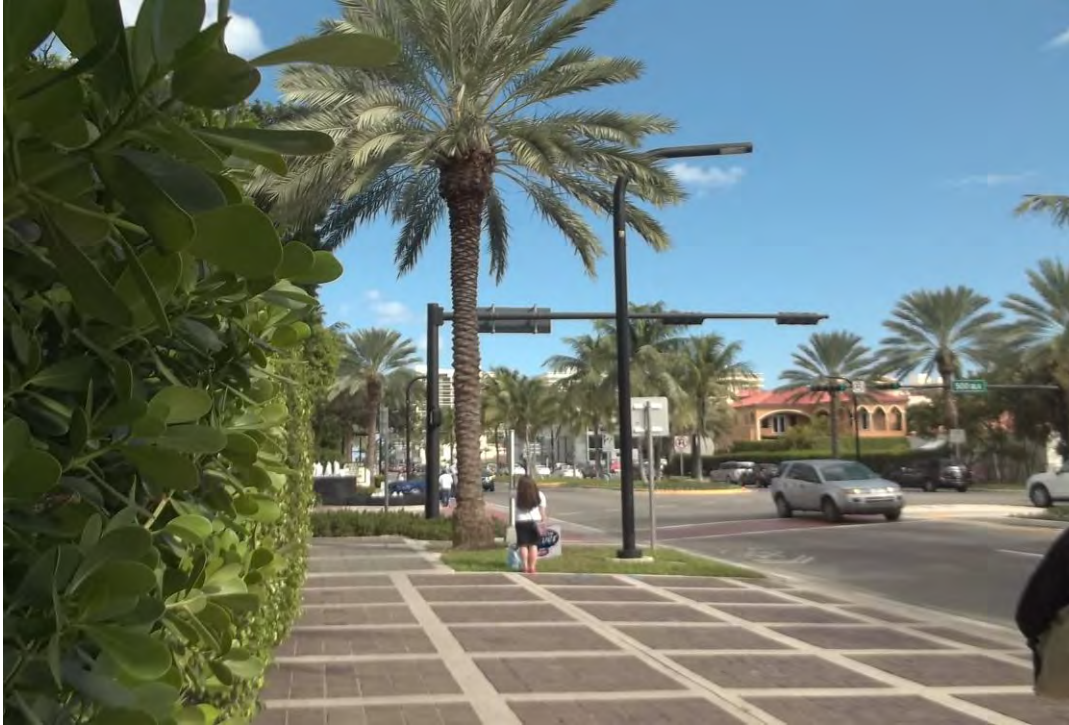
Photo 7: Existing light pole on north side of 96th Street, looking east.

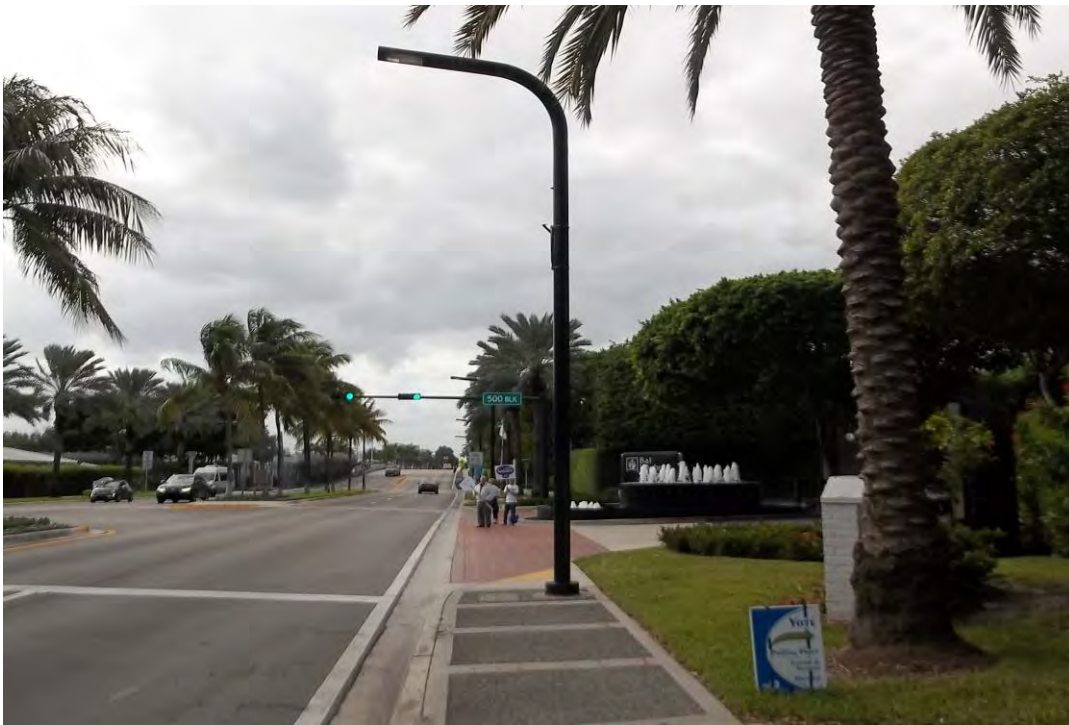
Photo 8: Existing light pole on the north side of 96th Street, looking west.

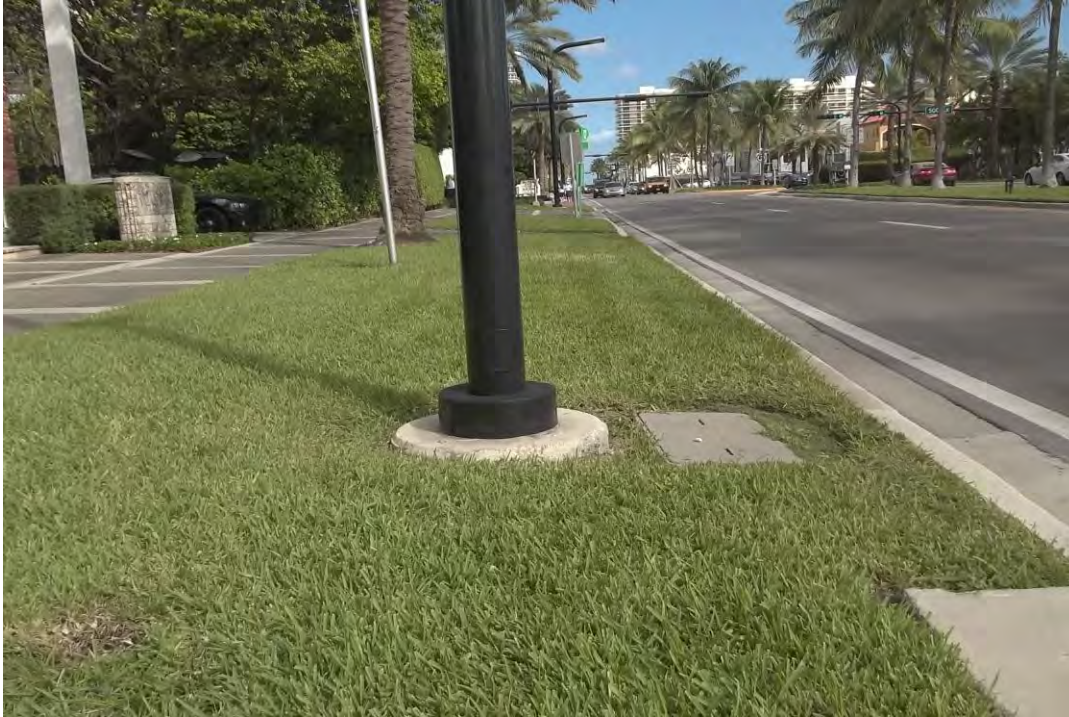
Photo 9 : Existing light pole pedestal and pull box in green area.

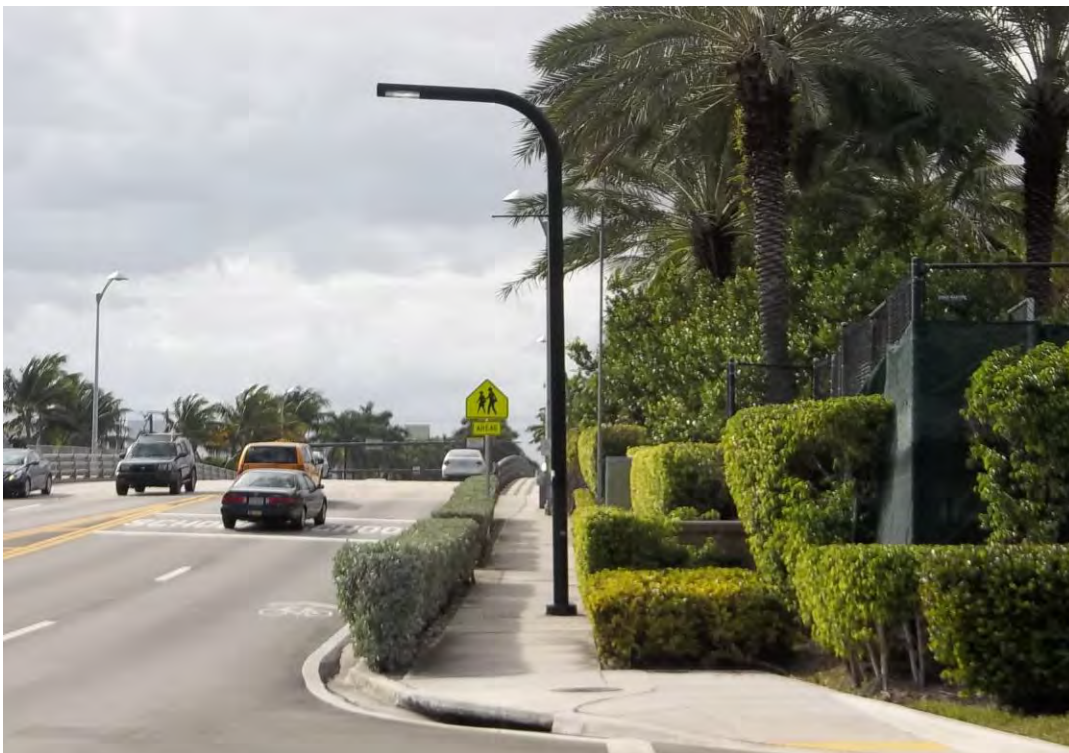
Photo 10: Existing light pole adjacent to the 96th Street bridge, looking west.

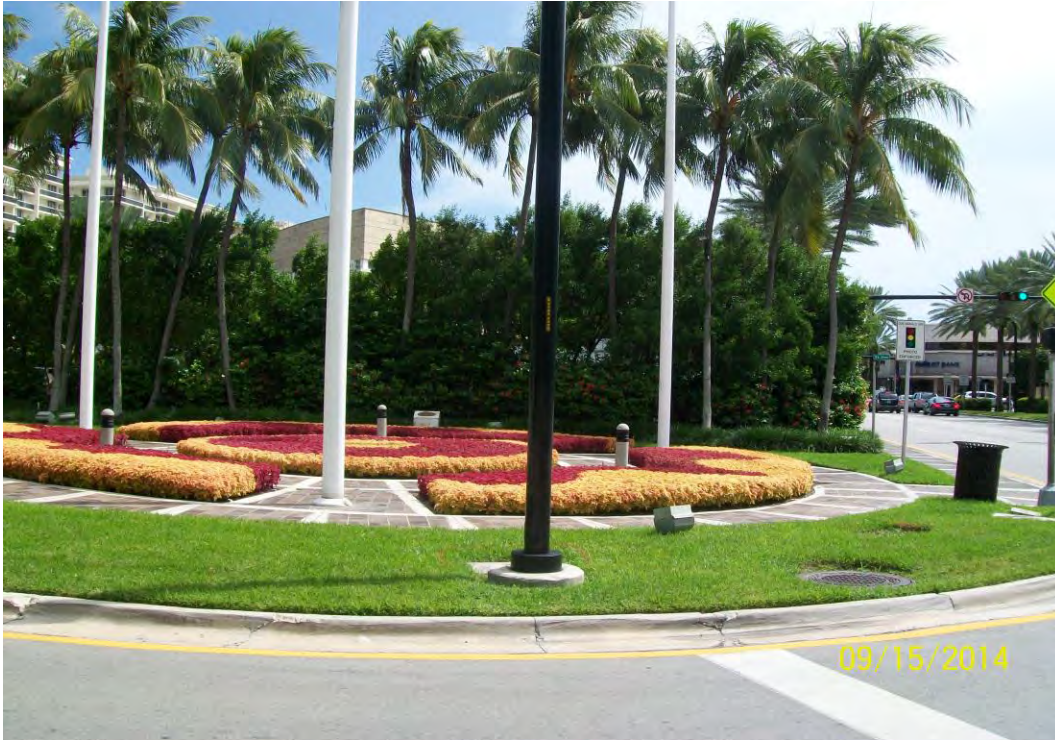
Photo 1 : Existing landscaping at Founder's Circle, looking south.

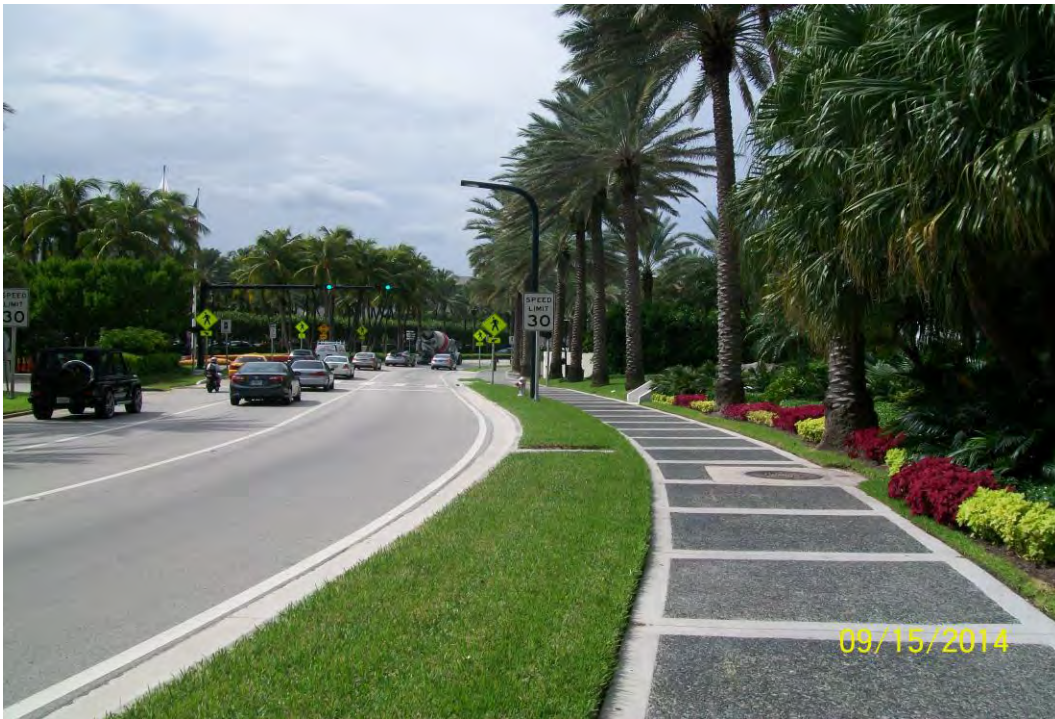
Photo 2: Existing landscaping east side of Collins Avenue at *Majestic*.

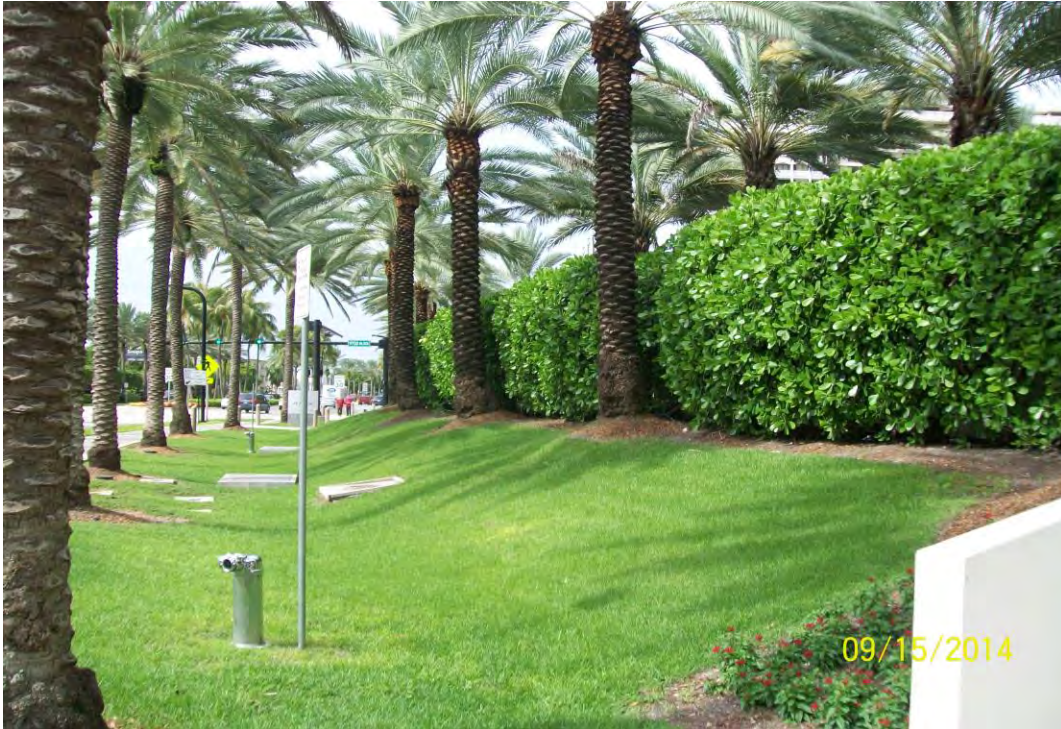
Photo 3: Existing landscaping east side of Collins Avenue at *St. Regis*.

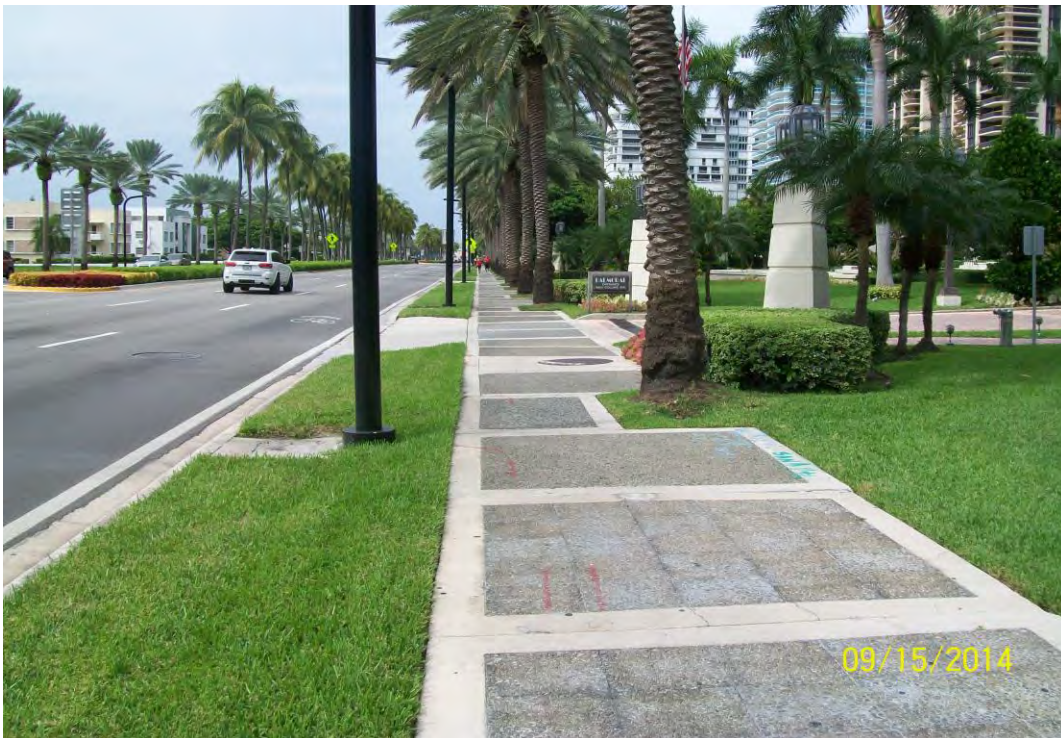
Photo 4: Existing landscaping east side of Collins Avenue at *Bal Moral*.

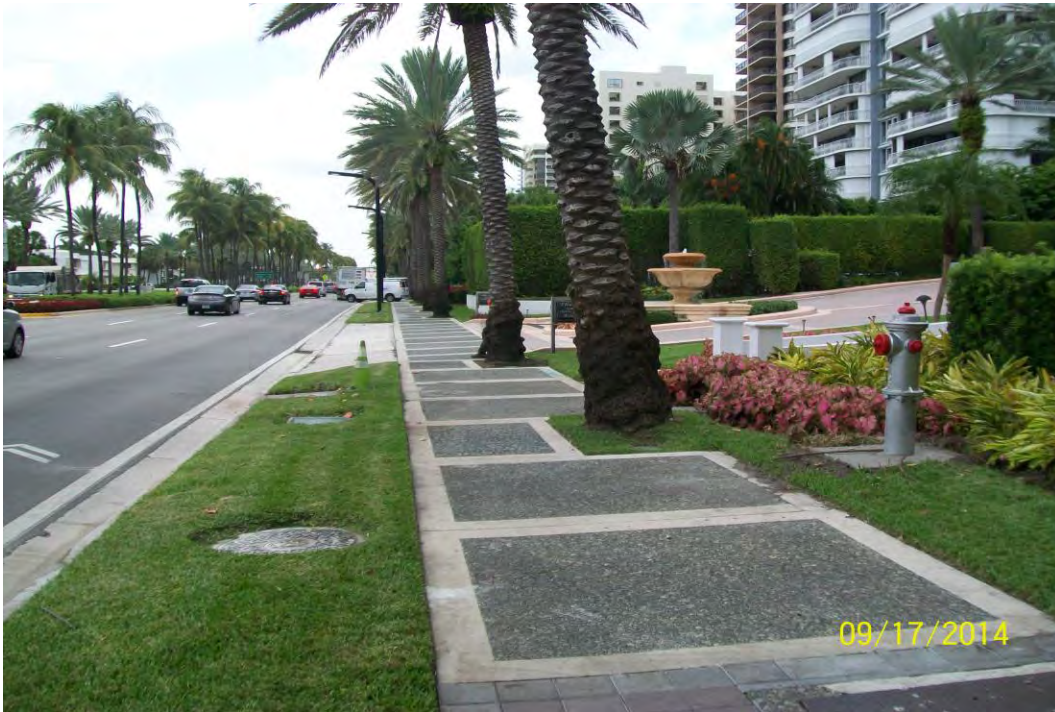
Photo 5: Existing landscaping east side of Collins Ave. at *The Tower*.

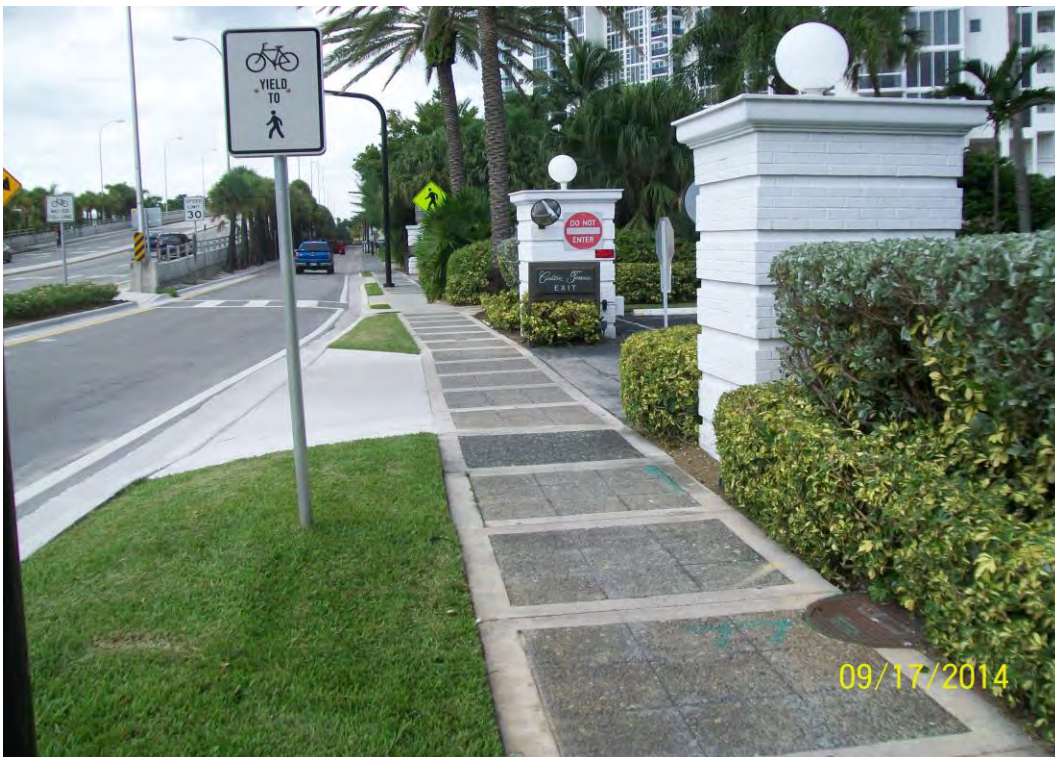
Photo 6: Existing landscaping at *Carlton Terrace*, looking north.

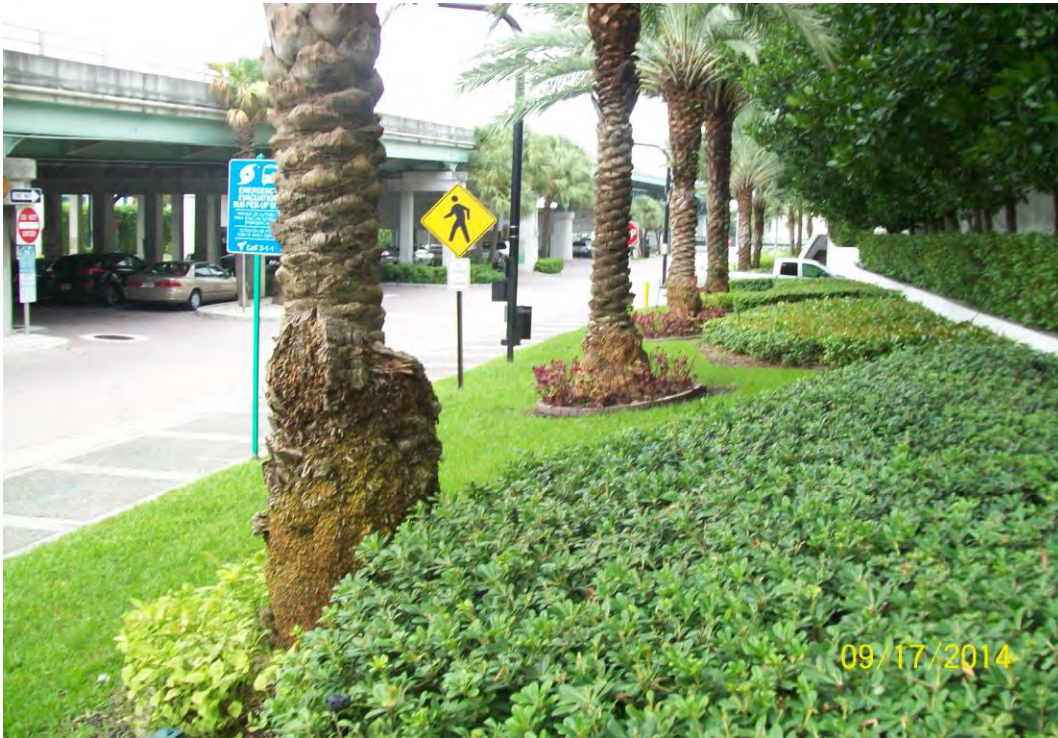
Photo 7: Existing landscaping at *One Bal Harbour*, looking north.

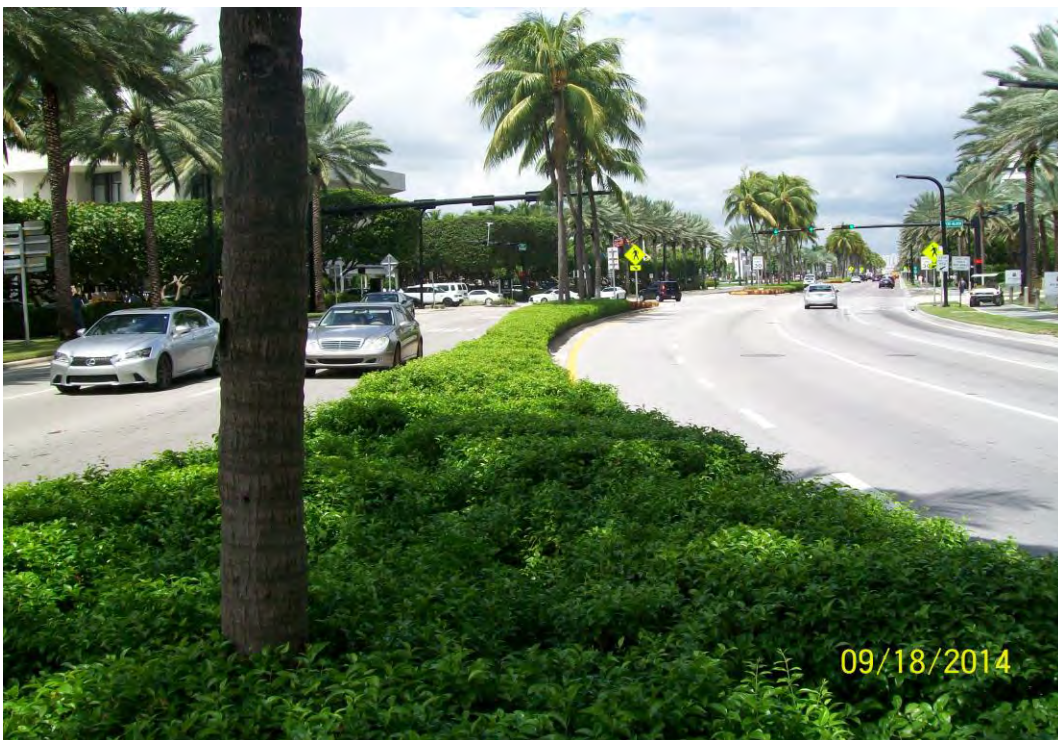
Photo 8: Center median landscaping adjacent to *The Shops*, looking north.

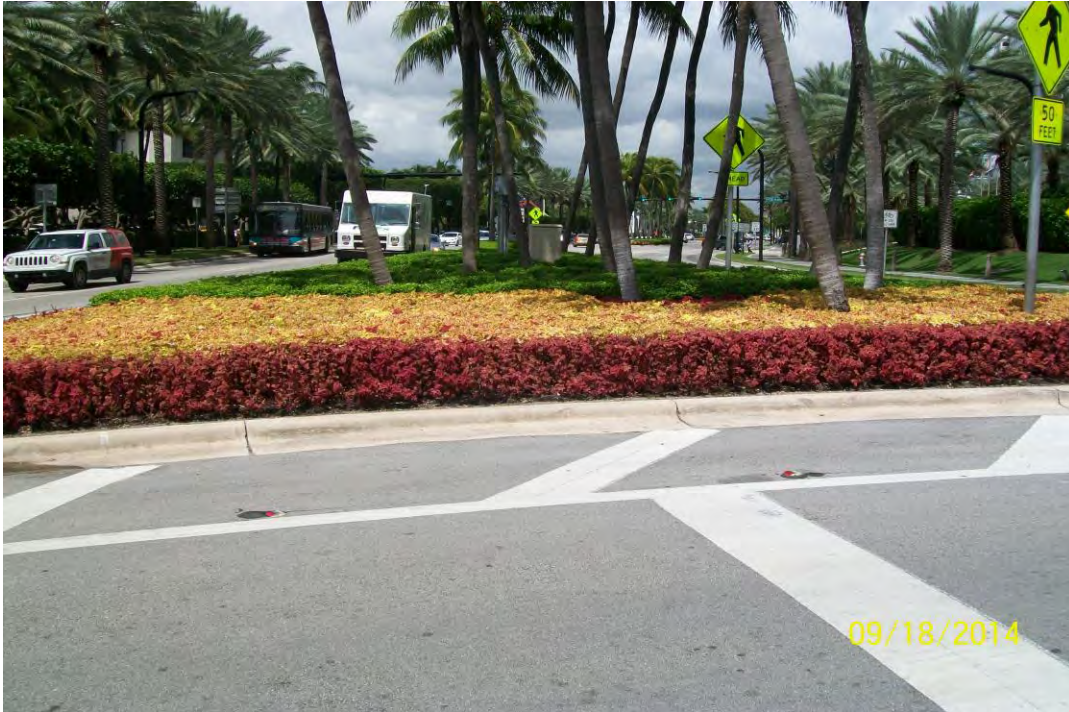
Photo 9: Median adjacent to Founder's Circle, looking north.

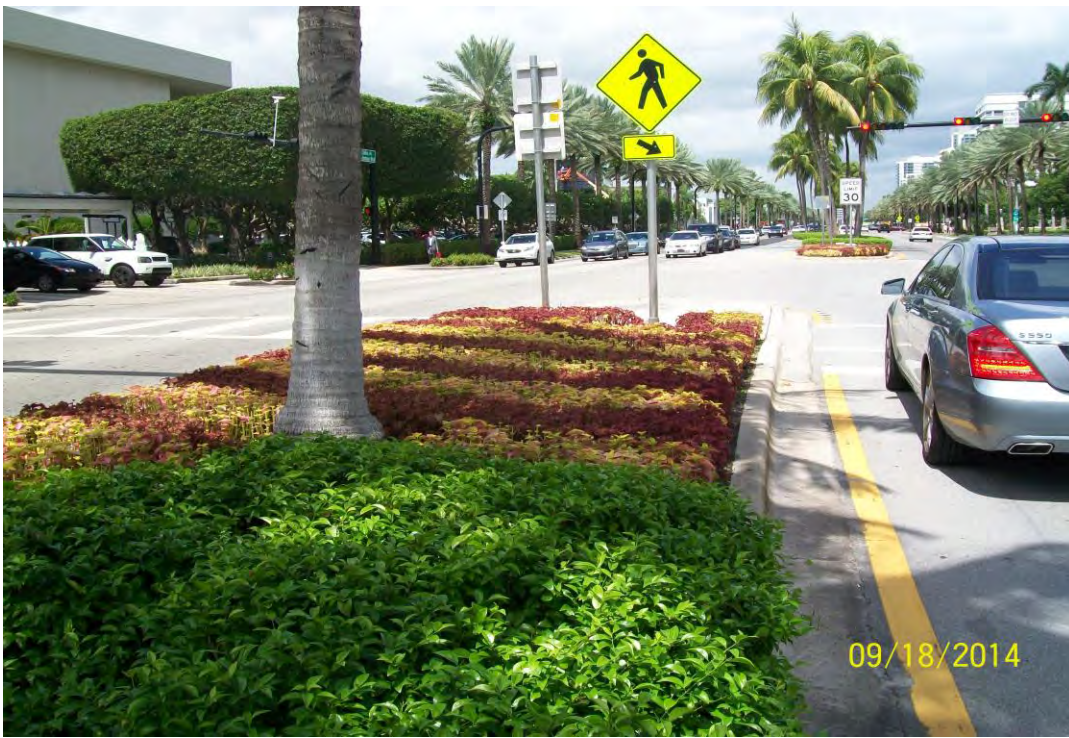
Photo 10: Center median landscaping at *The Shops*, looking north.

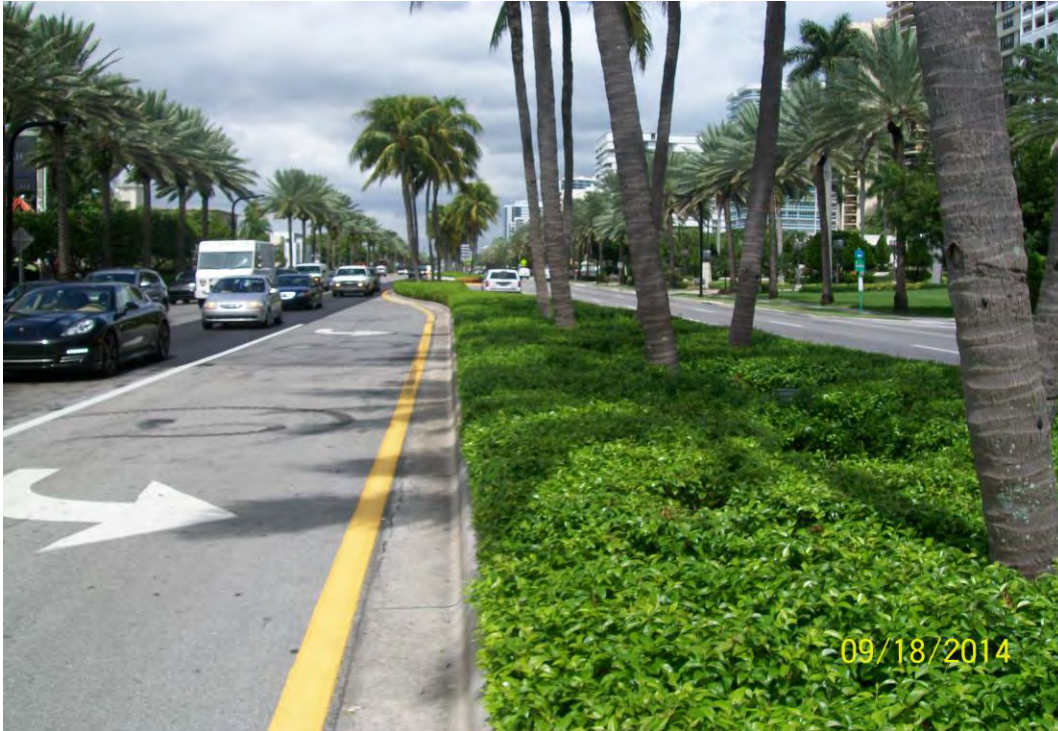
Photo 11: Center median landscaping at *St. Regis*, looking north.
