BAL HARBOUR VILLAGE

UTILITY MASTER PLAN

FEBRUARY 2015

CRAIG A. SMITH & ASSOCIATES
7777 GLADES RD, SUITE 410
BOCA RATON, FL 33434
561.314.4445

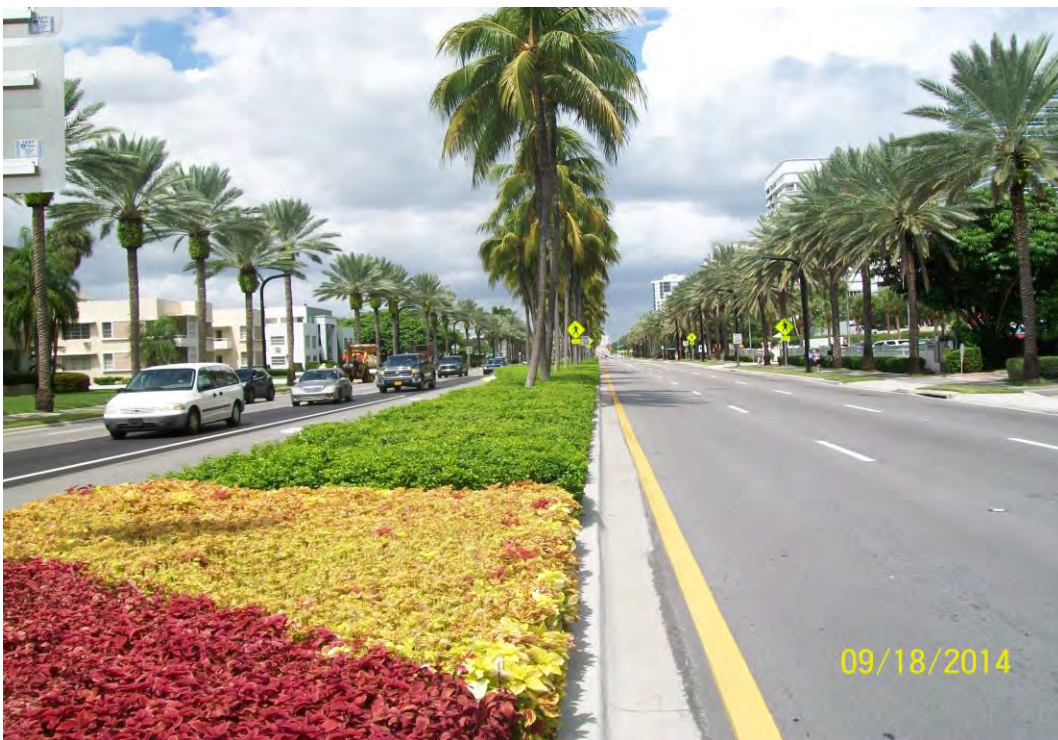
Photo 12: Center median north of Bal Cross Drive, looking north.

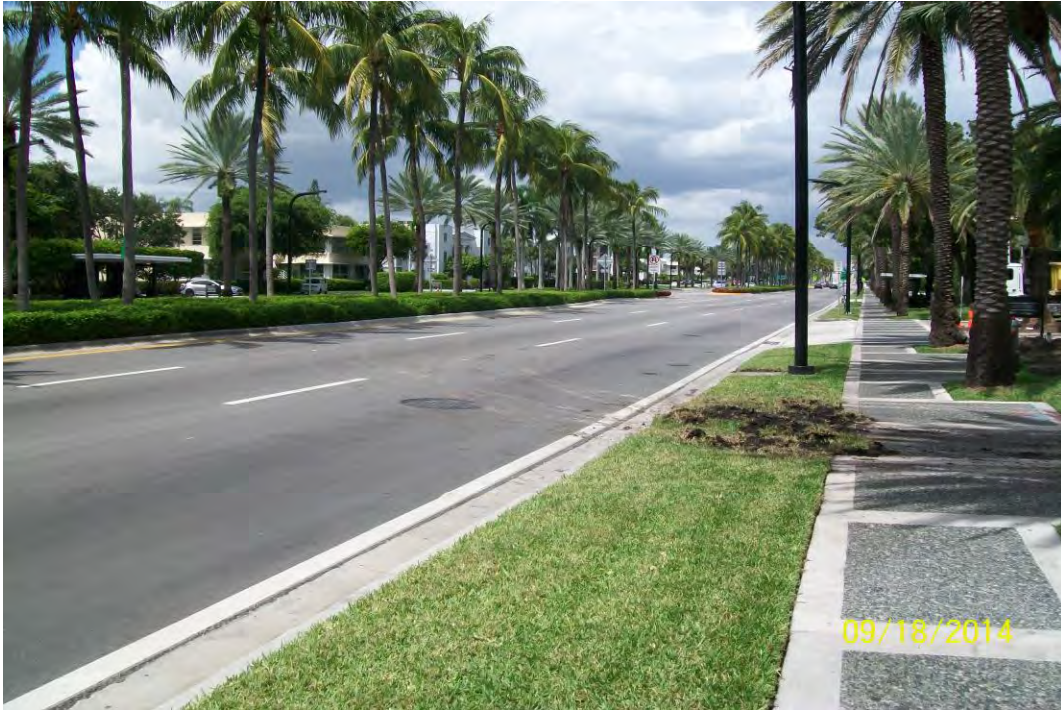
Photo 13: Center median, adjacent to *Tiffany*, looking north.

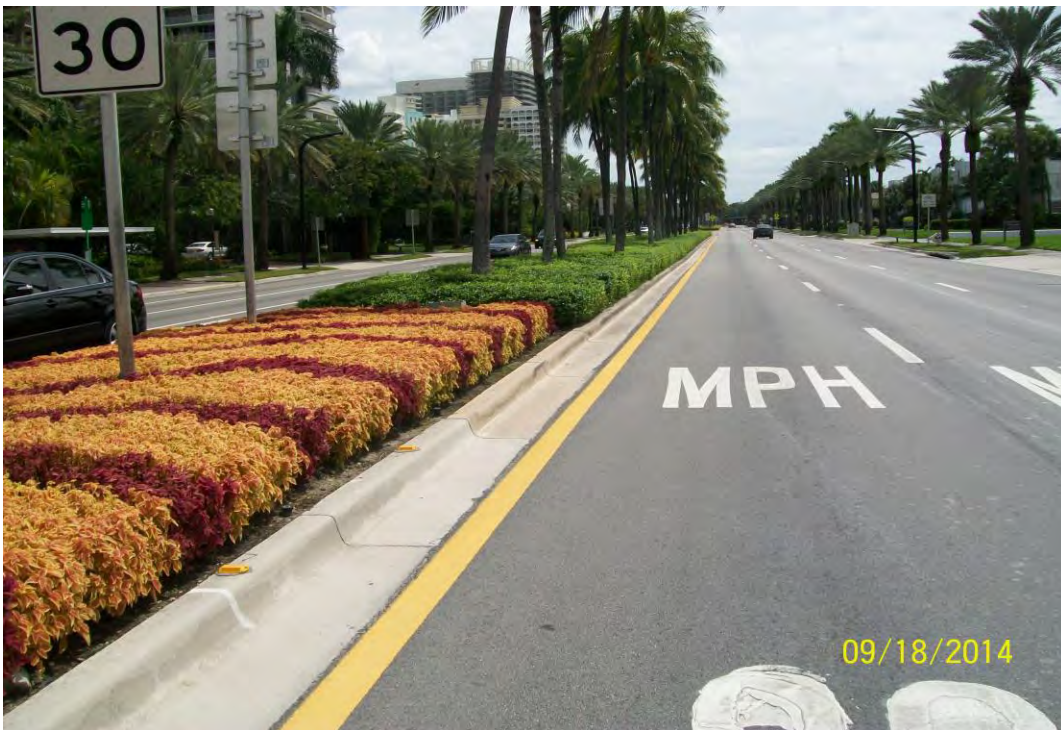
Photo 14: Center median landscaping adjacent to *Oceana*, looking south.

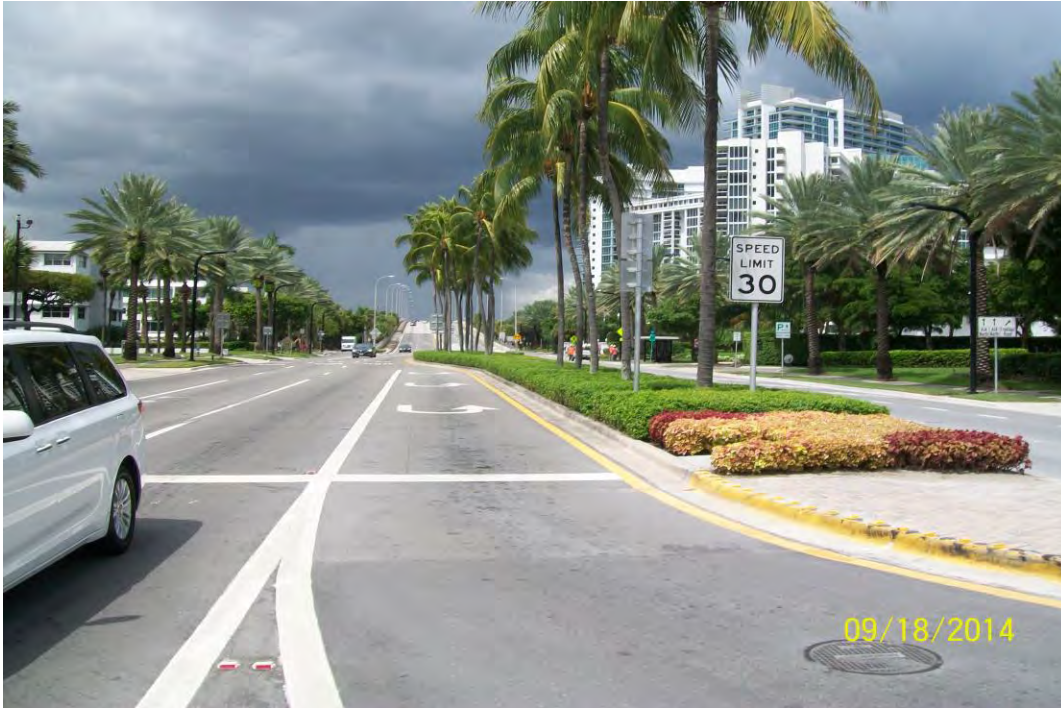
Photo 15: Center median landscaping adjacent to *Bellini*, looking north.

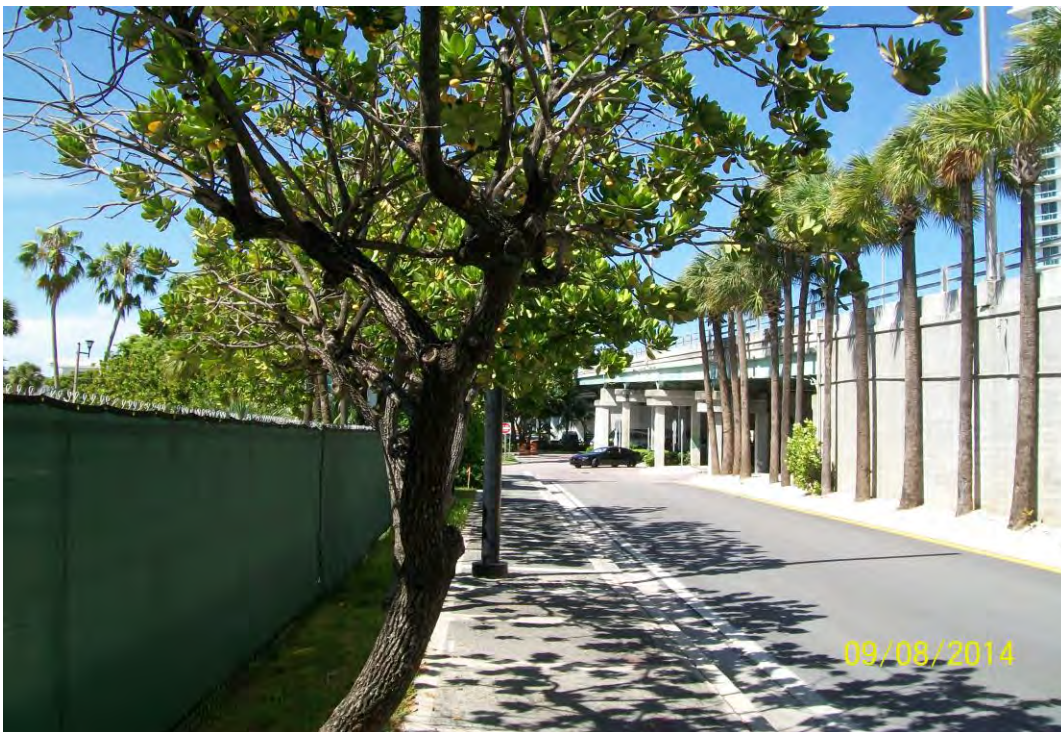
Photo 16: Landscaping on west access road adjacent to Haulover Bridge.

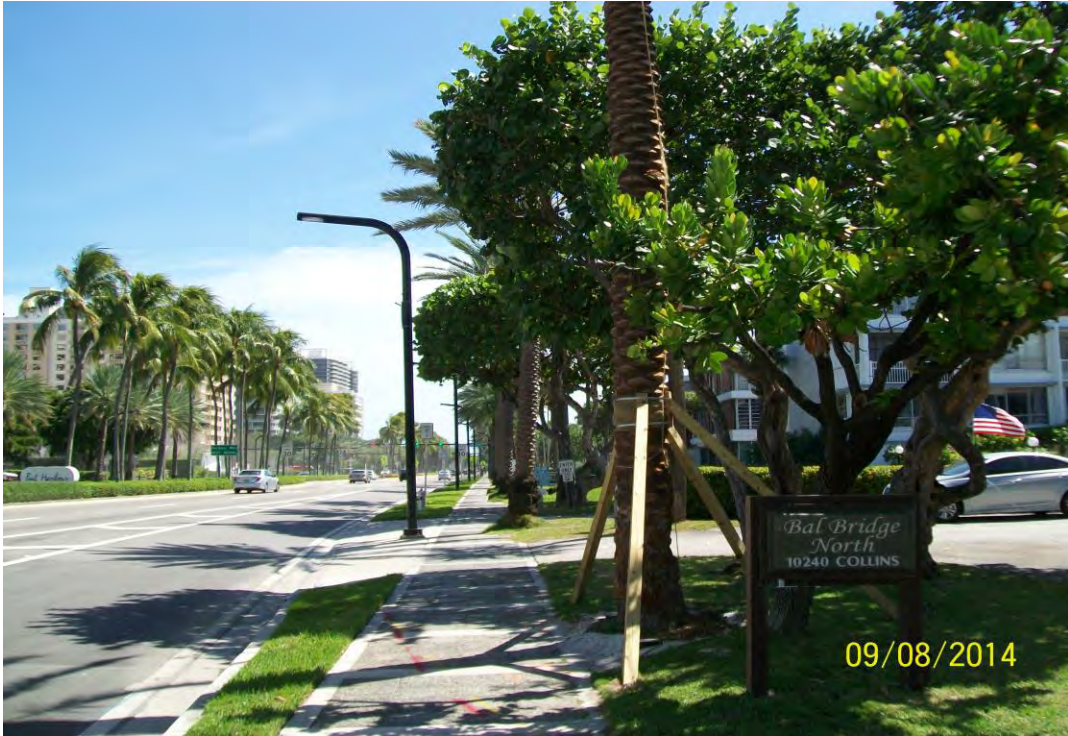
Photo 17: Existing landscaping at *Bal Bridge North*, looking south.

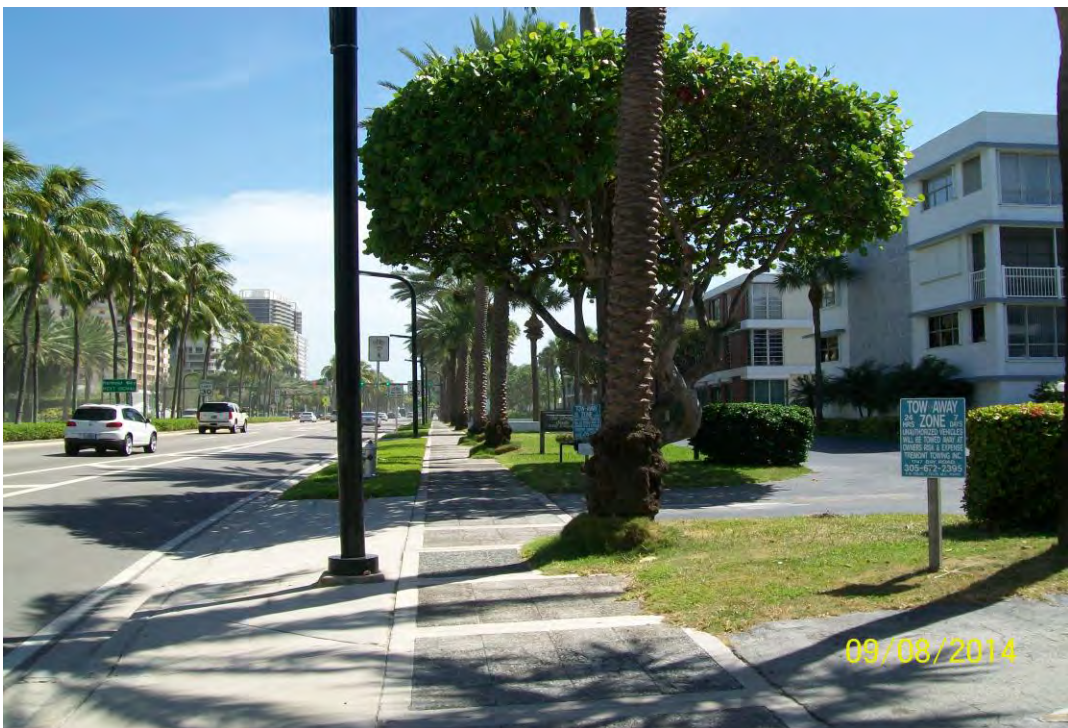
Photo 18: Existing landscaping at west side of Collins Avenue, looking south.

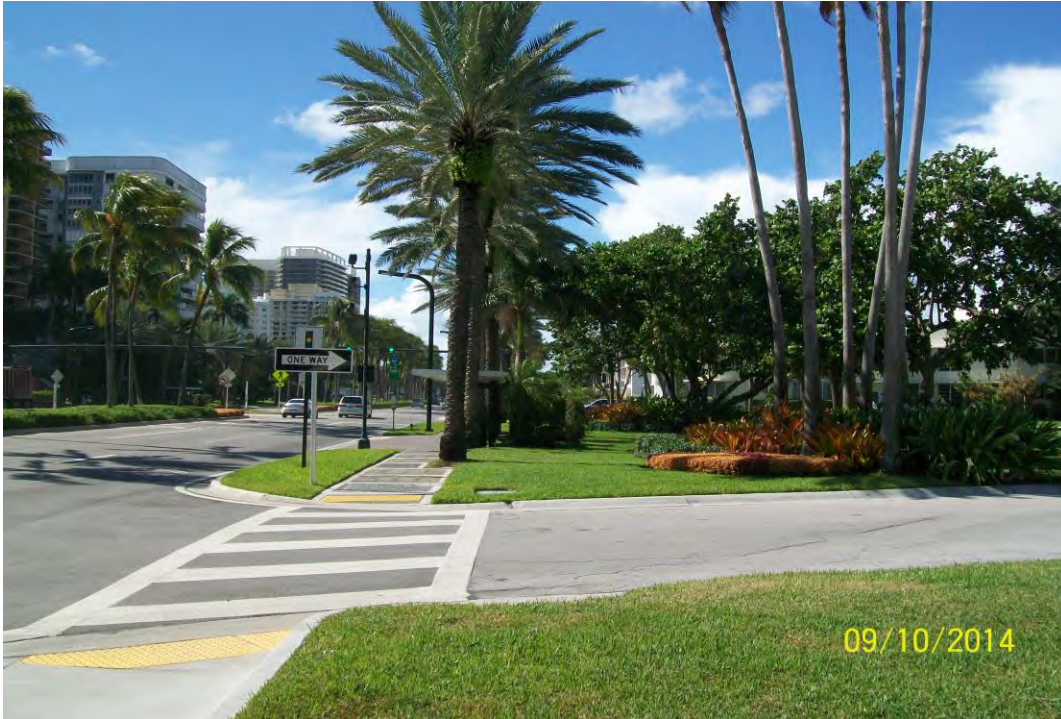
Photo 19: Existing landscaping at Harbour Way, looking south.

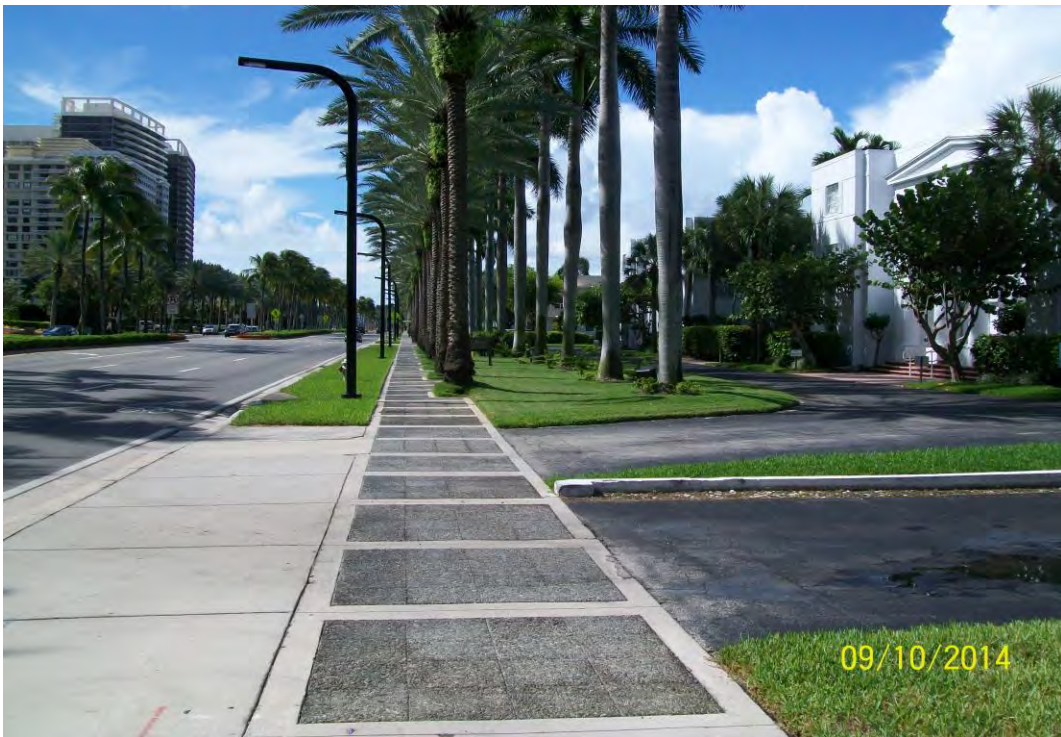
Photo 20: Landscaping at 10170 Collins Avenue, looking south.

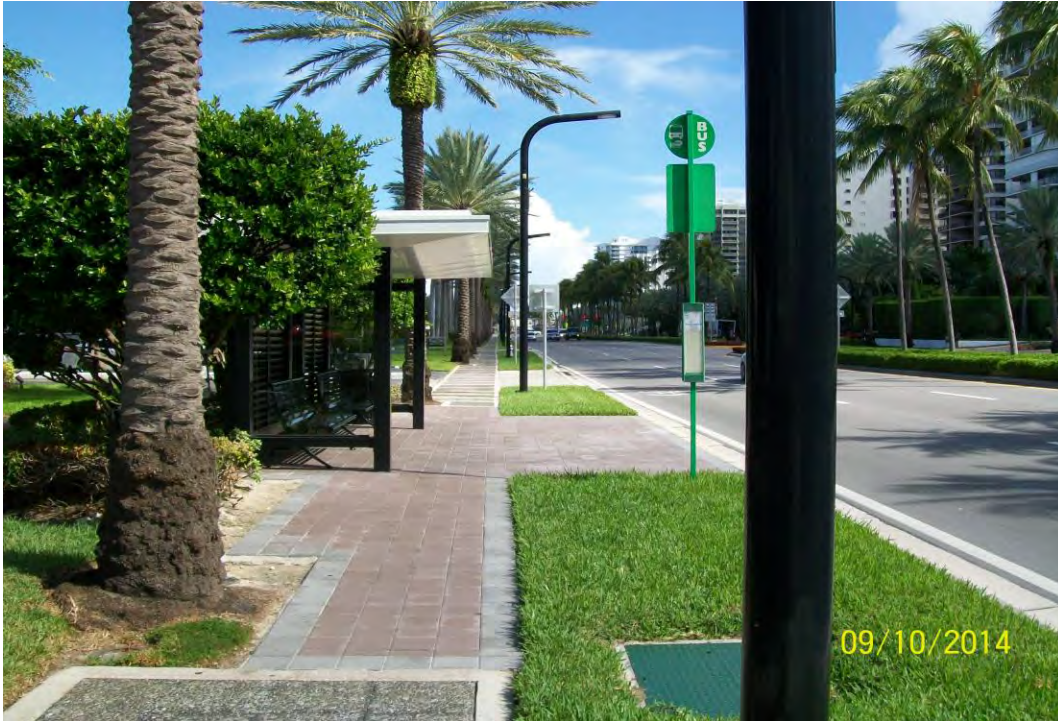
Photo 21: Landscaping near *Collins Apartments*, looking north.

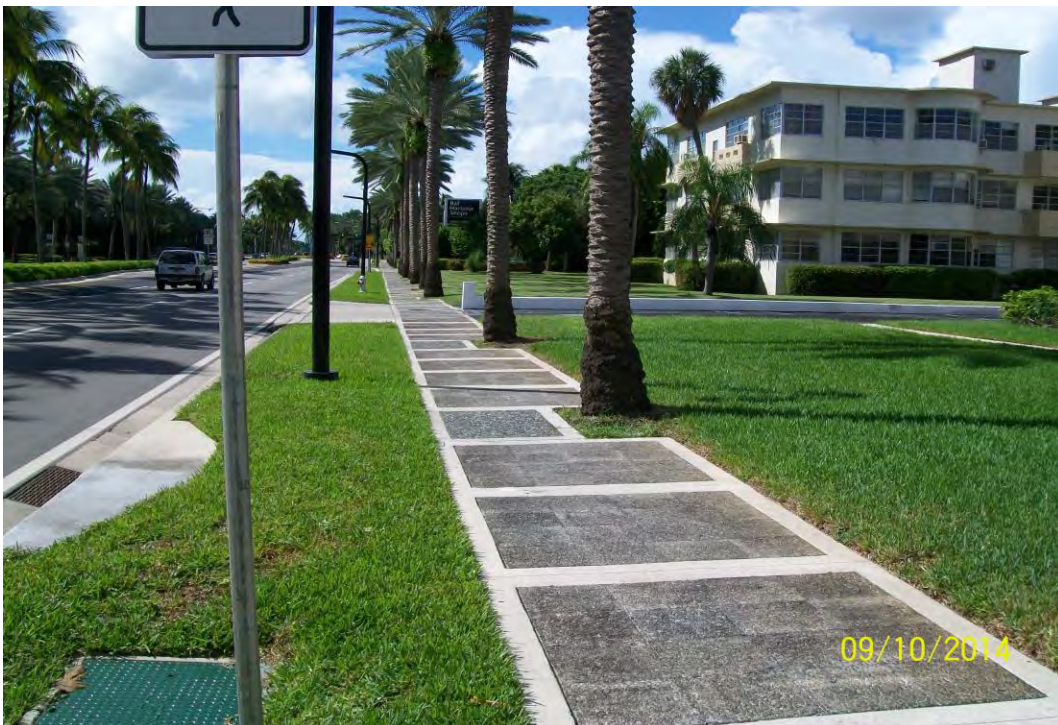
Photo 22: Landscaping adjacent to 9910 Collins Avenue, looking south.

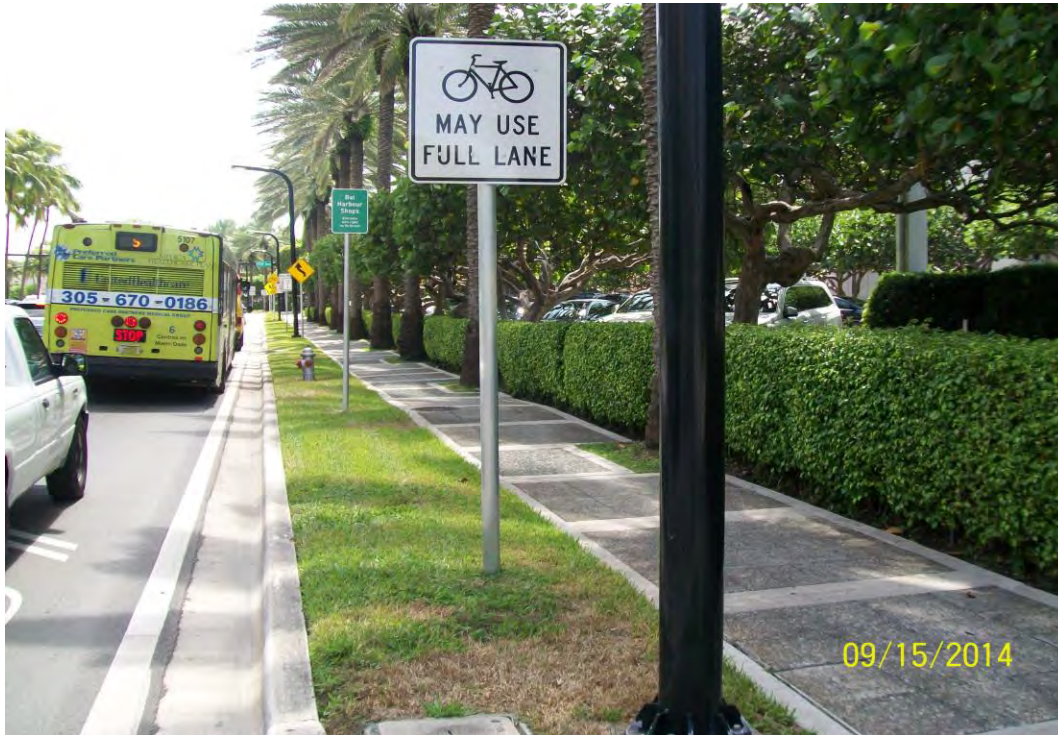
Photo 23: Landscaping adjacent to *The Shops*, looking south.

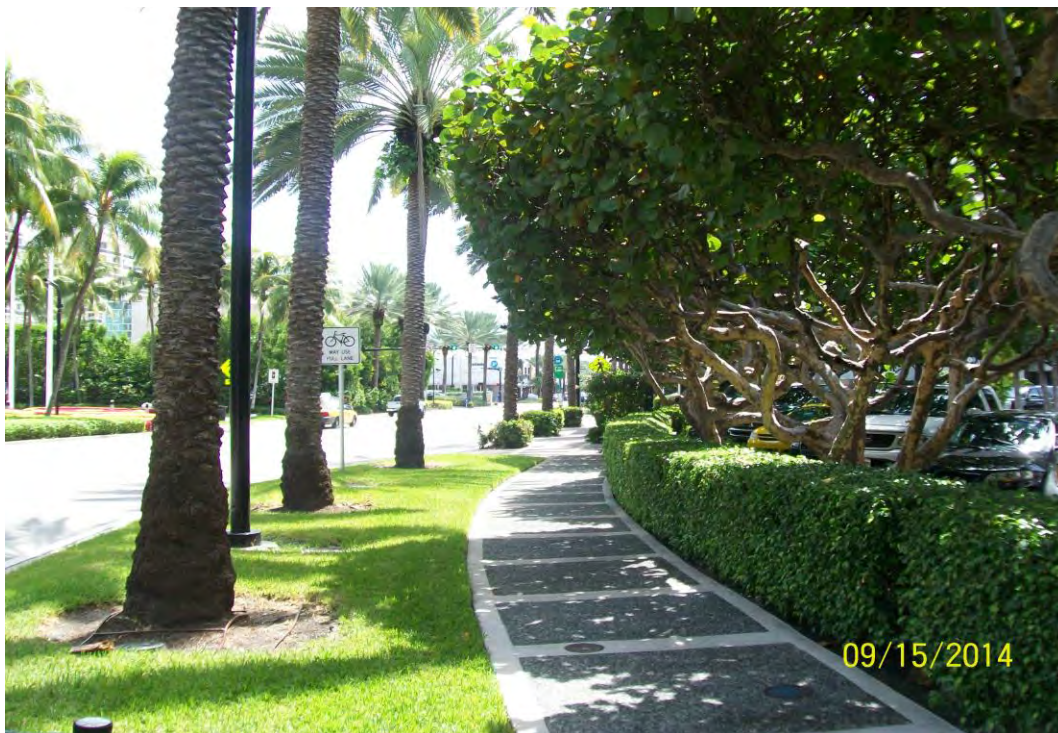
Photo 24: Landscaping adjacent to *The Shops*, looking south.

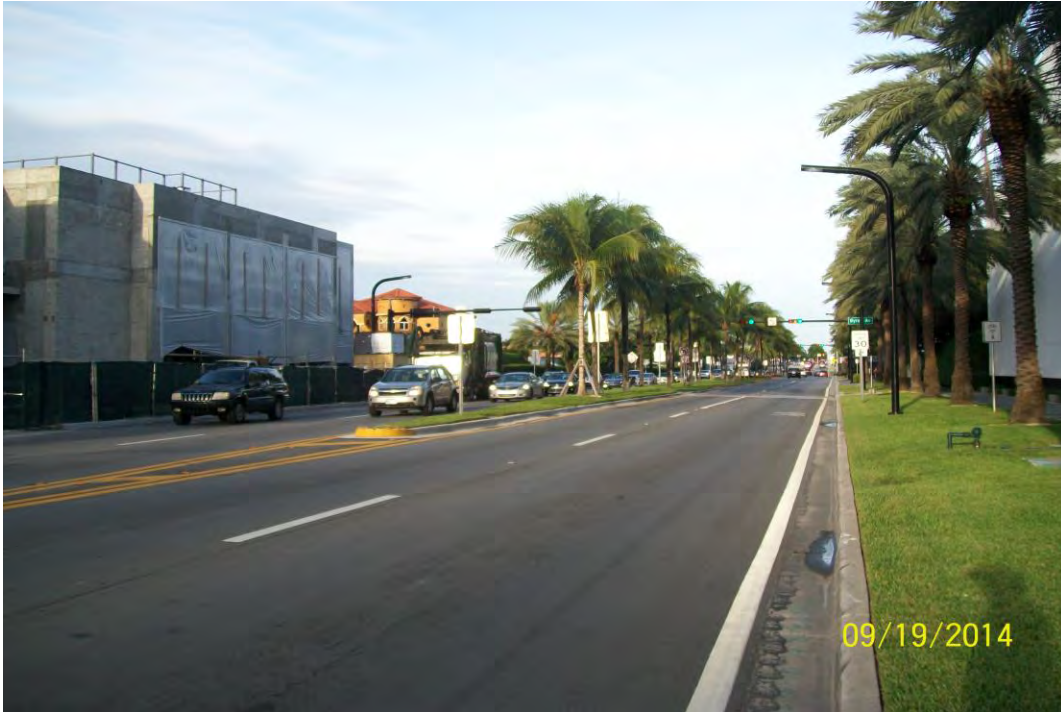
Photo 1 : Existing 96TH Street landscaping, looking east.

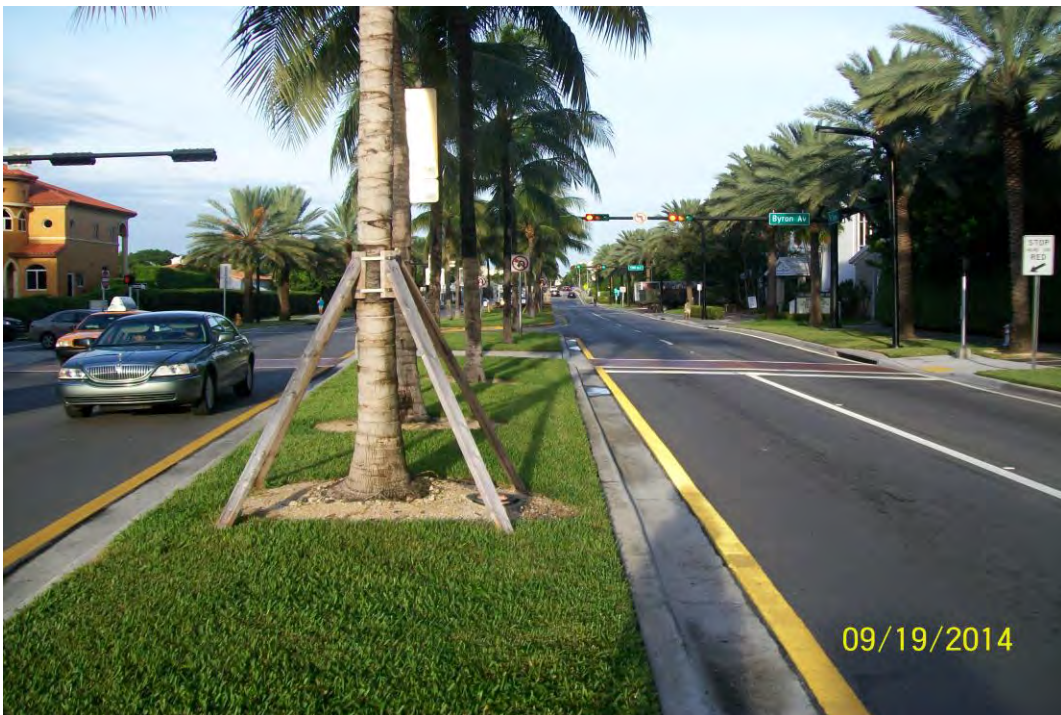
Photo 2: Median landscaping at Byron Avenue, looking east.

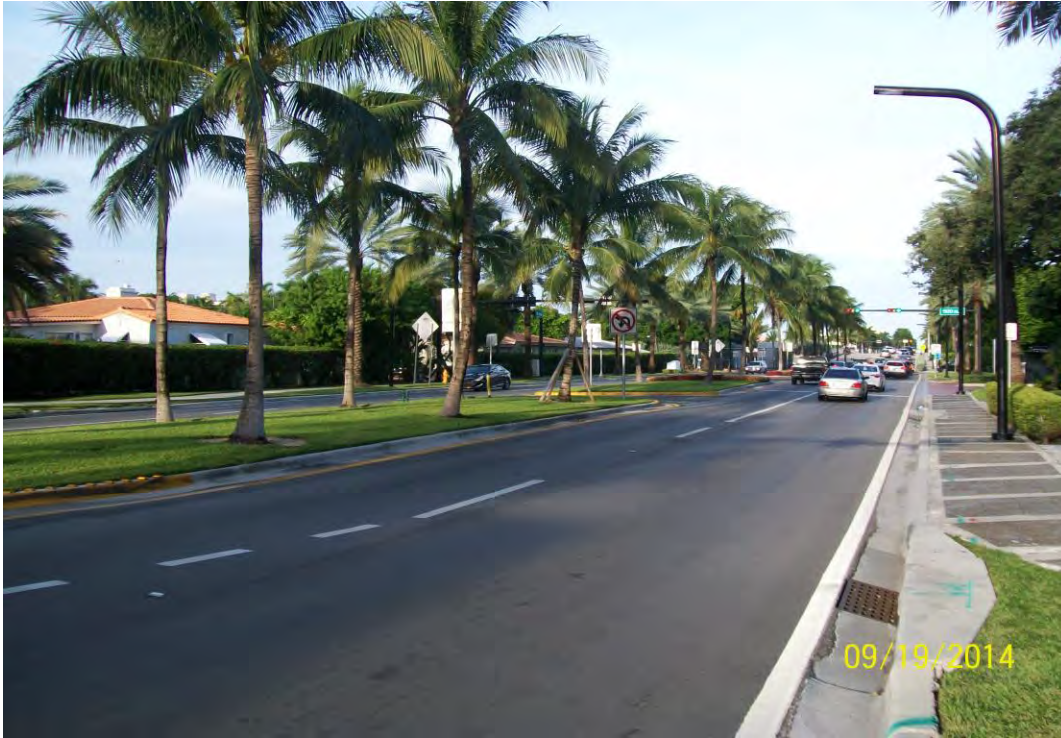
Photo 3: Median and north side landscaping, looking west.

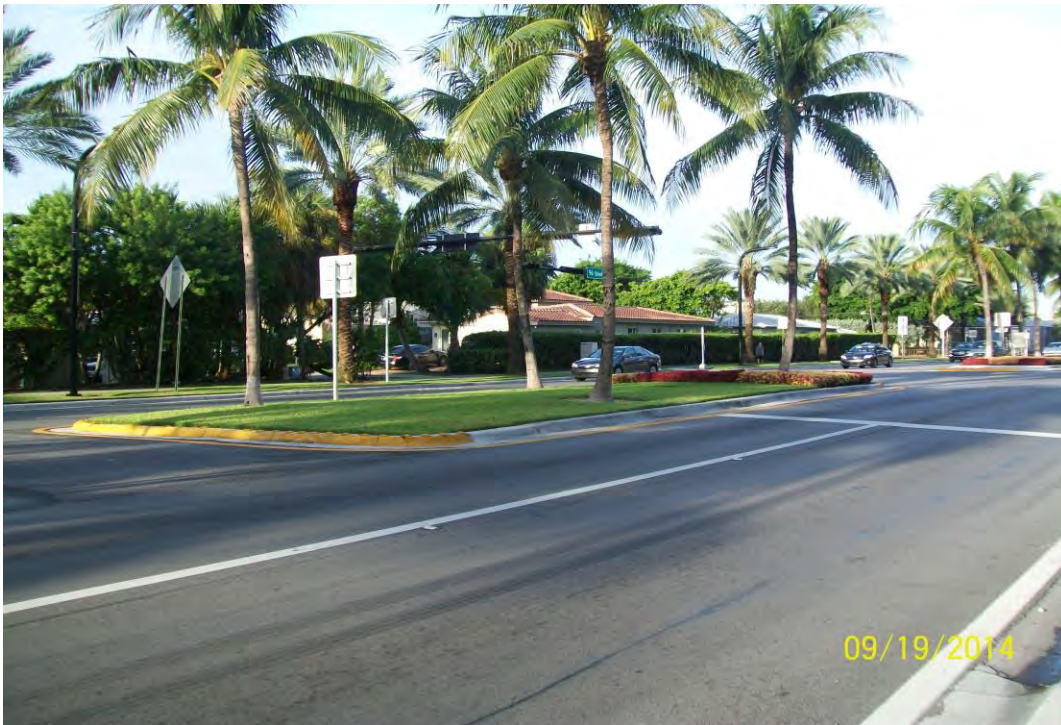
Photo 4: Existing median landscaping at 500 Block, looking southwest.

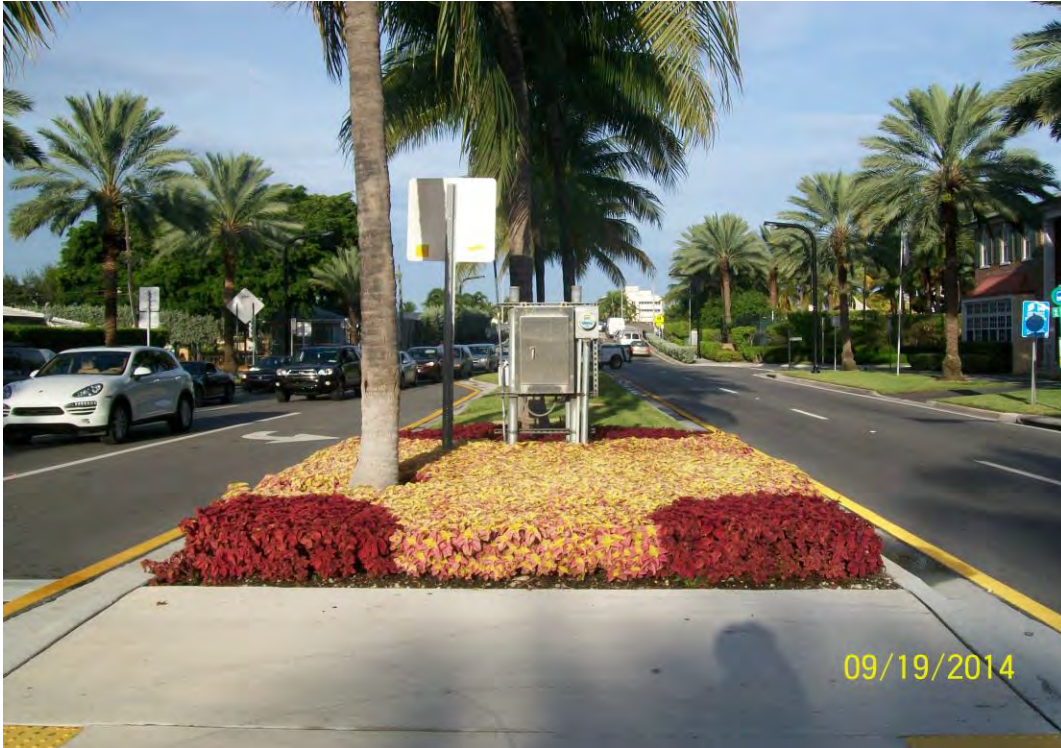
Photo 5: Existing median landscaping, looking west.

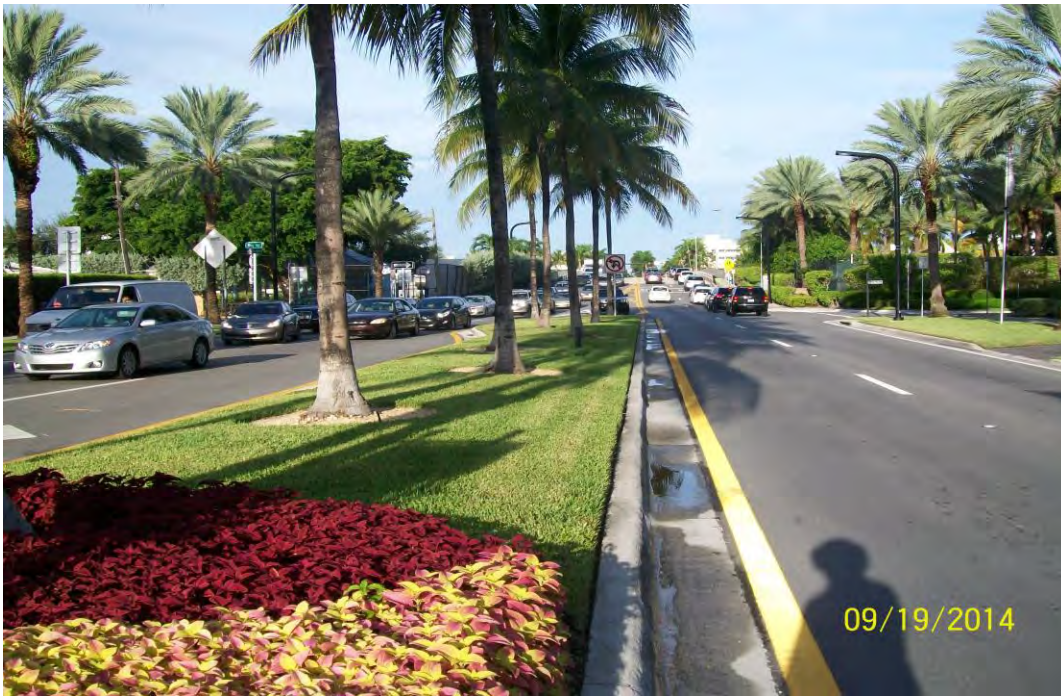
Photo 6: Existing median and north side landscaping, looking west.

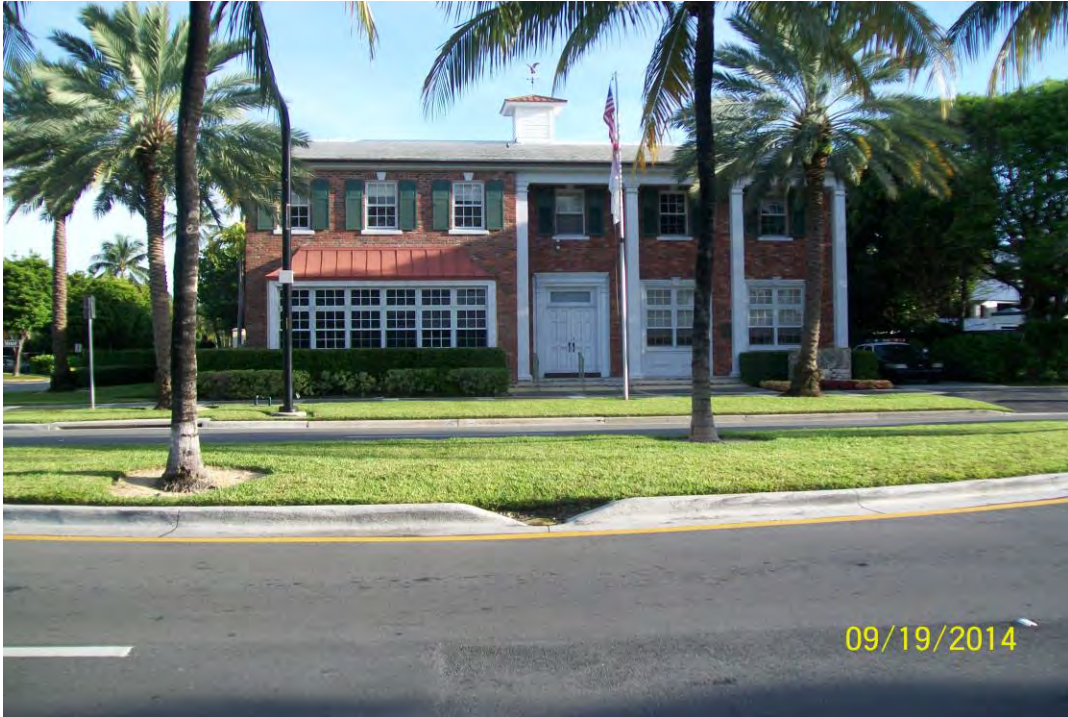
Photo 7: Existing landscaping at Village Hall, looking north.

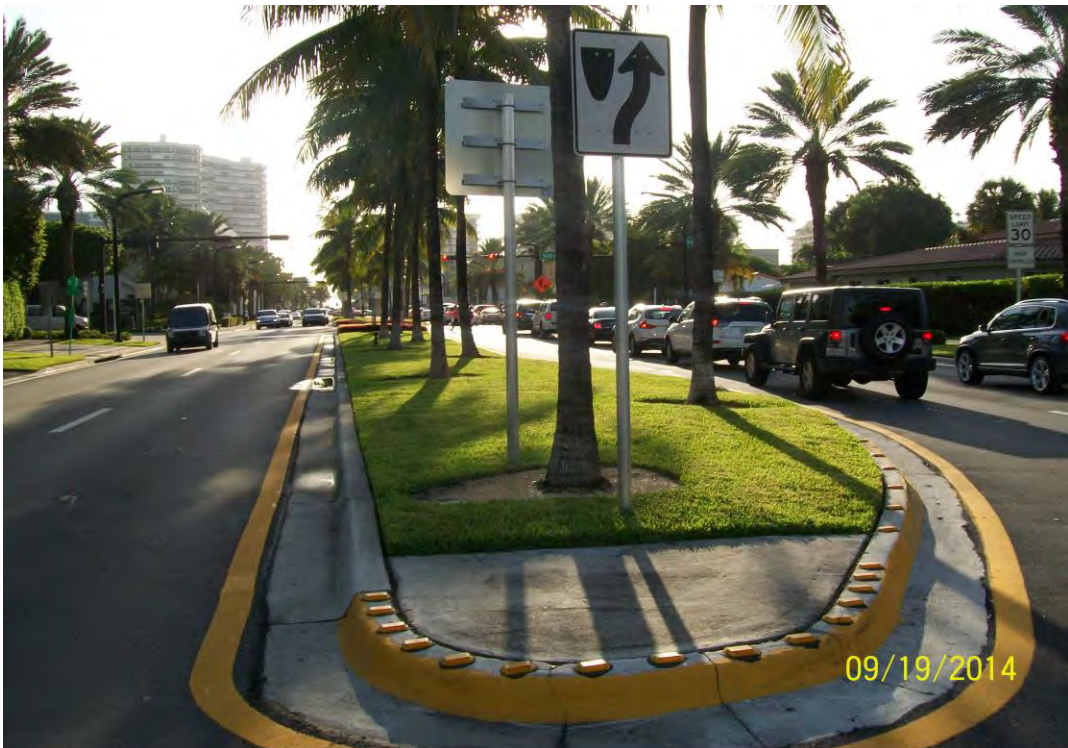
Photo 8: Existing median landscaping, looking east.

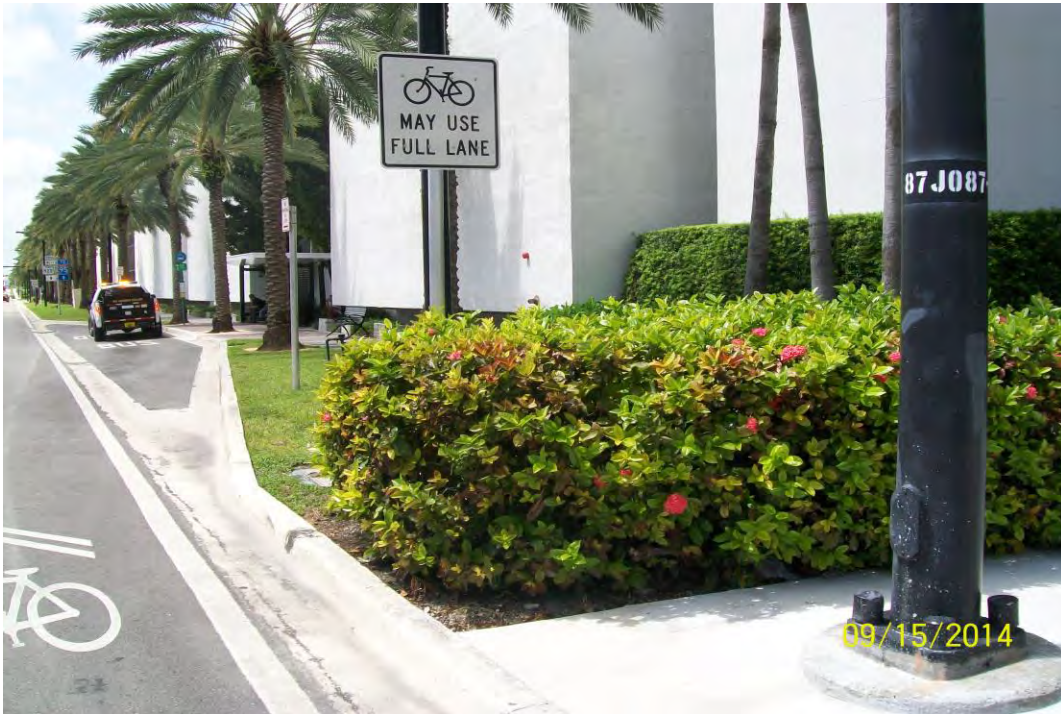
Photo 9 : Existing north landscaping at Harding Avenue, looking west.

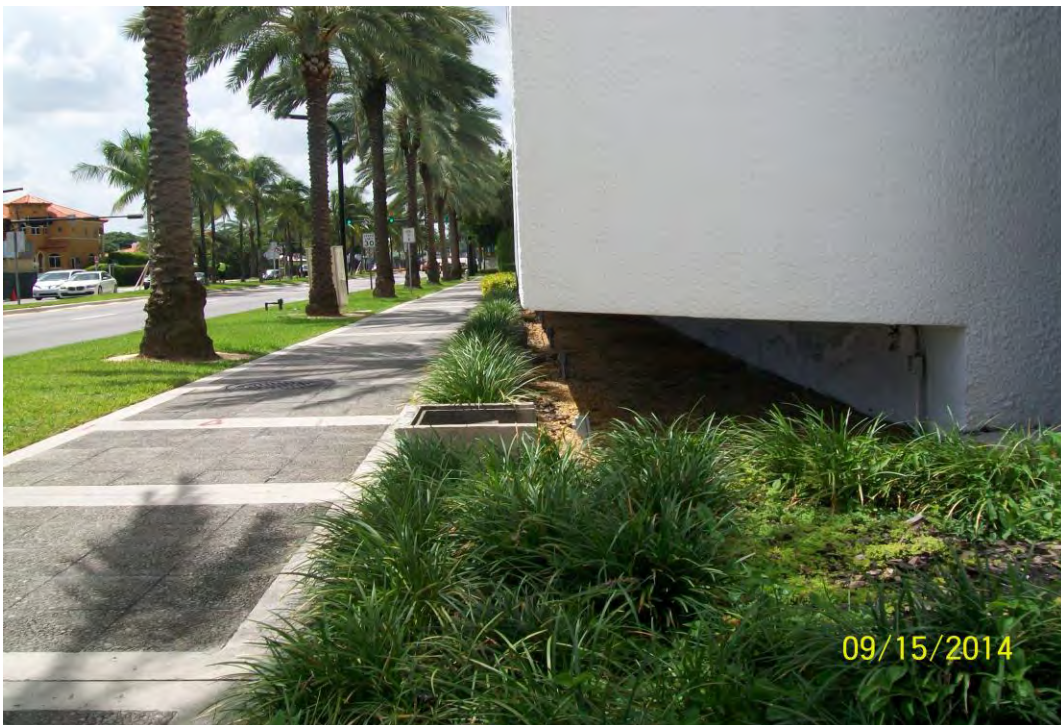
Photo 10: Existing landscaping at the Shops, looking west.

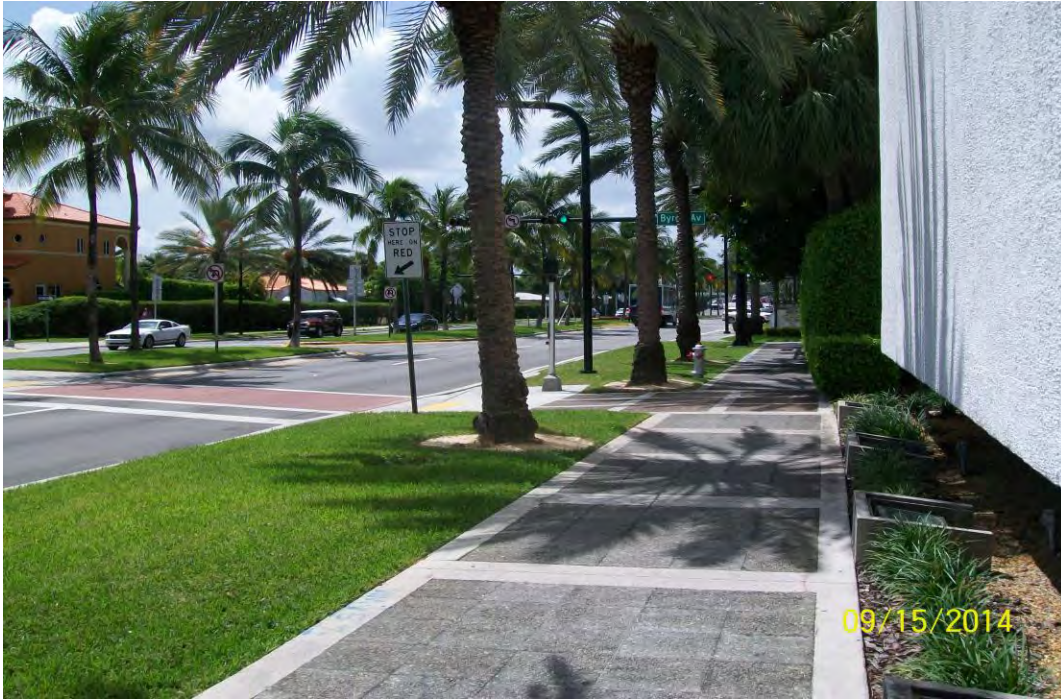
Photo 11: Existing landscaping at the Shops, looking west.

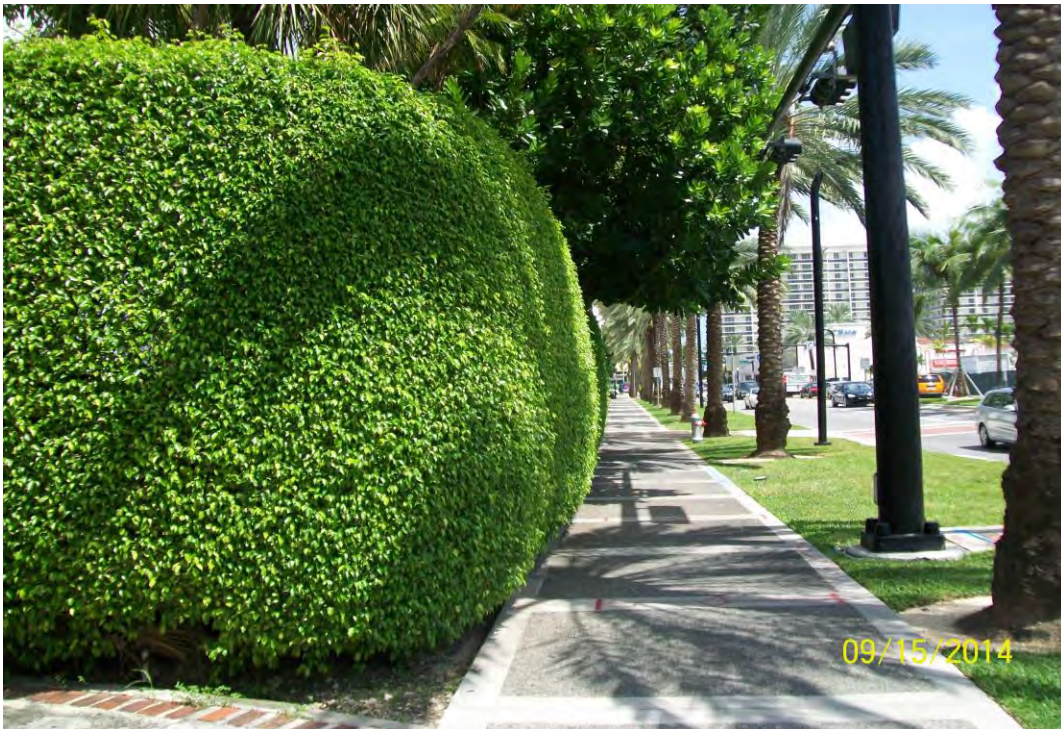
Photo 12: Existing landscaping at Byron Avenue, looking east.

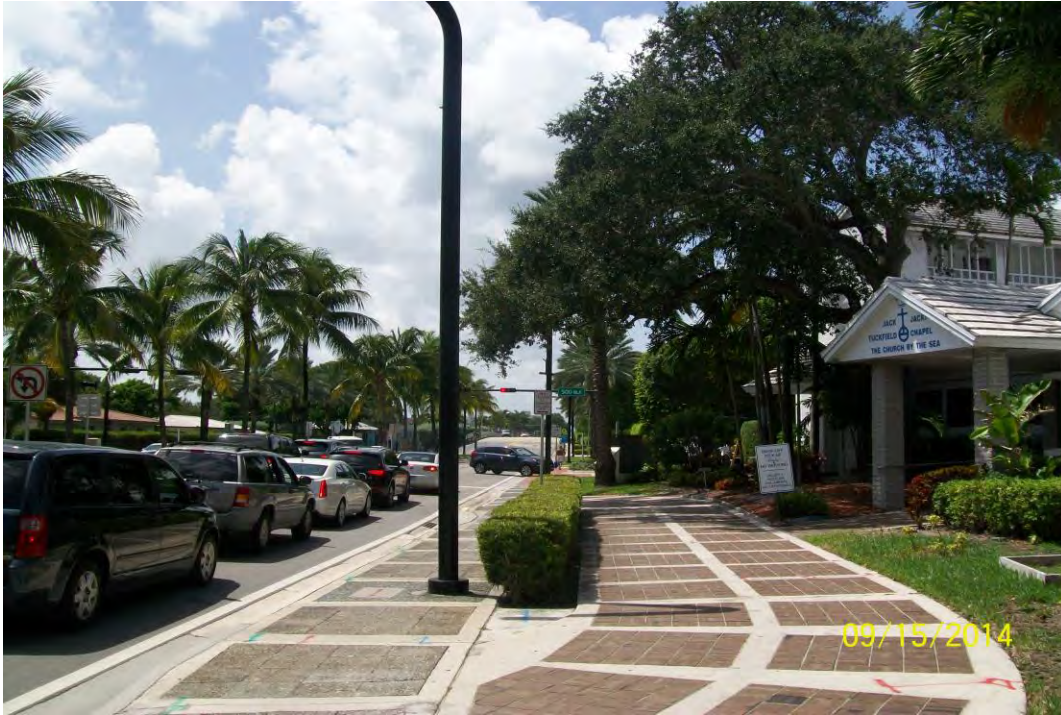
Photo 13: Existing landscaping at Church by the Sea, looking west.

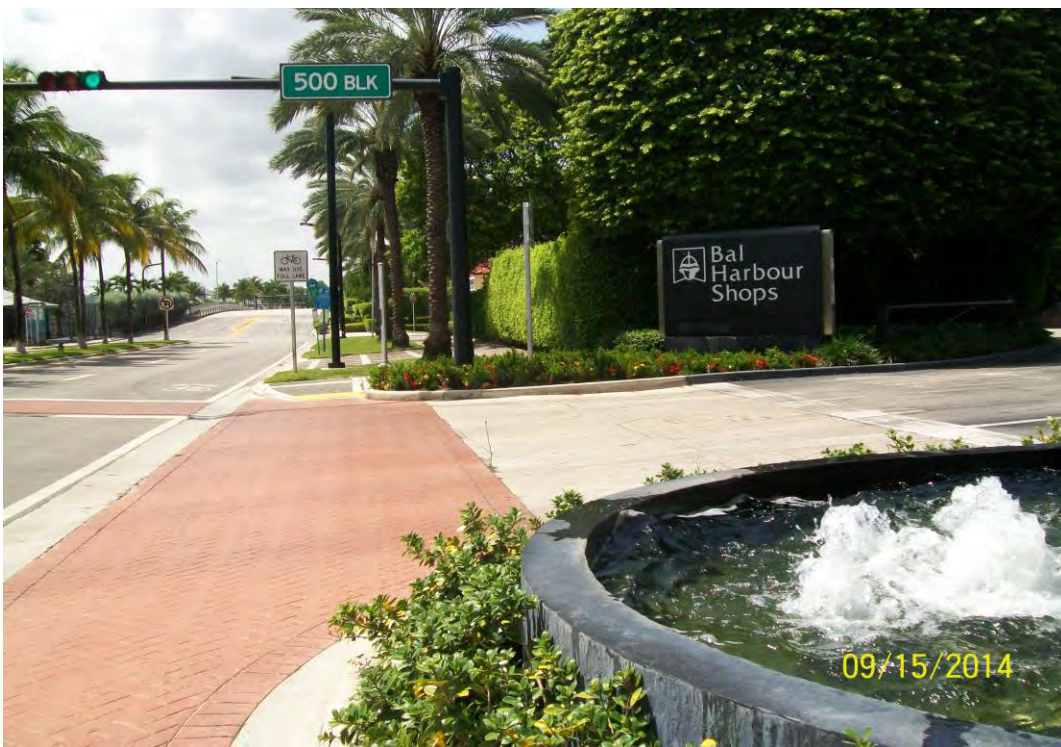
Photo 14: Existing north landscaping at 500 Block, looking west.

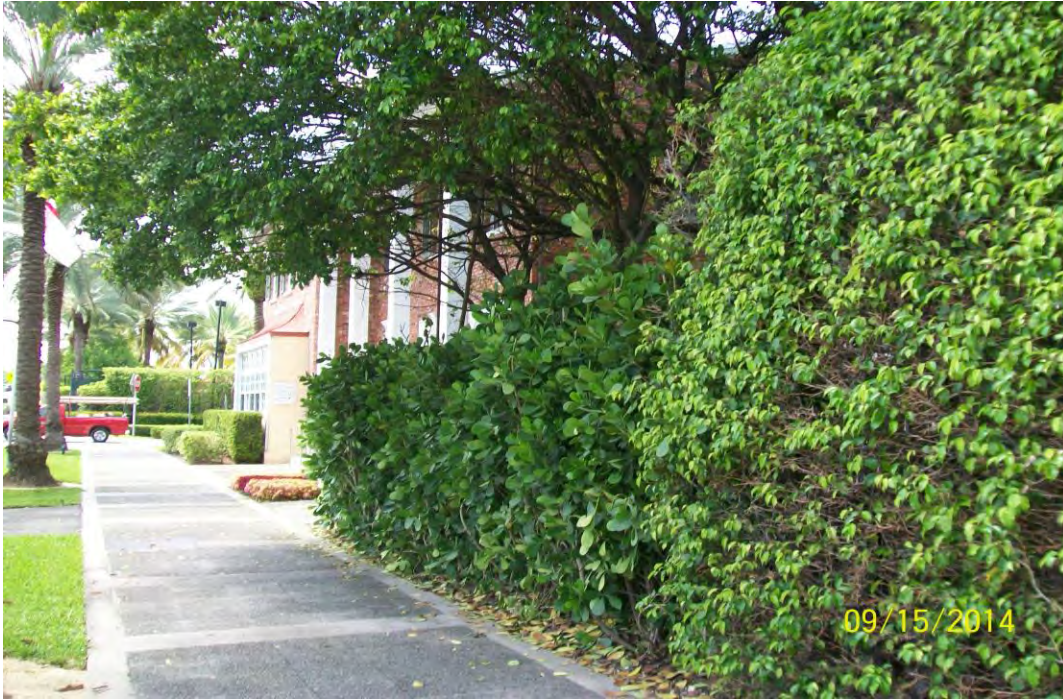
Photo 15: Existing north landscaping near Village Hall, looking west.

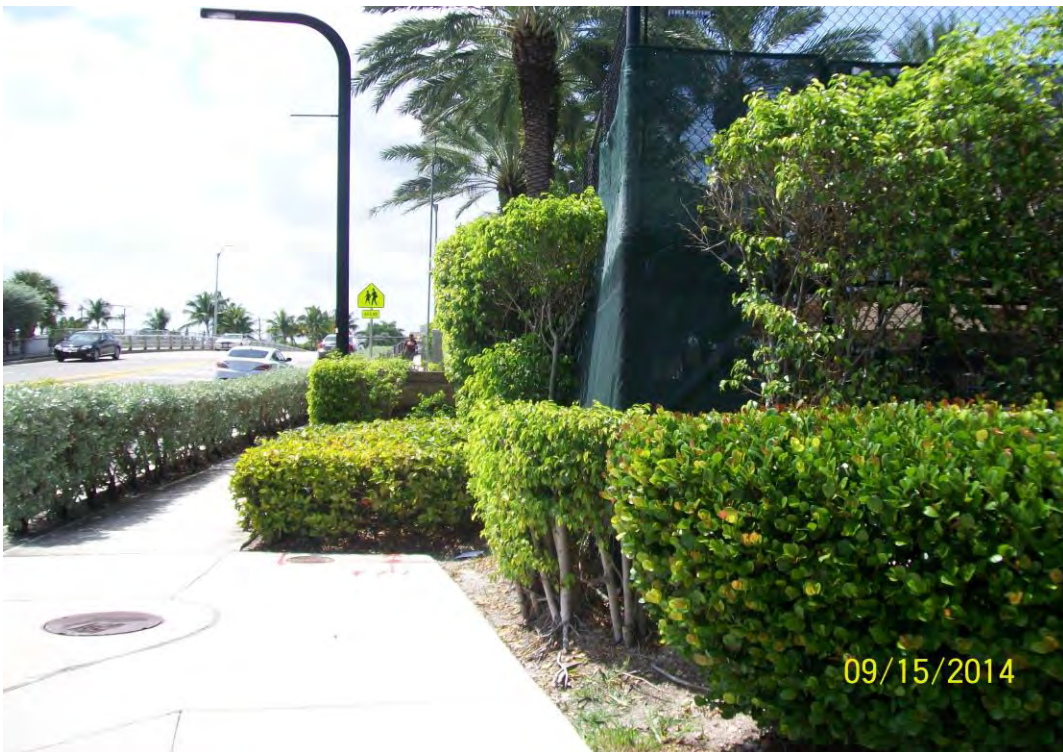
Photo 16: Existing north landscaping near bridge, looking west.
