BAL HARBOUR VILLAGE

UTILITY MASTER PLAN

FEBRUARY 2015

CRAIG A. SMITH & ASSOCIATES
7777 GLADES RD, SUITE 410
BOCA RATON, FL 33434
561.314.4445

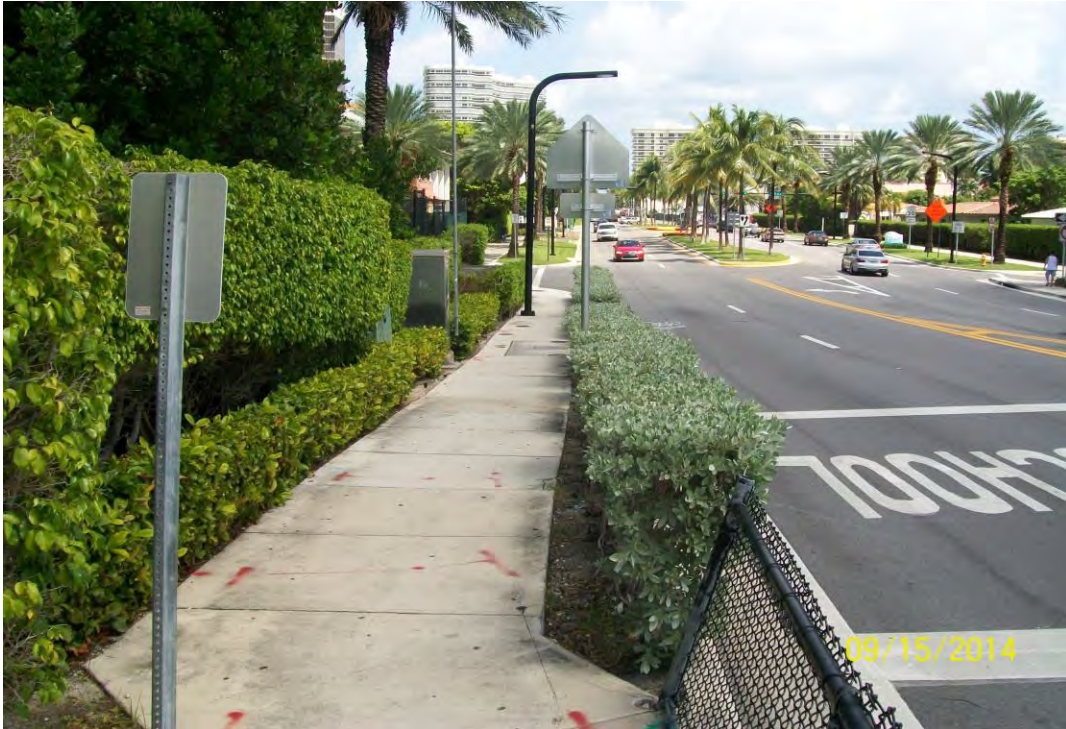
Photo 17 : Existing 96TH Street landscaping, looking east.

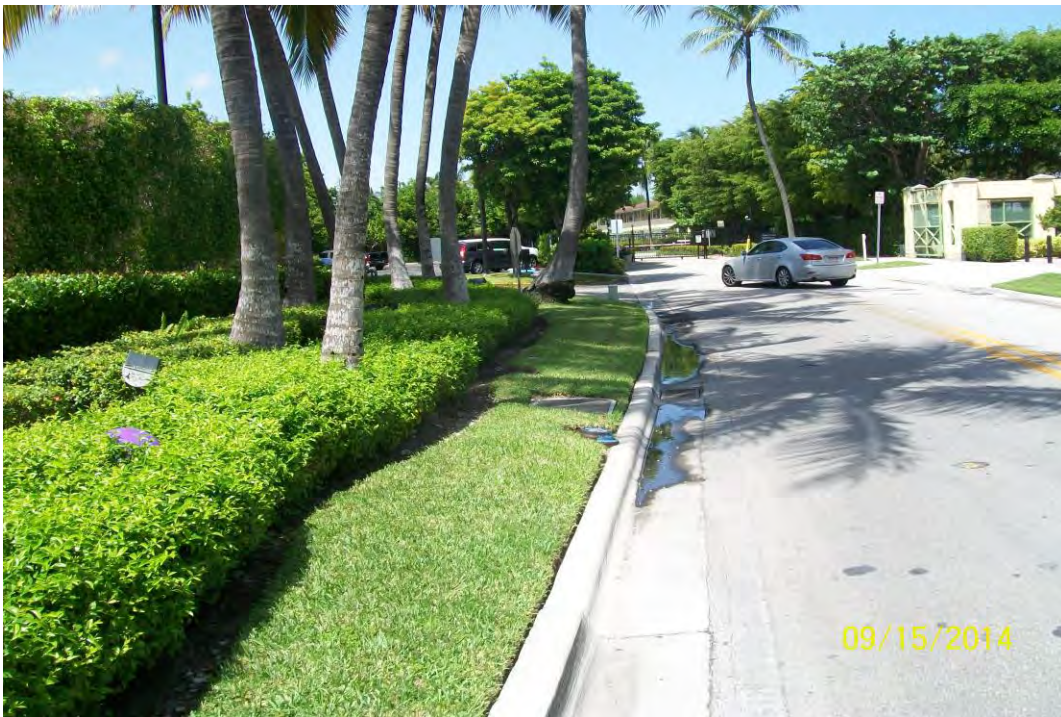
Photo 18: Existing landscaping at Bal Bay Drive, looking north.

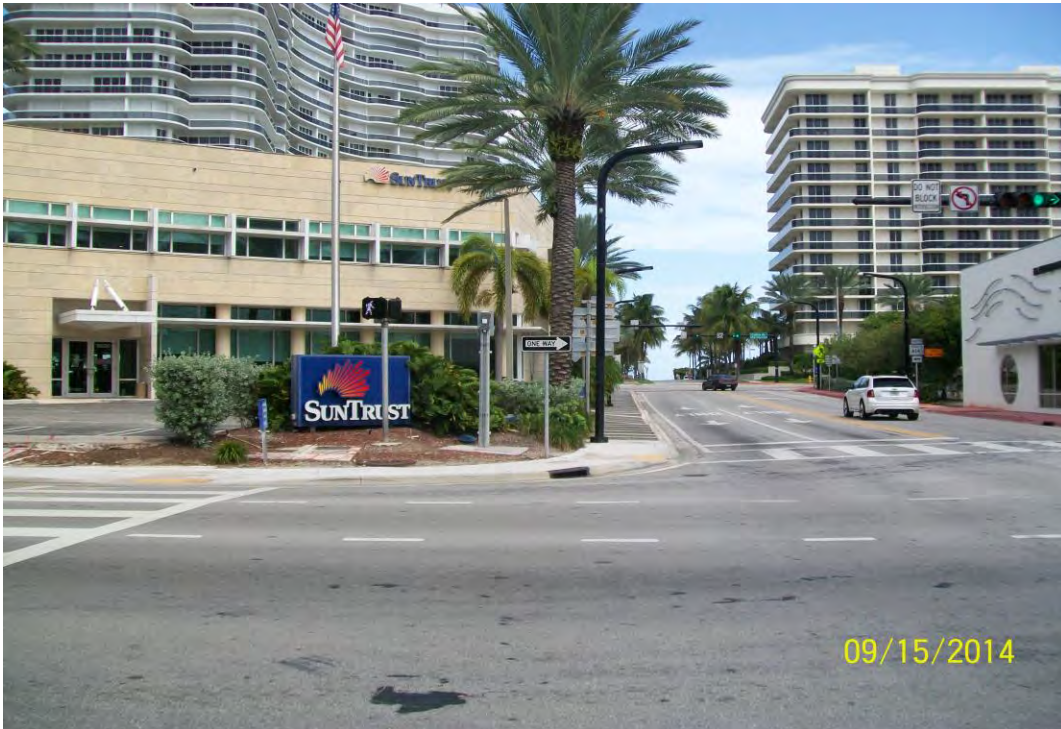
Photo 19: North side landscaping at Harding Avenue, looking east.

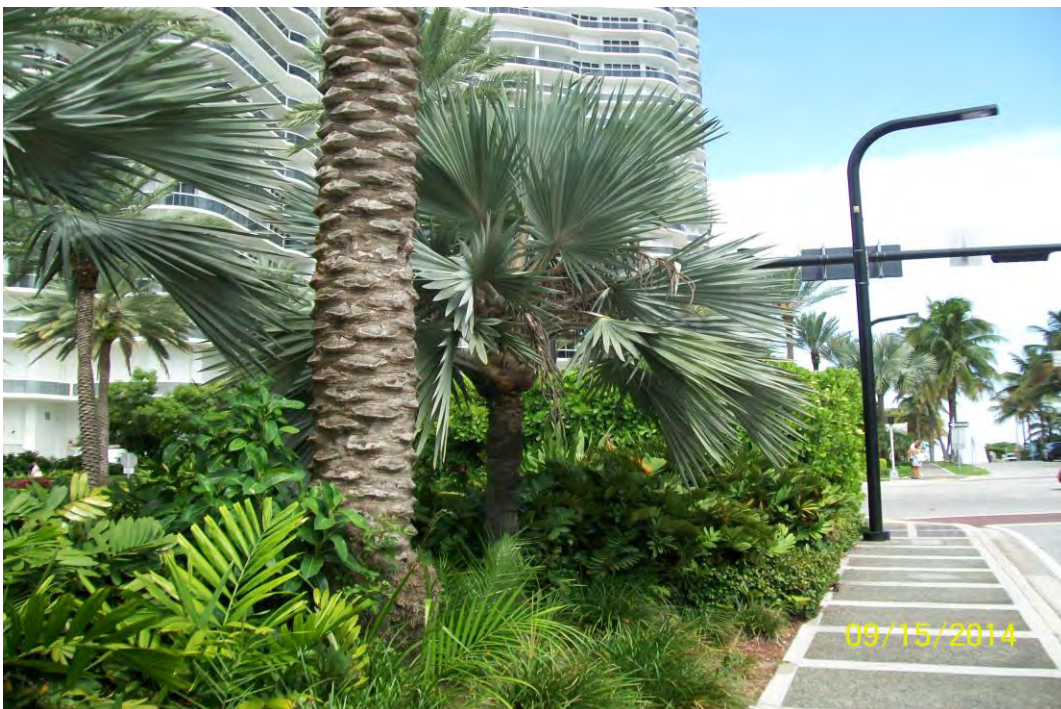
Photo 20: North side landscaping at Sun Trust Bank, looking east.

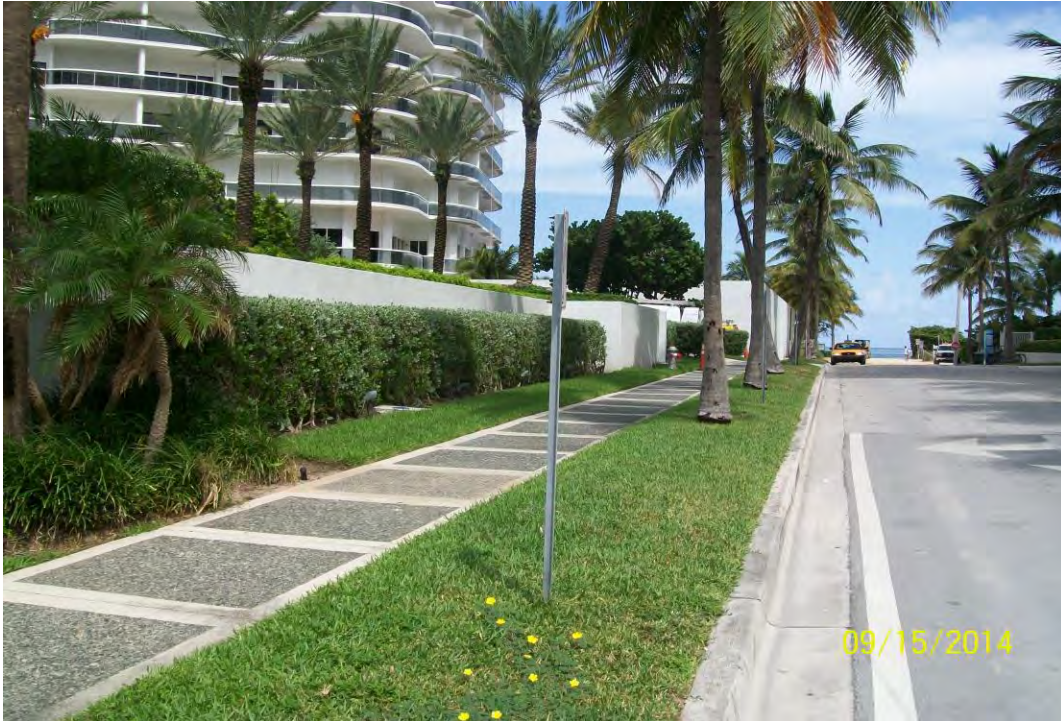
Photo 21: Landscaping at the Majestic, looking east.

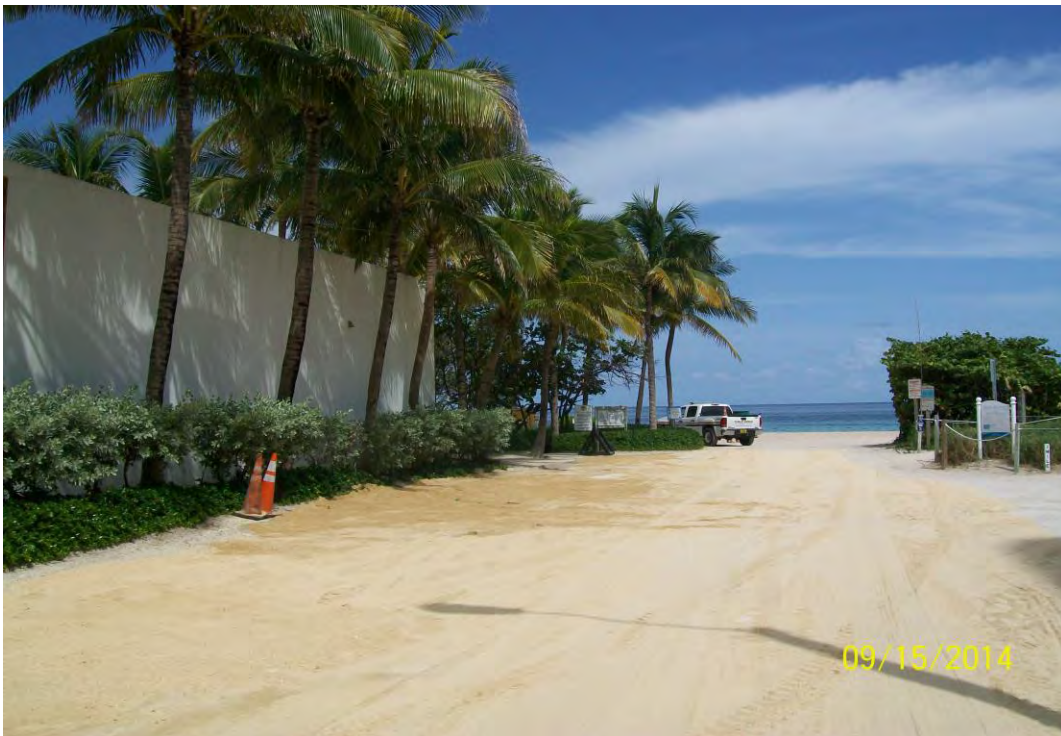
Photo 22: Existing landscaping at east end of 96th Street, looking east.
